Chico Creek Watershed Assessment for the Identification of Protection and Restoration Actions

Kitsap County, Washington

July 31, 2014

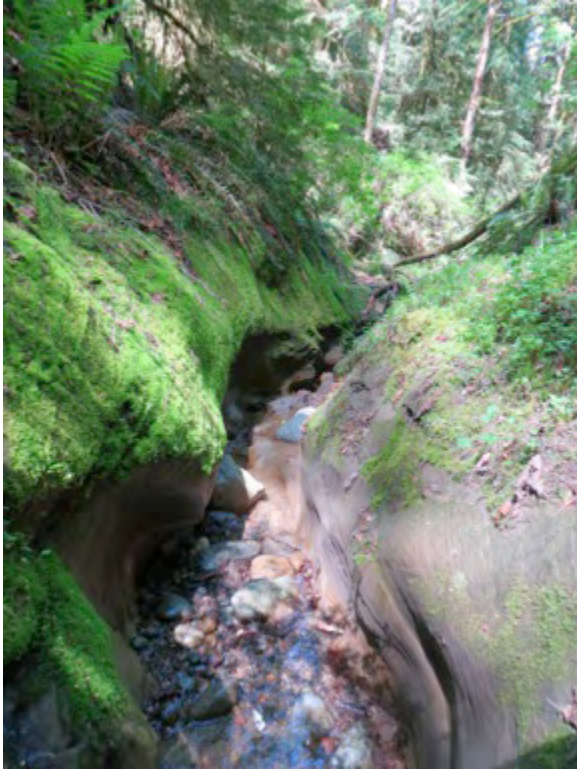
Figure 30. Photo of moderately steep, forested channel segment that has incised a narrow ravine in response to accelerated surface runoff. Much of the small watershed of this right bank tributary to Lost Creek was clearcut and had road construction in the 1990s and in about 2004. In 2009 the Ueland Tree Farm donated a conservation easement for part of the subbasin to the Mountaineers Foundation to protect this riparian corridor and stream into the future. The parcel was purchased by the Mountaineers Foundation in 2012 with a donation from the Suquamish Tribe under EPA's National Estuary Program. Photo taken May 2013 by Steve Todd

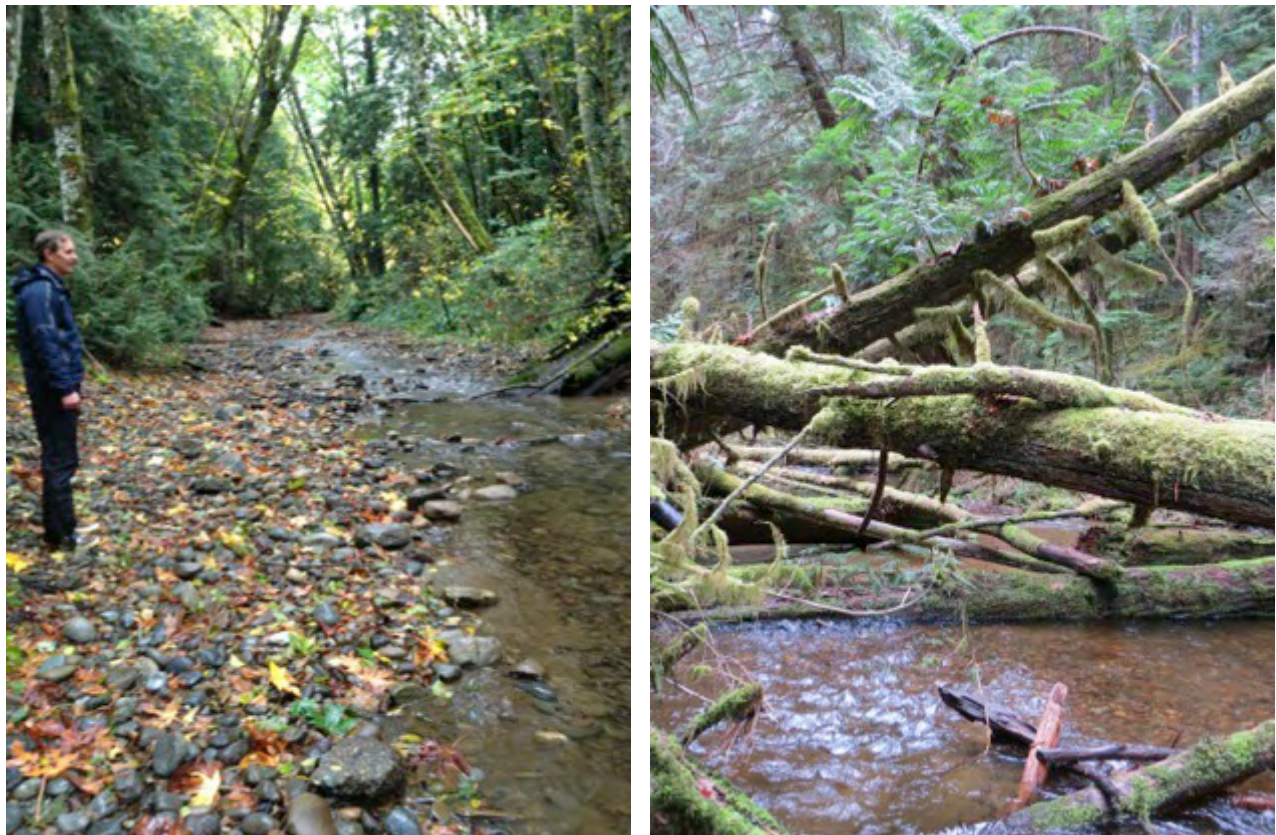
Figure 32. Photograph comparison of a reach lacking channel complexity due to deficiency of wood in Chico Creek upstream of Taylor Road (left) and a reach with active wood recruitment and increased channel complexity in Wildcat Creek (right). Photos by Shawn Higgins, NSD (left) and Steve Todd, Suquamish Tribe (right).

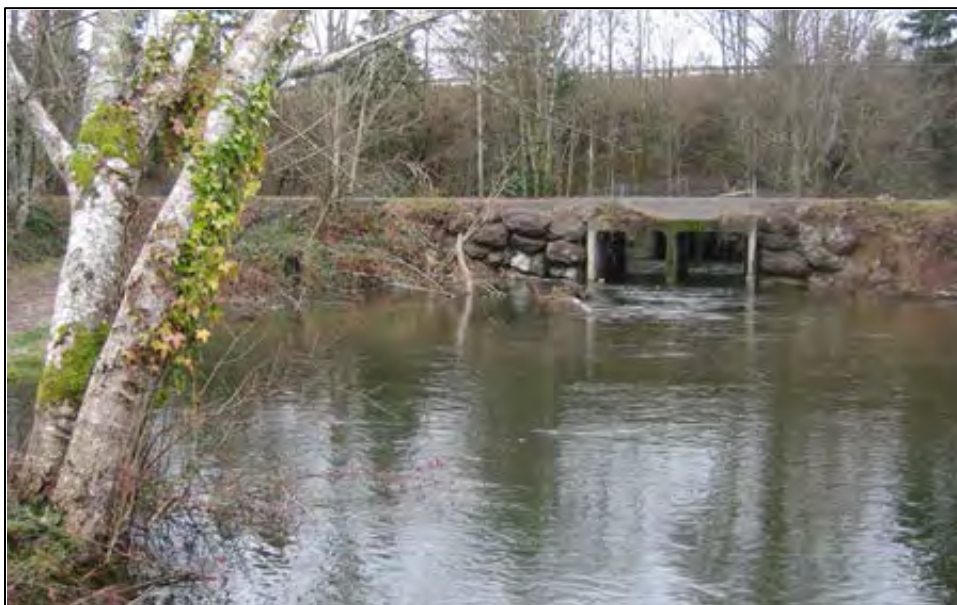
The double box culverts at SR 3, located immediately upstream of the Kittyhawk Drive culvert, constrain floodplain/upper estuarine habitat-forming processes in the reach and are also a partial barrier to fish passage. Much of the habitat benefit gained from removal of the Kittyhawk Drive culvert is dependent upon future action to address constraints at the SR 3 stream crossing.

Figure 46. Photo of double box culvert at Kittyhawk Drive (view upstream). Photo taken from Habitat Work Schedule, credit unknown.

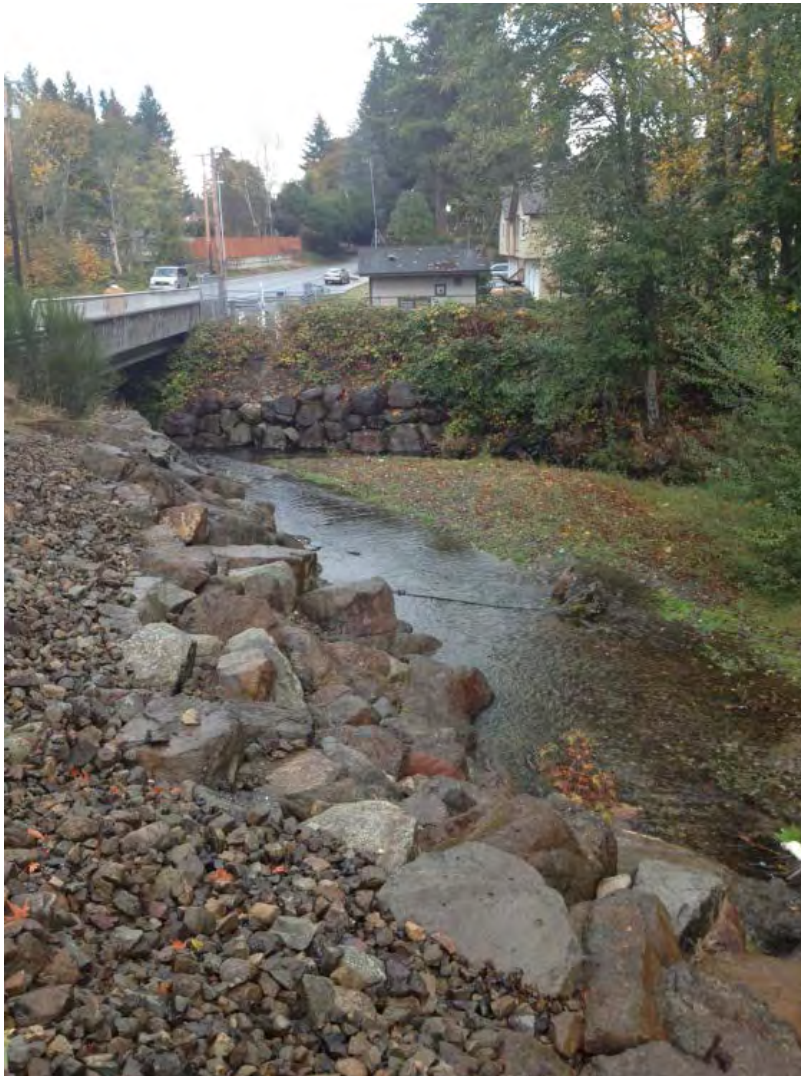
Figure 48. Bridge crossing at Erlands Point Road. View is looking downstream. Photo by Shawn Higgins (NSD), October 23, 2012.

Approach: The action will replace Erlands Point Road bridge with a wider span and reduce floodplain constriction. Fill material composing the existing road embankment would be removed. The property immediately upstream includes residential development on artificial fill that encroaches into the stream corridor and impairs natural processes. The bridge project should be coordinated as part of a more comprehensive project that includes channel and floodplain constraints created by residential development along Shadden Lane NW.

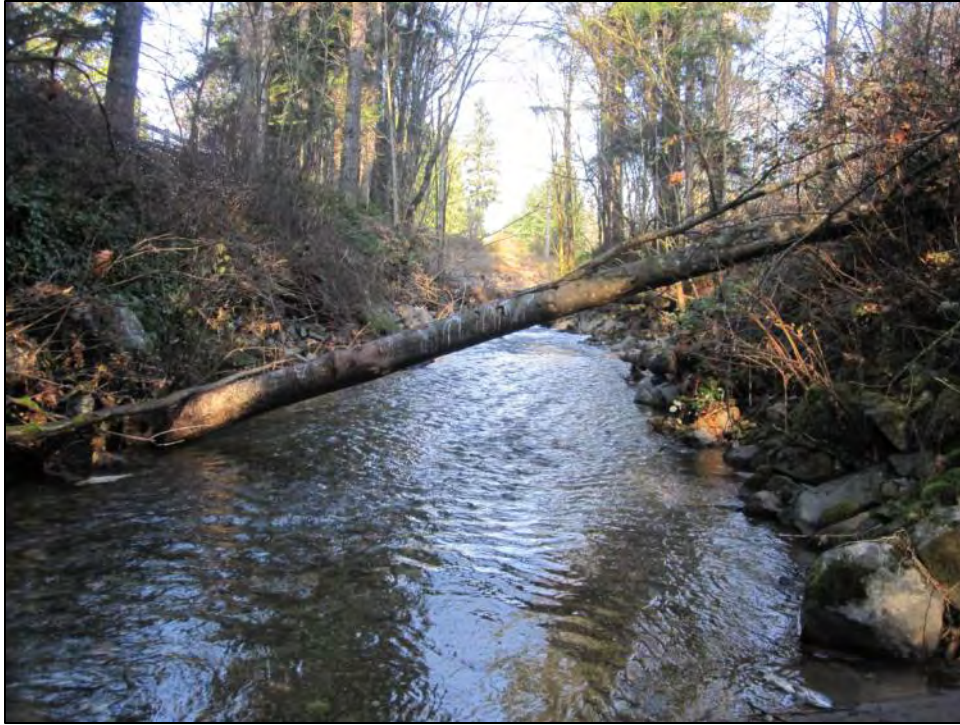
Figure 53. Photo of incised channel conditions, armored banks, and road fill (at left) in Chico Creek upstream of Chico Way NW (view upstream). Photo taken December 2011 by Steve Todd, Suquamish Tribe.

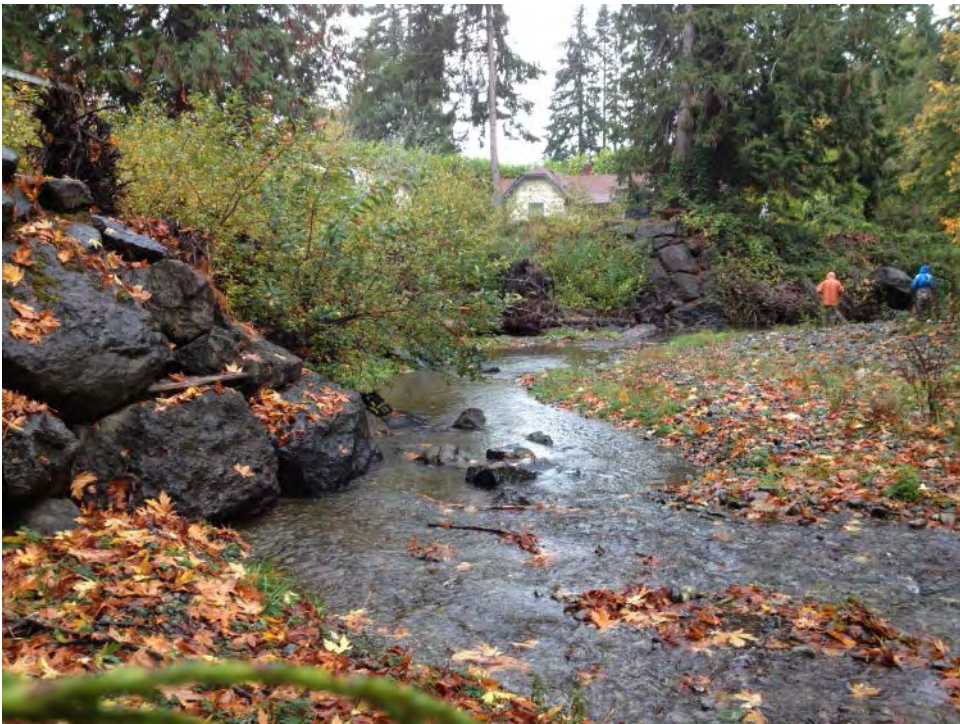
Figure 54. Photo of incised channel and riprap bank protection along the left bank downstream of Northlake Way. Photo taken in Oct. 2012 by Shawn Higgins (NSD).

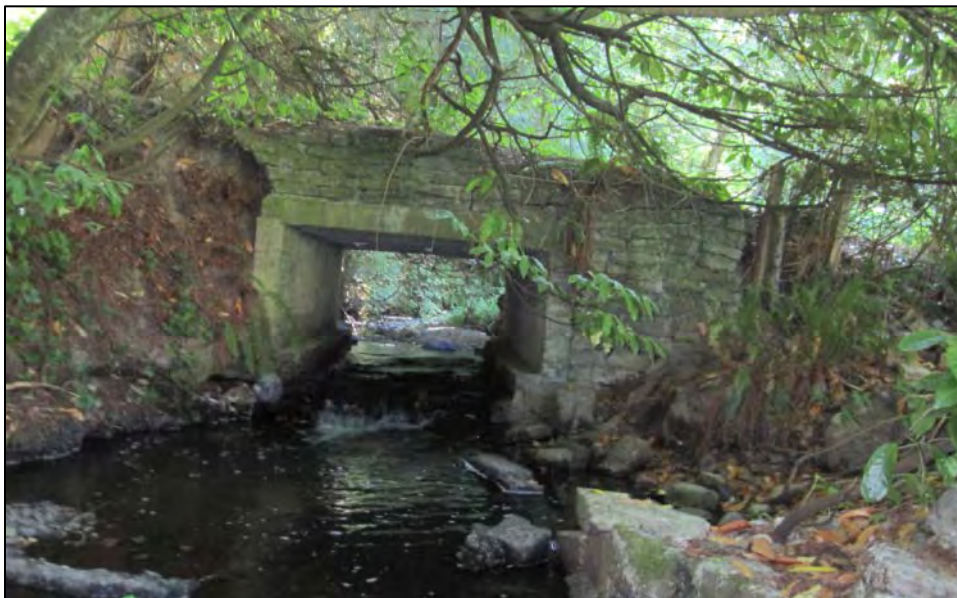
Figure 58. Photo of partial barrier to fish passage in Kitsap Creek at RS 2400 (view upstream). Photo taken August 2012 by Steve Todd, Suquamish Tribe.

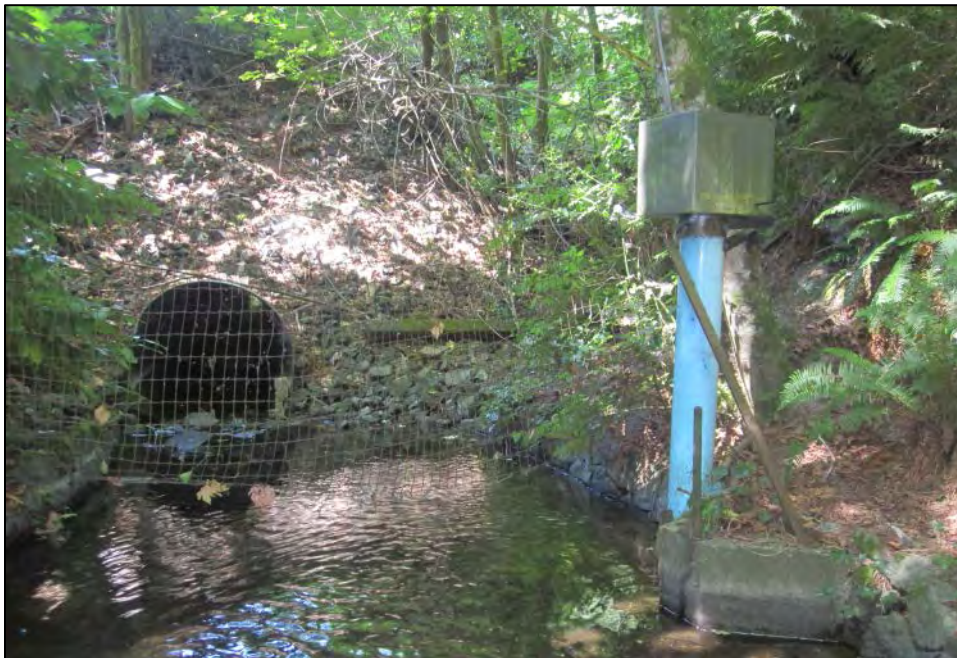
Figure 59. Photo of partial barrier to fish passage in Kitsap Creek at Northlake Way NW (view downstream). Photo taken August 2012 by Steve Todd, Suquamish Tribe.

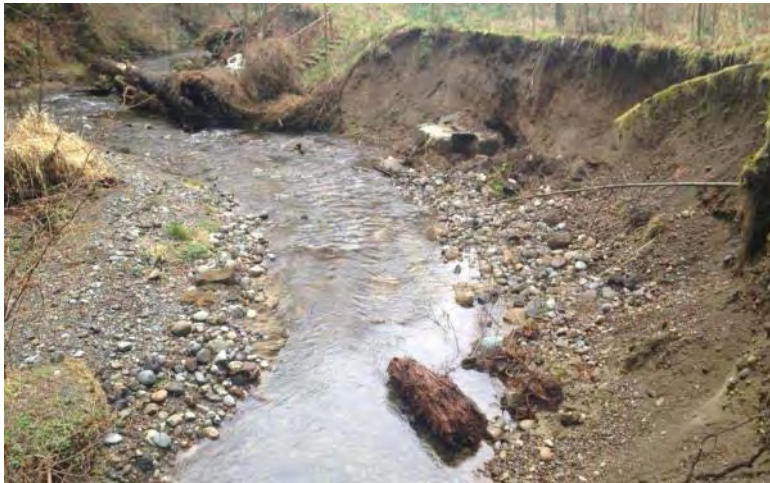
Figure 61. Photo of incised channel segment on Dickerson Creek downstream of failed log weirs (view downstream). Note box at toe of right bank is exposed septic basin. Photo by Tim Abbe, NSD (2/12/2013).

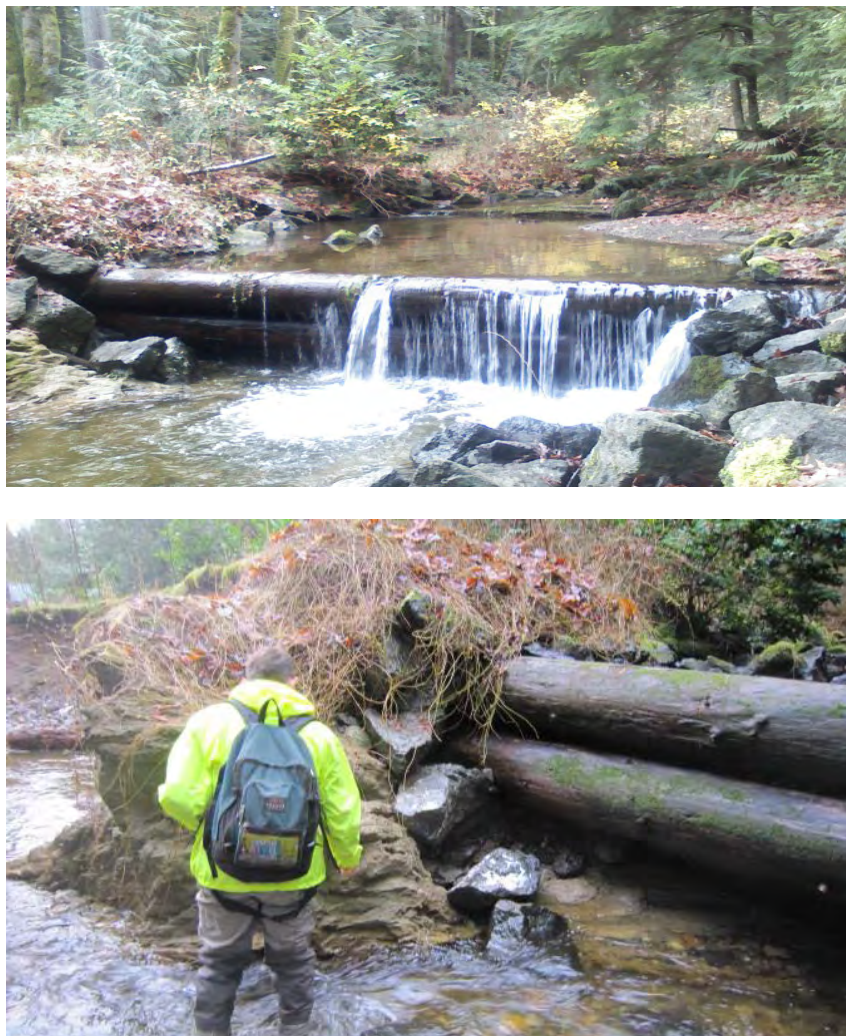
Figure 62. Photos of log weirs on Dickerson Creek downstream of Navy railroad in 2007 (Upper; photo by Jon Oleyar, Suquamish Tribe) and in February 2013 (Lower; photo by Paul Dorn, Suquamish Tribe). Note erosion around failing weir in 2013.

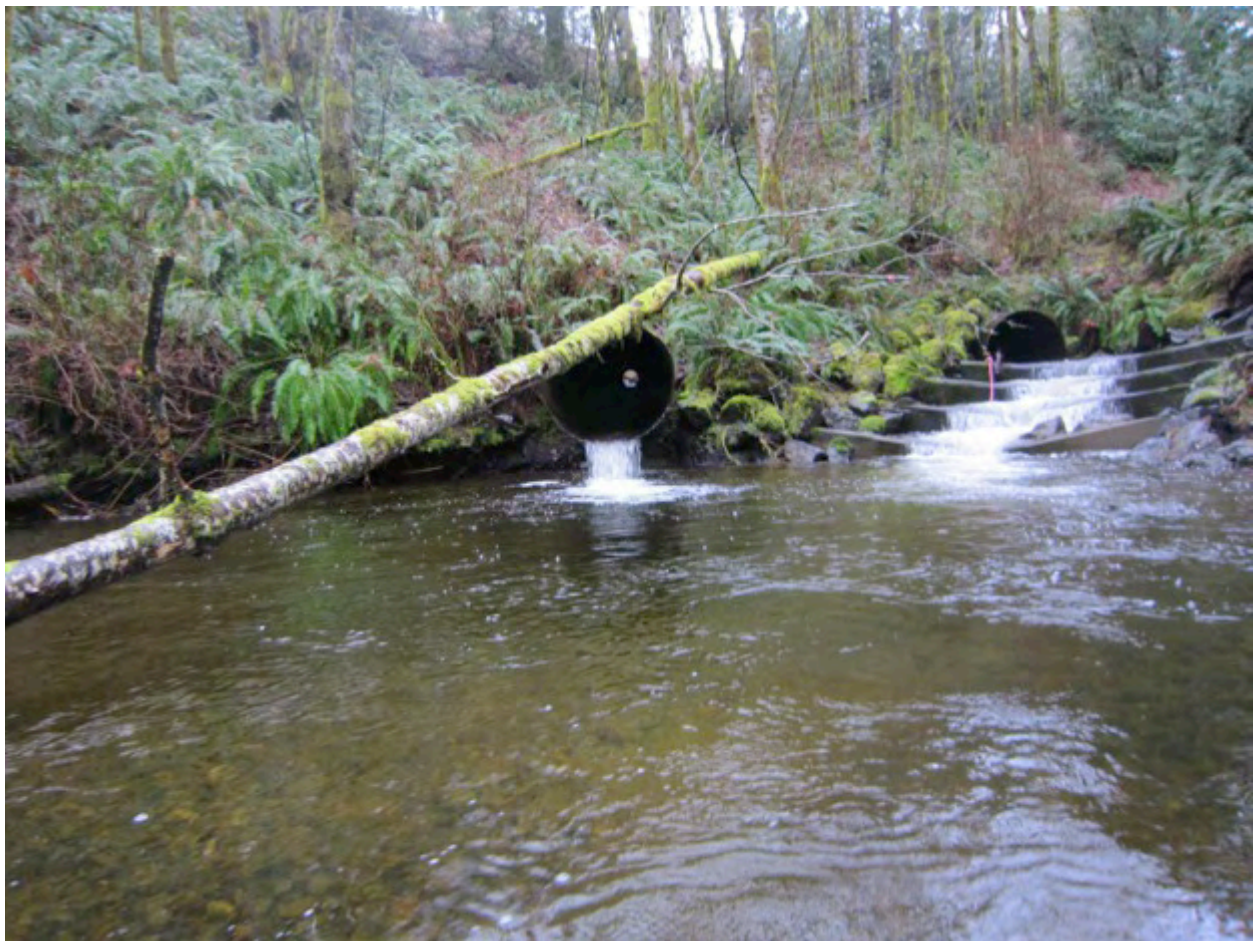
Figure 63. Photo of Dickerson Creek at the Navy railroad culverts. View upstream; February 2013 (photo by Paul Dorn, Suquamish Tribe).
