Strategic Identification of Areas and Projects for Nearshore Restoration throughout Key Peninsula-Gig Harbor-Islands Watershed, WRIA 15, Washington

March, 2011

Prepared for Salmon Recovery Funding Board and West Sound Watershed Lead Entity (WRIA 15)

Prepared by Kristin Williamson and Jerilyn Walley, South Puget Sound Salmon Enhancement Group, and Kyle Brakensiek, Independent Consultant

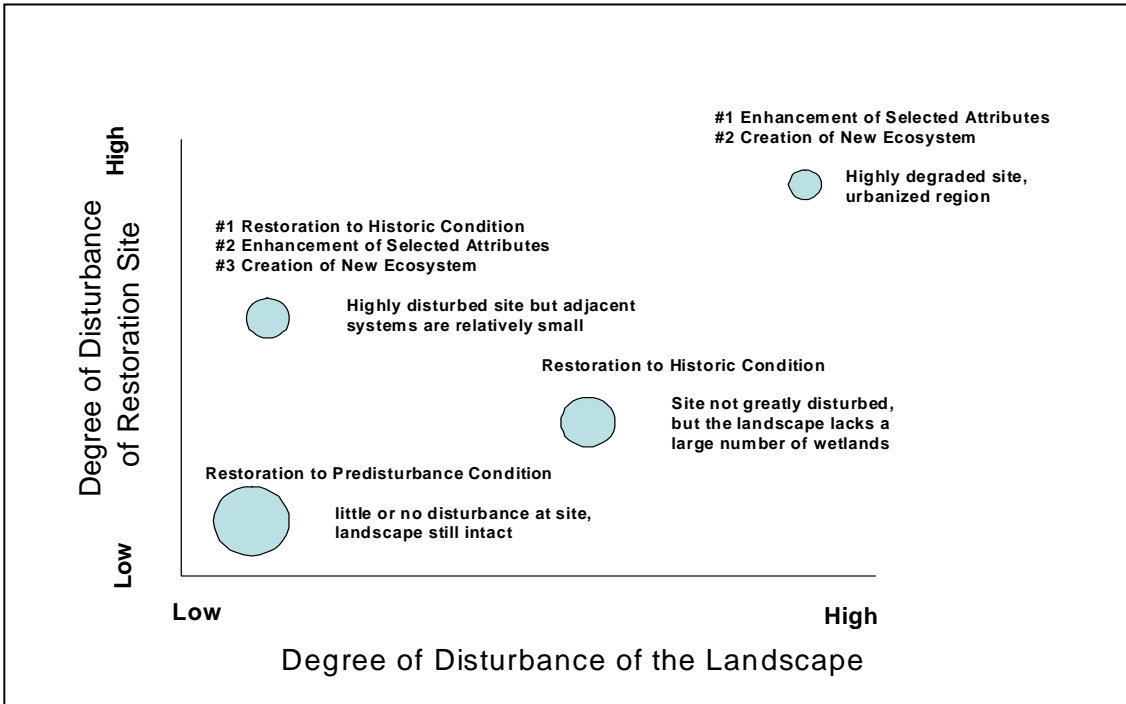
Figure 2. (Johnson et al. 2003 page 19, figure 2.3): Restoration Strategies for Estuarine Systems Relative to Disturbance Levels at the Site and in the Landscape (from Shreffler and Thom 1993). The relative chance of success increases with the size of the dot.

Johnson et al. (2003) further provide an illustrative figure to the above concepts relating environmental conditions at the site versus landscape scale, in the context of estuarine restoration strategies and therein potential for success (Figure 2).

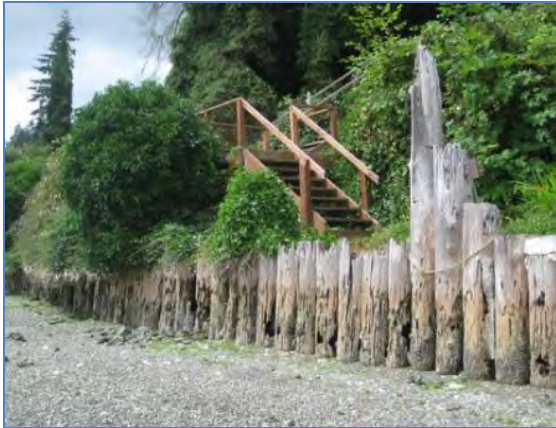
Project ID	Geographic Location		Project Category
1	Von Geldern		Bulkhead Removal
Preliminary Design	Primary Habitat Target	Latitude	Longitude
Y	Beach	47.278386	-122.756398
Unit ID	All Species	Fry Migrant	Limiting Score
1370	10	30	0.663
Description and Restoration Recommendation			
Remove series of soldier pile bulkheads (5+ homes) to improve beach and backshore connectivity

Ground based view (SPSSEG 2009)

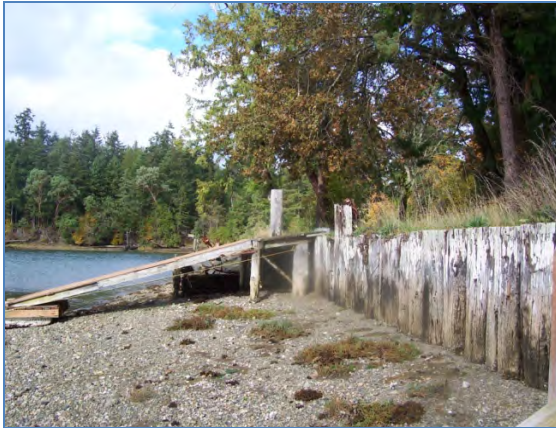
Project ID	Geographic Location		Project Category
3	Filucy Bay		Bulkhead Removal
Preliminary Design	Primary Habitat Target	Latitude	Longitude
Y	Beach	47.213353	-122.746849
Unit ID	All Species	Fry Migrant	Limiting Score
1589	22	30	0.825
Description and Restoration Recommendation			
Remove soldier pile and tiered timber/rock bulkhead to improve salt marsh habitat and habitat connectivity in Filucy Bay

Ground based view (SPSSEG 2009)

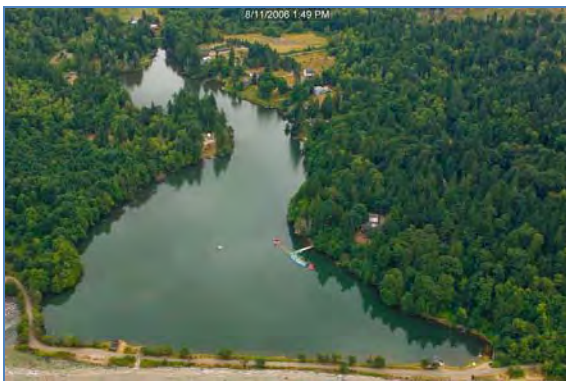
Project ID	Geographic Location		Project Category
4	Whiteman Cove		Culvert or Tide Gate Removal
Preliminary Design	Primary Habitat Target	Latitude	Longitude
Y	Embayment	47.220568	-122.806771
Unit ID	All Species	Fry Migrant	Limiting Score
2459	14	16	0.650
Description and Restoration Recommendation			
Remove sheet pile impoundment and two tide gates, restore spit and longshore drift, restore inlet to improve fish passage and tidal hydrology

Aerial view (DOE 2006)

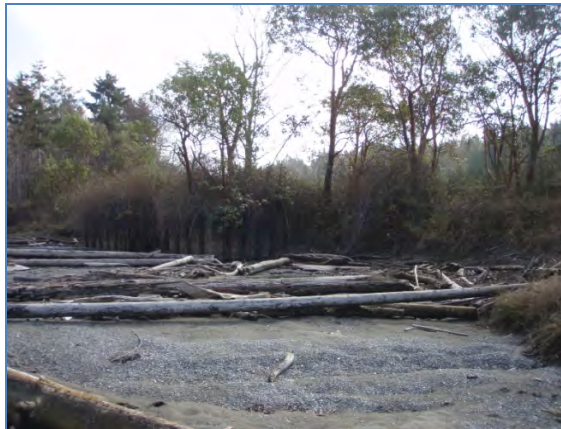
Ground based view (SPSSEG 2009)

Project ID	Geographic Location		Project Category
5	Vaughn Bay		Bulkhead Removal
Preliminary Design	Primary Habitat Target	Latitude	Longitude
Y	Beach	47.301138	-122.787404
Unit ID	All Species	Fry Migrant	Limiting Score
2418	14	16	0.800
Description and Restoration Recommendation			
Remove tire and rock bulkhead to improve beach and bluff connectivity and improve mouth of small embayment

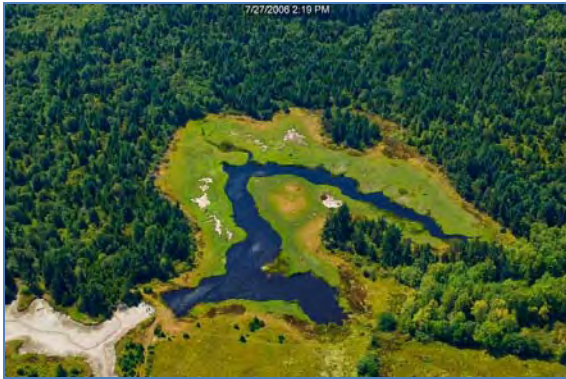
Project ID	Geographic Location		Project Category
6	Oro Bay		Culvert or Tide Gate Removal
Preliminary Design	Primary Habitat Target	Latitude	Longitude
N	Embayment	47.148704	-122.700726
Unit ID	All Species	Fry Migrant	Limiting Score
1774	20	33	0.900
Description and Restoration Recommendation			
Remove earthen dam impounding upper portion of finger estuary

Aerial view (DOE 2006)

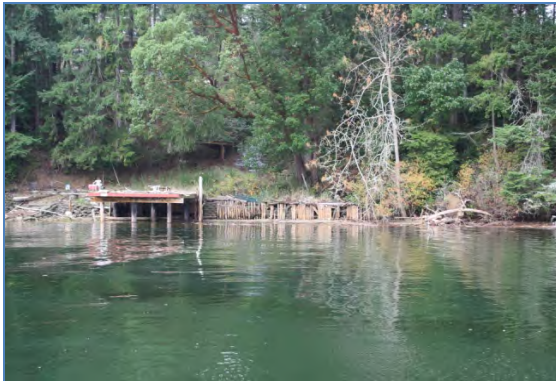
Ground based view (SPSSEG 2010)

Project ID	Geographic Location		Project Category
7	Rocky Bay		Bulkhead Removal
Preliminary Design	Primary Habitat Target	Latitude	Longitude
N	Beach	47.362300	-122.788080
Unit ID	All Species	Fry Migrant	Limiting Score
2389	29	32	0.875
Description and Restoration Recommendation			
Remove pile bulkhead and concrete pillows, creosote platform and random creosote piles inside Rocky Bay to improve beach and salt marsh habitat

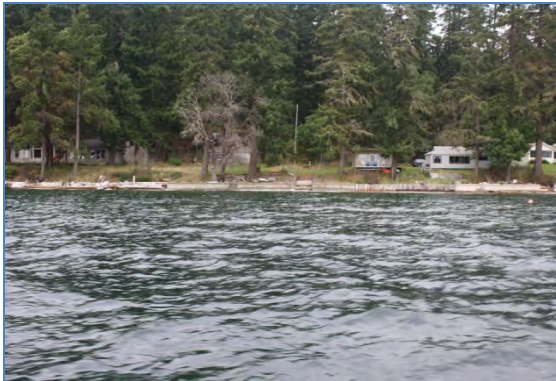
Ground based view (SPSSEG 2010)

Project ID	Geographic Location		Project Category
8	Rocky Bay		Bulkhead Removal
Preliminary Design	Primary Habitat Target	Latitude	Longitude
N	Beach	47.364690	-122.785600
Unit ID	All Species	Fry Migrant	Limiting Score
2392	27	38	0.850
Description and Restoration Recommendation			
Remove concrete bulkheads (3) and replace with soft armor to improve drift to estuarine spit and improve habitat connectivity to unarmored shorelines

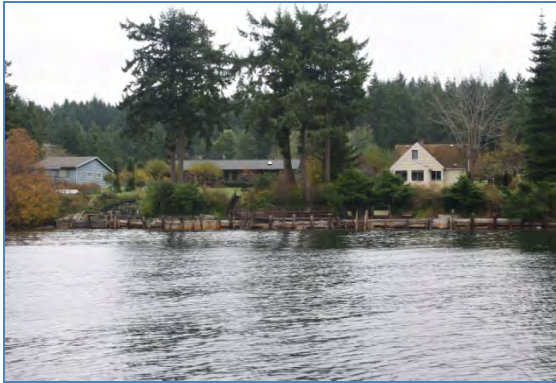
Project ID	Geographic Location		Project Category
9	Rocky Bay		Bulkhead Removal
Preliminary Design	Primary Habitat Target	Latitude	Longitude
N	Embayment	47.361290	-122.789110
Unit ID	All Species	Fry Migrant	Limiting Score
2387	17	19	0.900
Description and Restoration Recommendation			
Remove tire and pile bulkhead from the toe of a forested bank

Ground based view (SPSSEG 2010)

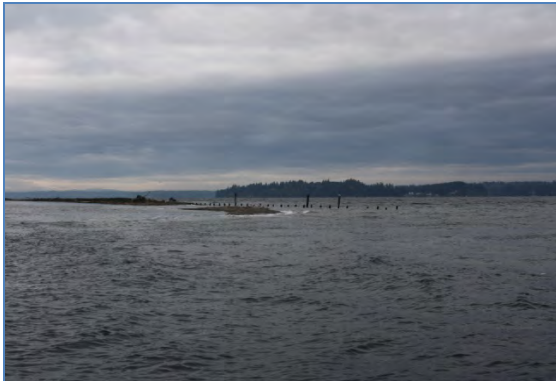
Ground based view (SPSSEG 2010)

Project ID	Geographic Location		Project Category
10	Vaughn Bay		Dock or Pier to Remove
Preliminary Design	Primary Habitat Target	Latitude	Longitude
N	Beach	47.342600	-122.785400
Unit ID	All Species	Fry Migrant	Limiting Score
2404	20	31	0.900
Description and Restoration Recommendation			
Remove derelict piles from barrier spit

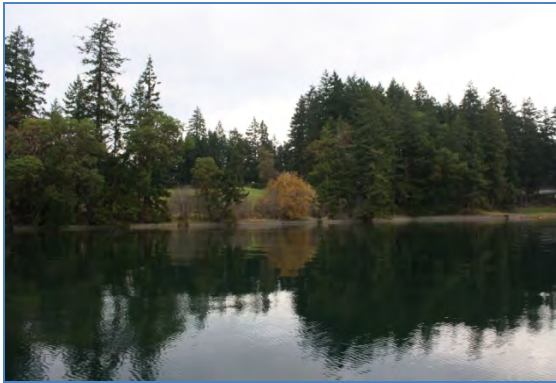
Project ID	Geographic Location		Project Category
11	Vaughn Bay		Bulkhead Removal
Preliminary Design	Primary Habitat Target	Latitude	Longitude
N	Beach	47.340540	-122.771100
Unit ID	All Species	Fry Migrant	Limiting Score
2400	16	26	0.550
Description and Restoration Recommendation			
Remove concrete bulkhead to reconnect riparian and salt marsh

Ground based view (SPSSEG 2010)

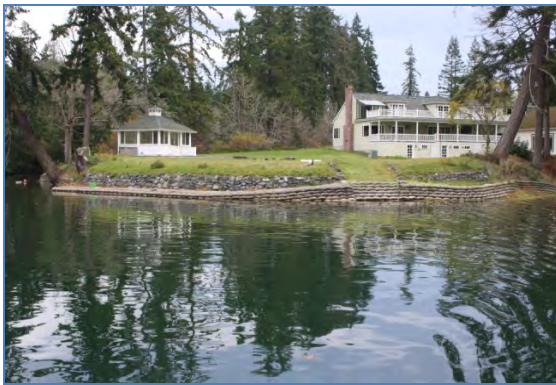
Project ID	Geographic Location		Project Category
12	Vaughn Bay		Bulkhead Removal
Preliminary Design	Primary Habitat Target	Latitude	Longitude
N	Beach	47.341410	-122.764830
Unit ID	All Species	Fry Migrant	Limiting Score
2401	20	23	0.875
Description and Restoration Recommendation			
Remove concrete pillow bulkhead at head of Vaughn Bay to improve habitat connectivity

Ground based view (SPSSEG 2010)

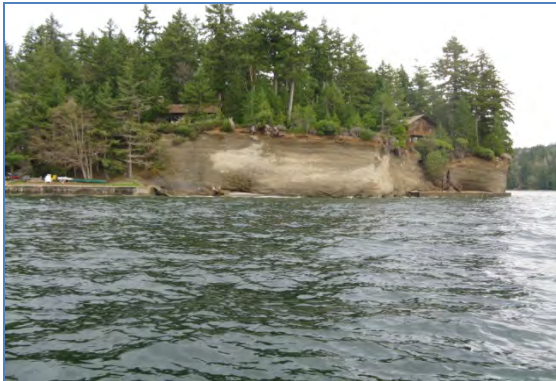
Ground based view (SPSSEG 2010)

Project ID	Geographic Location		Project Category
14	Case Inlet		Bulkhead Removal
Preliminary Design	Primary Habitat Target	Latitude	Longitude
N	Feeder Bluff	47.306800	-122.793210
Unit ID	All Species	Fry Migrant	Limiting Score
2408	8	12	0.913
Description and Restoration Recommendation			
Remove concrete bulkheads (2) from toe of feeder bluff to restore sediment input and beach connectivity

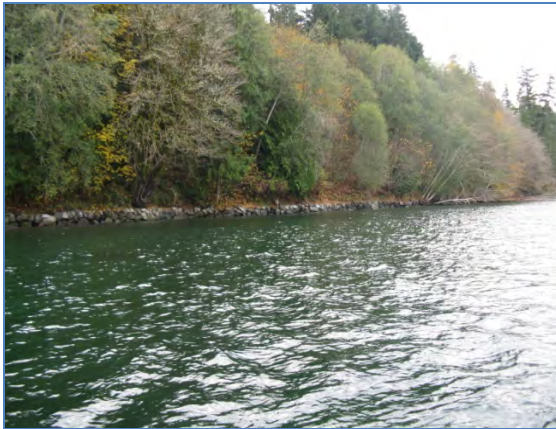
Project ID	Geographic Location		Project Category
16	Case Inlet		Bulkhead Removal
Preliminary Design	Primary Habitat Target	Latitude	Longitude
N	Feeder Bluff	47.294890	-122.791930
Unit ID	All Species	Fry Migrant	Limiting Score
2422	10	12	0.950
Description and Restoration Recommendation			
Remove rock bulkhead from toe of forested bluff to restore sediment input

Ground based view (SPSSEG 2010)

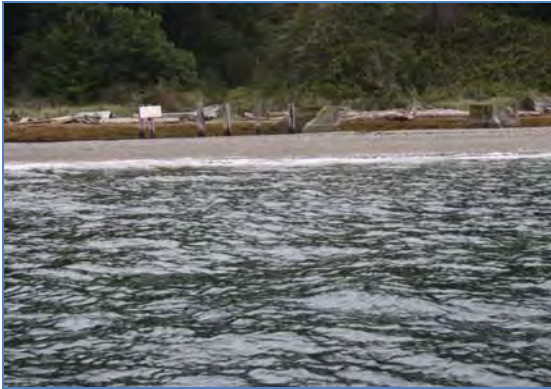
Project ID	Geographic Location		Project Category
18	Case Inlet		Bulkhead Removal
Preliminary Design	Primary Habitat Target	Latitude	Longitude
N	Beach	47.245620	-122.83101
Unit ID	All Species	Fry Migrant	Limiting Score
2436	10	12	0.750
Description and Restoration Recommendation			
Remove rock and tire bulkhead and invasive plants from spit, remove concrete abutments from creek channel

Ground based view (SPSSEG 2010)

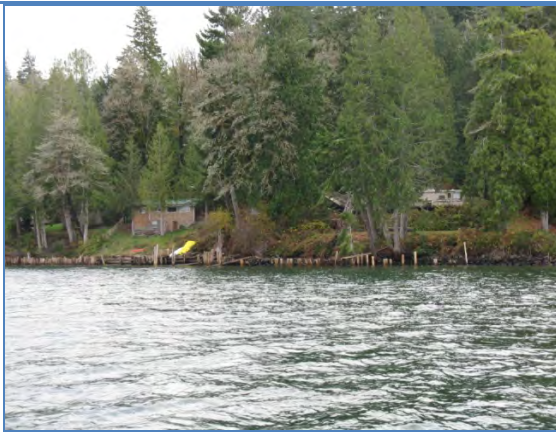
Project ID	Geographic Location		Project Category
19	Case Inlet		Bulkhead Removal
Preliminary Design	Primary Habitat Target	Latitude	Longitude
N	Embayment	47.233130	-122.824210
Unit ID	All Species	Fry Migrant	Limiting Score
2454	10	12	0.913
Description and Restoration Recommendation			
Remove failing concrete bulkhead and adjacent abandoned piles and concrete bulkhead

Ground based view (SPSSEG 2010)

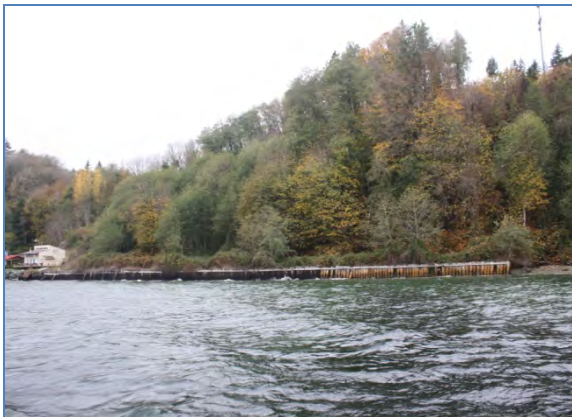
Project ID	Geographic Location		Project Category
20	Carr Inlet		Bulkhead Removal
Preliminary Design	Primary Habitat Target	Latitude	Longitude
N	Feeder Bluff	47.313190	-122.736910
Unit ID	All Species	Fry Migrant	Limiting Score
1374	6	10	0.763
Description and Restoration Recommendation			
Remove failing pile bulkhead from toe of feeder bluff

Ground based view (SPSSEG 2010)

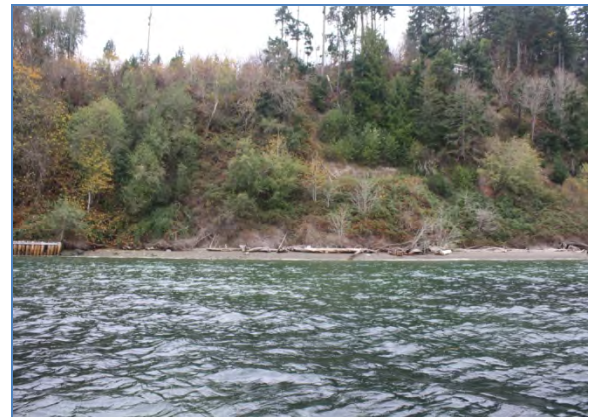
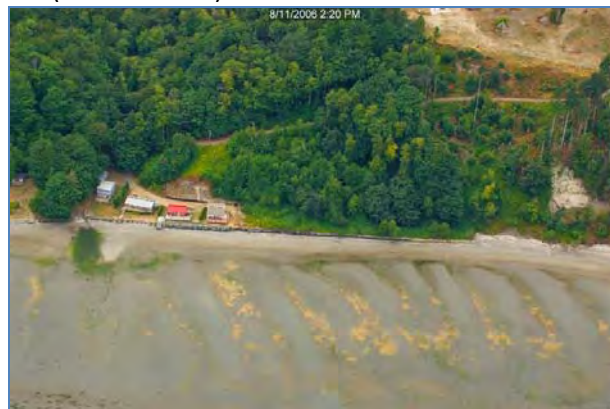
Ground based view (SPSSEG 2010)

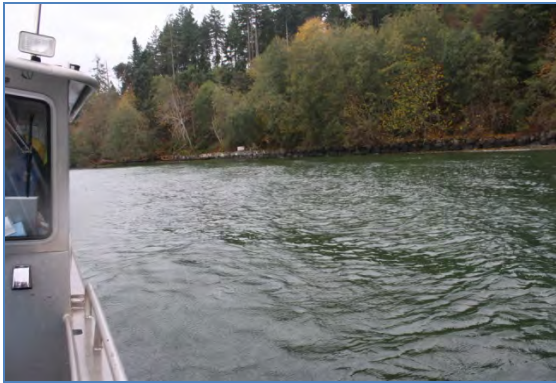
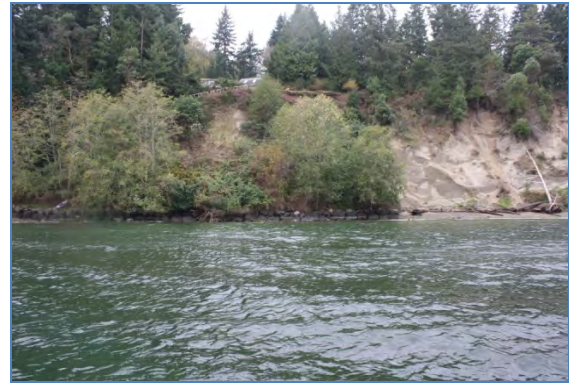
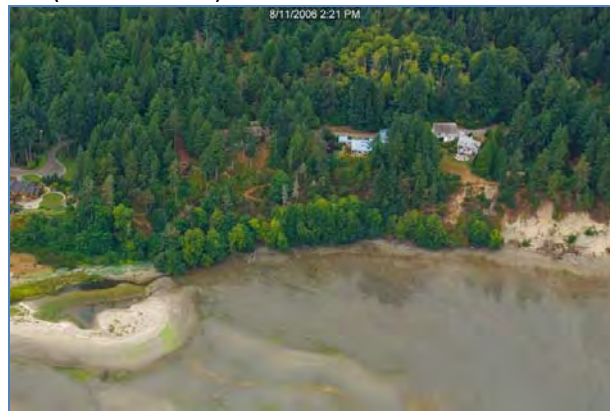
Project ID	Geographic Location		Project Category
21	Carr Inlet		Bulkhead Removal
Preliminary Design	Primary Habitat Target	Latitude	Longitude
N	Feeder Bluff	47.321640	-122.731170
Unit ID	All Species	Fry Migrant	Limiting Score
1376	6	8	0.875
Description and Restoration Recommendation			
Remove rock bulkhead from toe of feeder bluff

Ground based view (SPSSEG 2010)

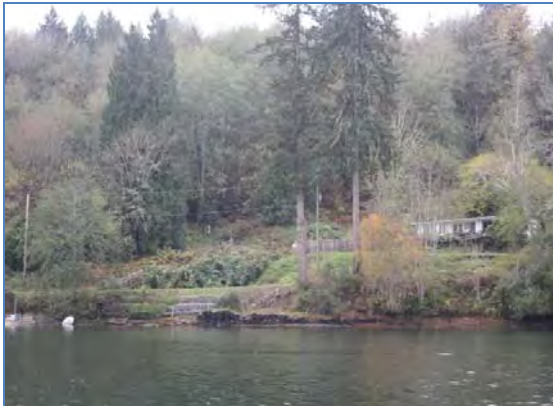
Project ID	Geographic Location		Project Category
22	Glen Cove		Bulkhead Removal
Preliminary Design	Primary Habitat Target	Latitude	Longitude
N	Beach	47.341151	-122.731310
Unit ID	All Species	Fry Migrant	Limiting Score
1381	20	16	0.813
Description and Restoration Recommendation			
Remove tire and gabion bulkhead

Ground based view (SPSSEG 2010)

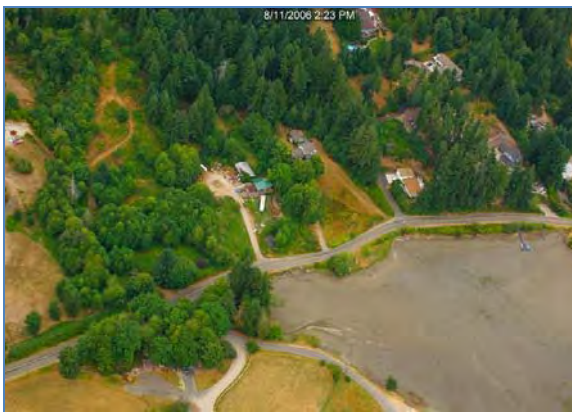
Project ID	Geographic Location		Project Category
23	Glen Cove		Culvert or Tide Gate Removal
Preliminary Design	Primary Habitat Target	Latitude	Longitude
N	Embayment	47.344990	-122.735290
Unit ID	All Species	Fry Migrant	Limiting Score
1382	24	25	0.700
Description and Restoration Recommendation			
Replace perched tidal culvert under road with larger structure to restore fish passage and tidal hydology

Aerial view (DOE 2006)

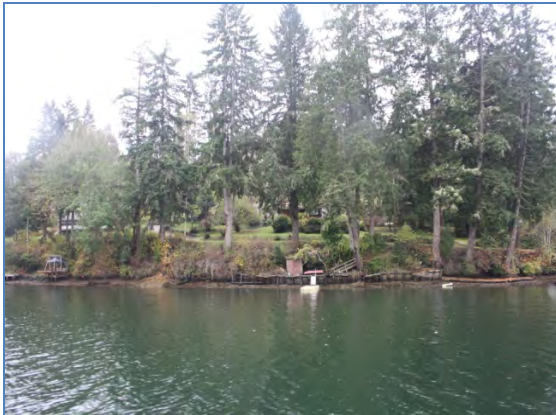
Project ID	Geographic Location		Project Category
24	Glen Cove		Bulkhead Removal
Preliminary Design	Primary Habitat Target	Latitude	Longitude
N	Beach	47.343118	-122.734020
Unit ID	All Species	Fry Migrant	Limiting Score
1381	20	16	0.813
Description and Restoration Recommendation			
Remove failing bulkhead to restore beach structure and improve salt marsh

Ground based view (SPSSEG 2010)

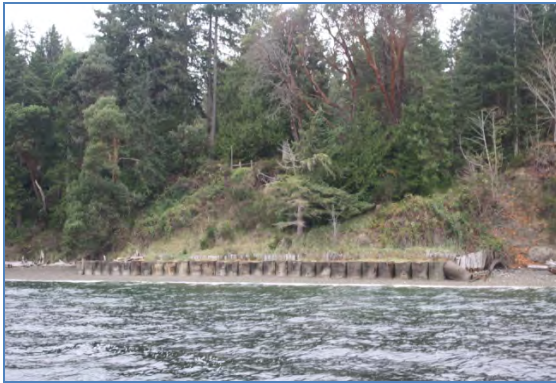
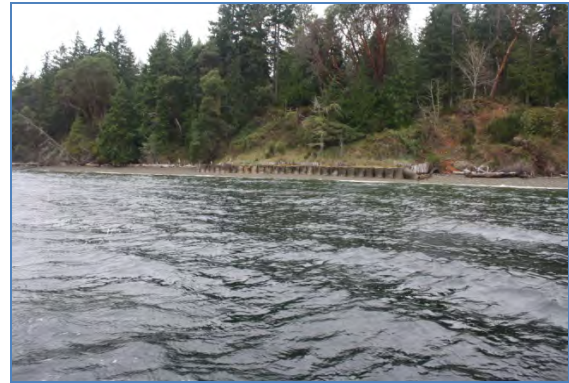
Project ID	Geographic Location		Project Category
25	Carr Inlet		Bulkhead Removal
Preliminary Design	Primary Habitat Target	Latitude	Longitude
N	Beach	47.343100	-122.712300
Unit ID	All Species	Fry Migrant	Limiting Score
1390	10	12	0.900
Description and Restoration Recommendation			
Remove concrete (pipe section) encroached bulkhead to restore beach structure

Ground based view (SPSSEG 2010)

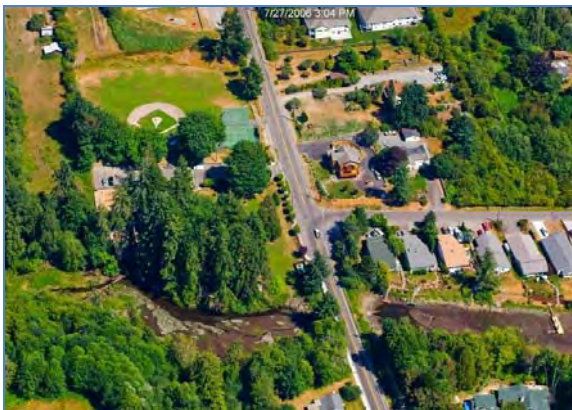
Project ID	Geographic Location		Project Category
26	Gig Harbor		Culvert or Tide Gate Removal
Preliminary Design	Primary Habitat Target	Latitude	Longitude
N	Embayment	47.345426	-122.583089
Unit ID	All Species	Fry Migrant	Limiting Score
1415	16	18	0.725
Description and Restoration Recommendation			
Replace tidal culvert in Crescent Creek with larger structure to restore tidal flow and fish passage

Aerial view (DOE 2006)

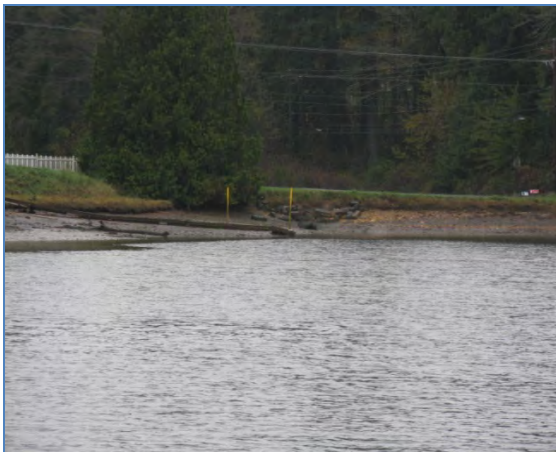
Project ID	Geographic Location		Project Category
28	Lay Inlet		Culvert or Tide Gate Removal
Preliminary Design	Primary Habitat Target	Latitude	Longitude
N	Embayment	47.338890	-122.653880
Unit ID	All Species	Fry Migrant	Limiting Score
1444	18	21	0.563
Description and Restoration Recommendation			
Replace buried tidal culvert under road with larger structure to restore fish passage and tidal hydrolgy

Ground based view (SPSSEG 2010)

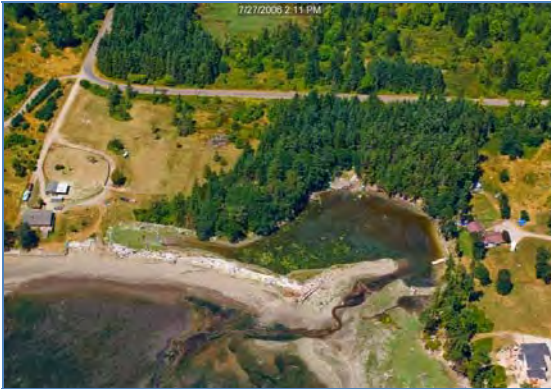
Project ID	Geographic Location		Project Category
29	Thompson Cove		Bulkhead Removal
Preliminary Design	Primary Habitat Target	Latitude	Longitude
N	Beach	47.127645	-122.708391
Unit ID	All Species	Fry Migrant	Limiting Score
1756	18	45	0.900
Description and Restoration Recommendation			
Remove ecoblock bulkhead and rock bulkhead adjacent to spit and stream to improve beach structure and longshore drift

Aerial view (DOE 2006)

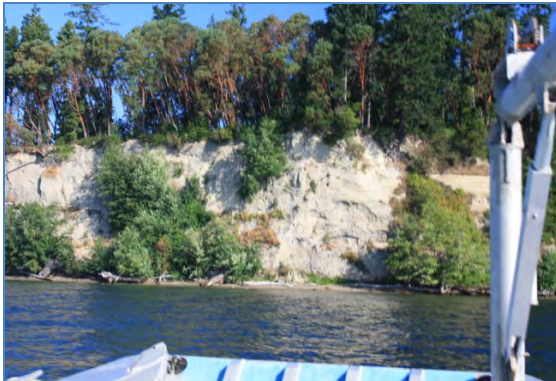
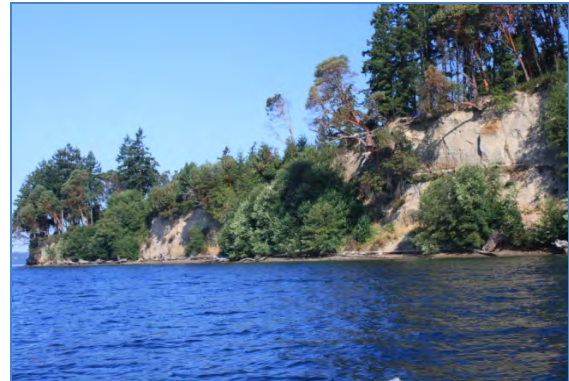
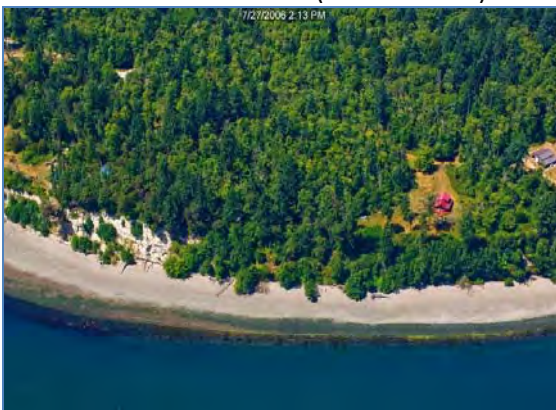
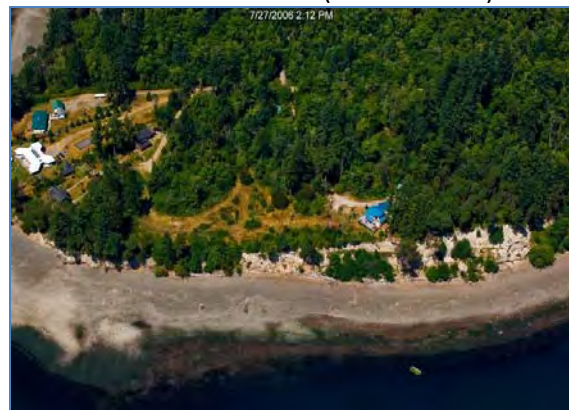
Project ID	Geographic Location		Project Category
30	Anderson Island		Feeder Bluff to Protect
Preliminary Design	Primary Habitat Target	Latitude	Longitude
N	Feeder Bluff	47.124722	-122.698611
Unit ID	All Species	Fry Migrant	Limiting Score
1759	12	16	0.925
Description and Restoration Recommendation			
Protect feeder bluff

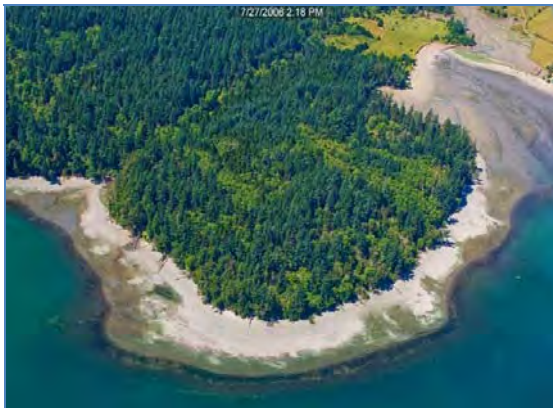
Project ID	Geographic Location		Project Category
31	East Oro Bay		Estuary to Protect
Preliminary Design	Primary Habitat Target	Latitude	Longitude
N	Embayment	47.141389	-122.698611
Unit ID	All Species	Fry Migrant	Limiting Score
1772	10	30	1.138
Description and Restoration Recommendation			
Protect beach and estuarine embayment

Aerial view (DOE 2006)

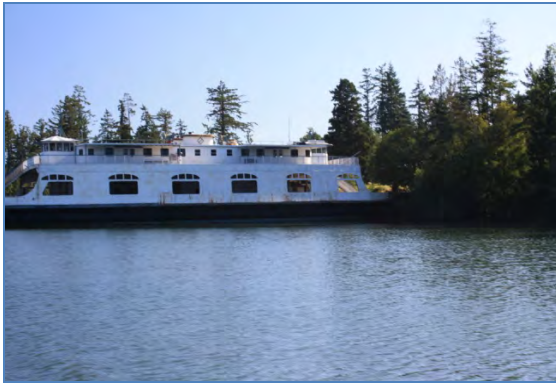
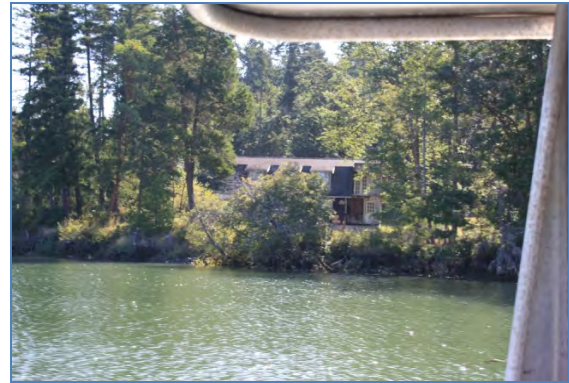
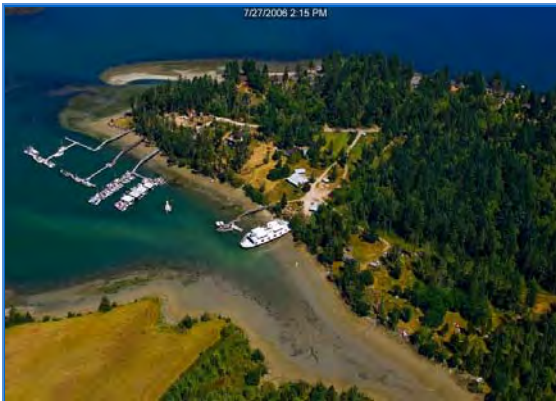
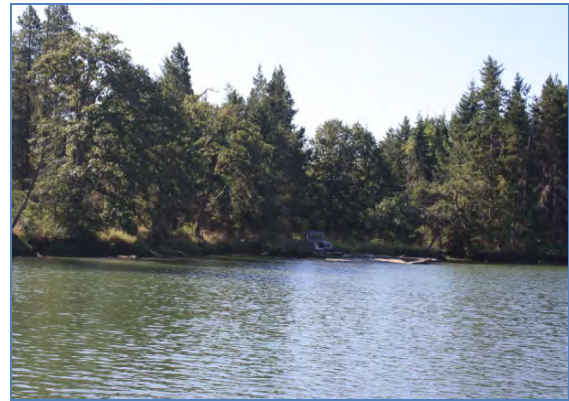
Project ID	Geographic Location		Project Category
32	Oro Bay		Bulkhead Removal
Preliminary Design	Primary Habitat Target	Latitude	Longitude
N	Embayment	47.139444	-122.701667
Unit ID	All Species	Fry Migrant	Limiting Score
1771	14	32	1.075
Description and Restoration Recommendation			
Remove derelict structures in Oro Bay - 6 derelict boats on shore, and derelict boat ramp

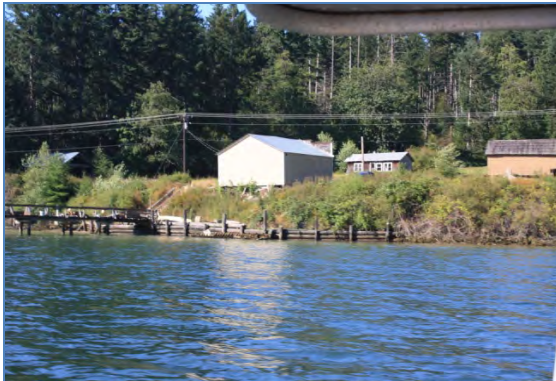
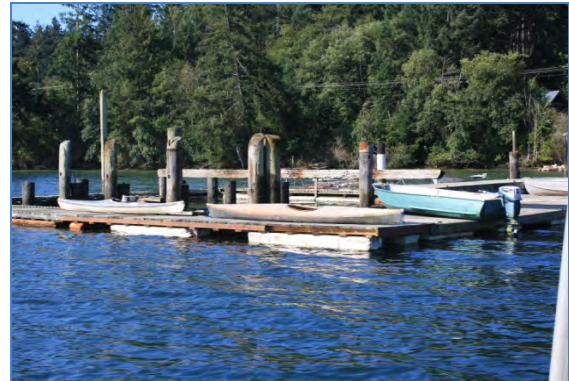
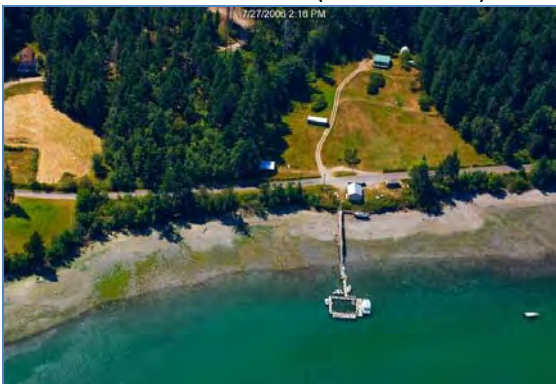
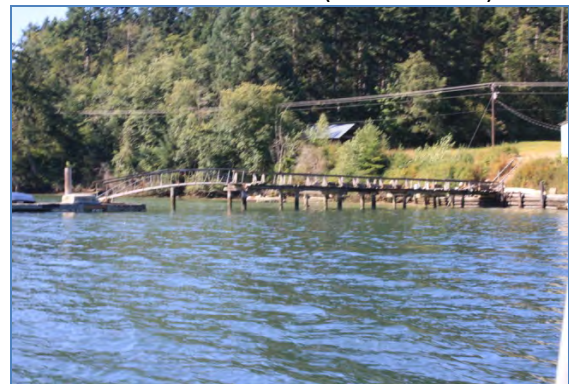
Project ID	Geographic Location		Project Category
33	Oro Bay		Bulkhead Removal
Preliminary Design	Primary Habitat Target	Latitude	Longitude
N	Beach	47.137786	-122.707543
Unit ID	All Species	Fry Migrant	Limiting Score
1798	20	28	0.900
Description and Restoration Recommendation			
Remove timber/crib bulkhead and ramp, remove invasives and replant with native vegetation to improve beach and riparian connectivity

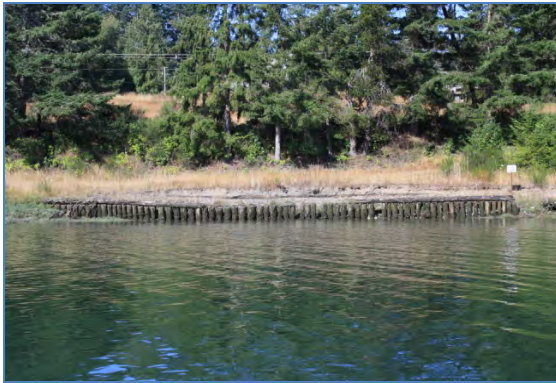
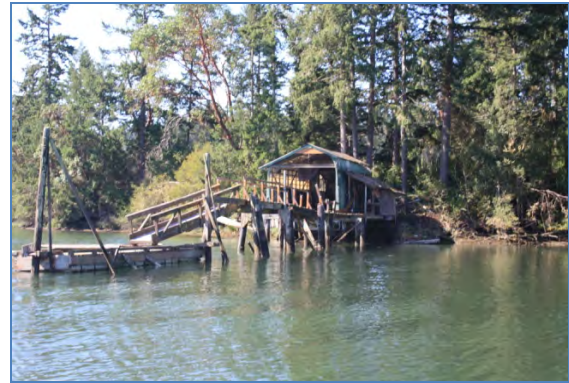
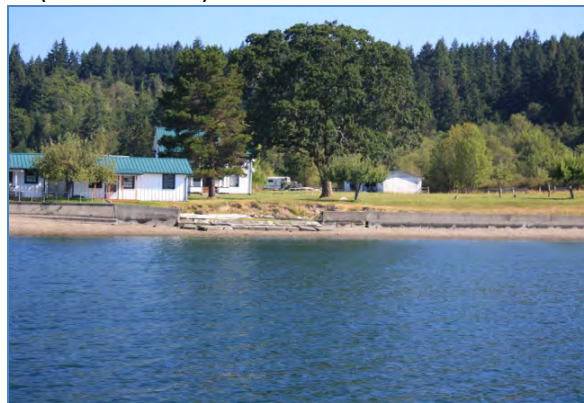
Project ID	Geographic Location		Project Category
34	Oro Bay		Bulkhead Removal
Preliminary Design	Primary Habitat Target	Latitude	Longitude
N	Embayment	47.135278	-122.695000
Unit ID	All Species	Fry Migrant	Limiting Score
1761	14	34	0.850
Description and Restoration Recommendation			
Remove pile and concrete bulkheads, old pier and boat house

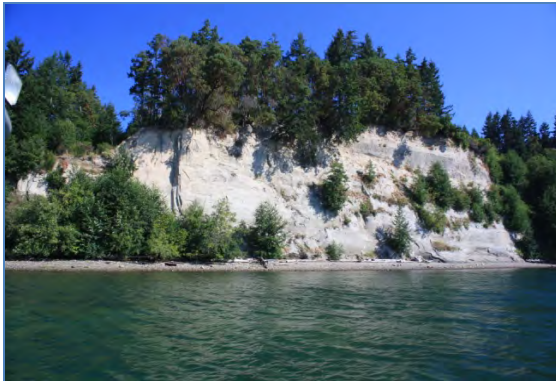
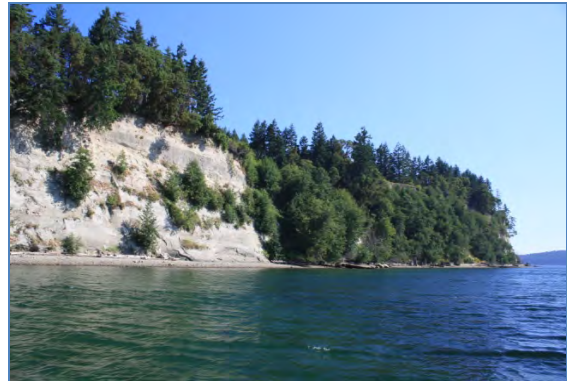
Project ID	Geographic Location		Project Category
35	Anderson Island		Feeder Bluff to Protect
Preliminary Design	Primary Habitat Target	Latitude	Longitude
N	Feeder Bluff	47.144722	-122.677222
Unit ID	All Species	Fry Migrant	Limiting Score
1780	12	30	1.025
Description and Restoration Recommendation			
Protect feeder bluff with easement or acquisition

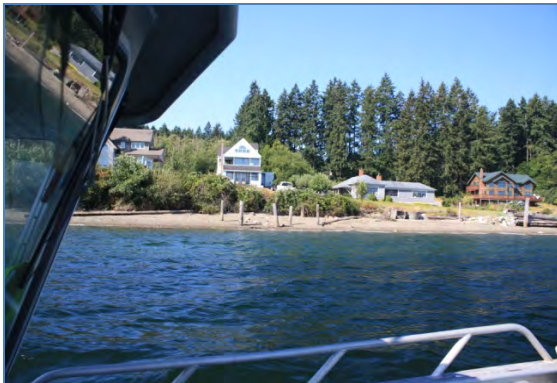
Project ID	Geographic Location		Project Category
36	Anderson Island		Bulkhead Removal
Preliminary Design	Primary Habitat Target	Latitude	Longitude
N	Beach	47.170220	-122.674790
Unit ID	All Species	Fry Migrant	Limiting Score
1784	10	30	1.113
Description and Restoration Recommendation			
Remove bulkheads, derelict piles and corrugated plastic culvert diverting small creek to restore beach and freshwater input

Ground based view (SPSSEG 2010)

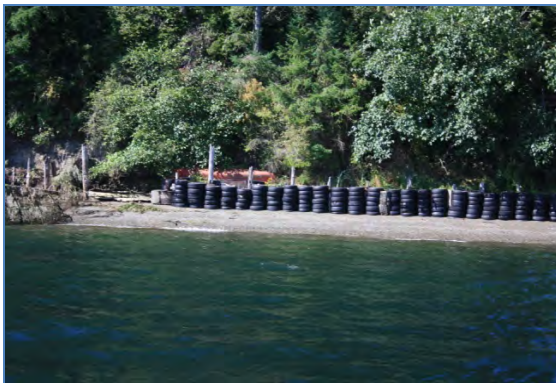
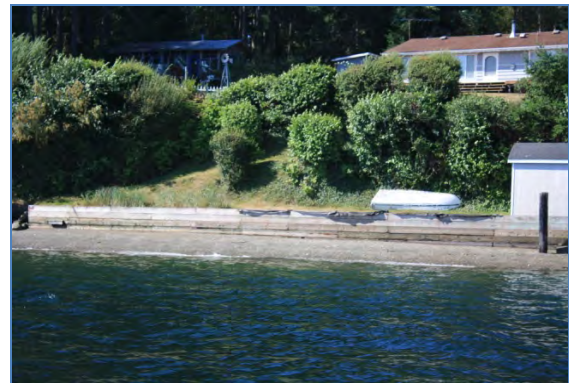
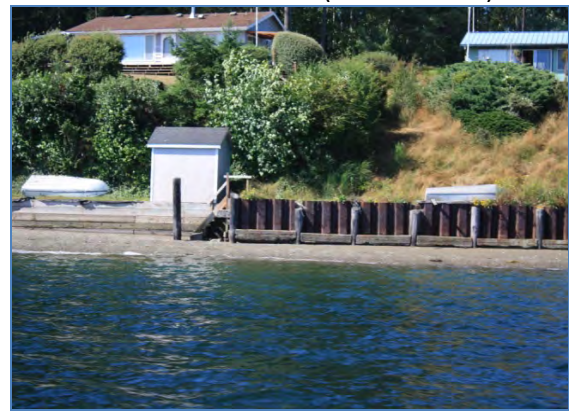
Project ID	Geographic Location		Project Category
37	Anderson Island		Bulkhead Removal
Preliminary Design	Primary Habitat Target	Latitude	Longitude
N	Beach	47.179060	-122.677700
Unit ID	All Species	Fry Migrant	Limiting Score
1785	8	10	0.713
Description and Restoration Recommendation			
Remove tire, timber and sheet pile bulkheads (3) to restore beach profile

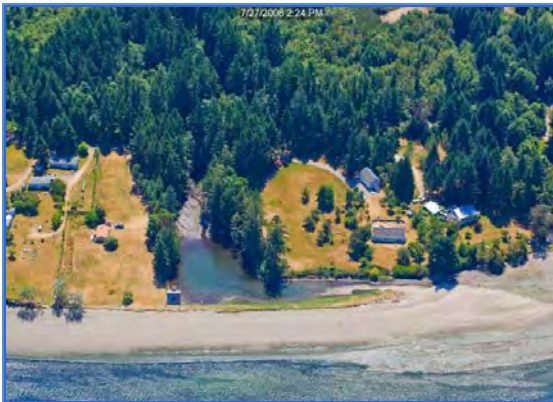
Project ID	Geographic Location		Project Category
38	Anderson Island		Estuary to Protect
Preliminary Design	Primary Habitat Target	Latitude	Longitude
N	Embayment	47.181910	-122.683790
Unit ID	All Species	Fry Migrant	Limiting Score
1787	20	28	0.900
Description and Restoration Recommendation			
Protect sand spit and small embayment stream

Aerial view (DOE 2006)

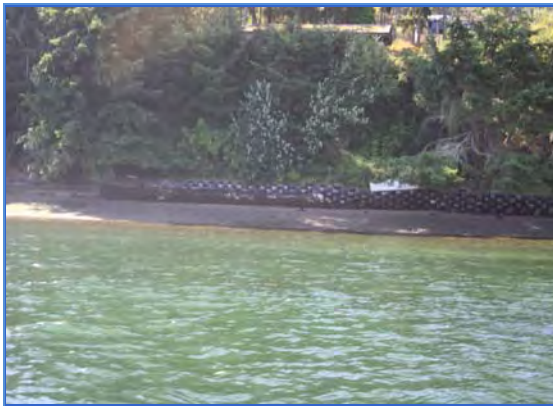
Project ID	Geographic Location		Project Category
39	Anderson Island		Bulkhead Removal
Preliminary Design	Primary Habitat Target	Latitude	Longitude
N	Beach	47.185560	-122.699167
Unit ID	All Species	Fry Migrant	Limiting Score
1793	4	6	1.125
Description and Restoration Recommendation			
Remove tire & concrete bulkhead to improve beach and riparian connectivity

Ground based view (SPSSEG 2010)

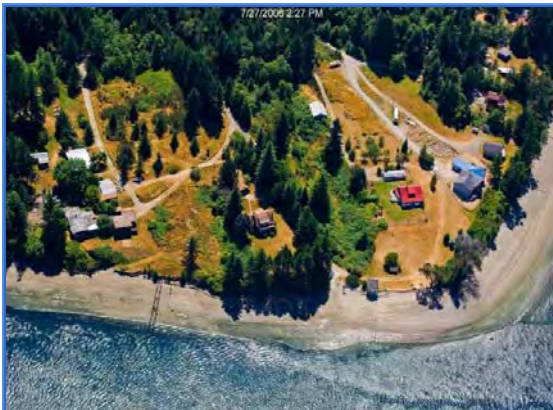
Project ID	Geographic Location		Project Category
40	Anderson Island		Bulkhead Removal
Preliminary Design	Primary Habitat Target	Latitude	Longitude
N	Beach	47.186776	-122.704040
Unit ID	All Species	Fry Migrant	Limiting Score
1795	10	12	0.875
Description and Restoration Recommendation			
Remove derelict pilings and boat ramp to improve longshore drift

Aerial view (DOE 2006)

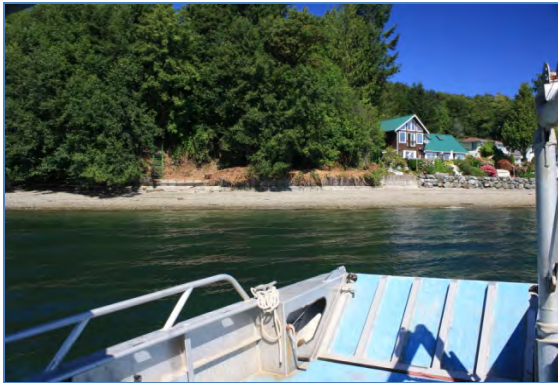
Project ID	Geographic Location		Project Category
41	Drayton Passage		Bulkhead Removal
Preliminary Design	Primary Habitat Target	Latitude	Longitude
N	Beach	47.172279	-122.754460
Unit ID	All Species	Fry Migrant	Limiting Score
1564	10	14	1.025
Description and Restoration Recommendation			
Remove failed ecoblock bulkhead and improve beach and riparian connectivity

Ground based view (SPSSEG 2010)

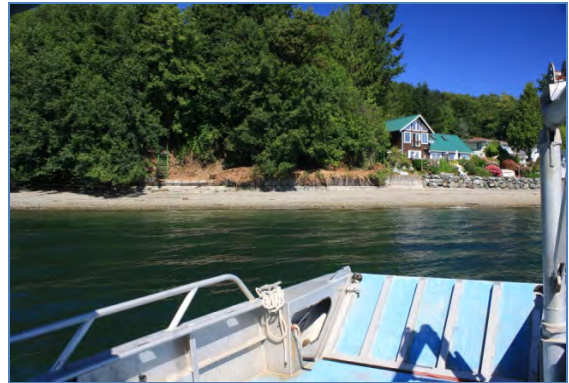
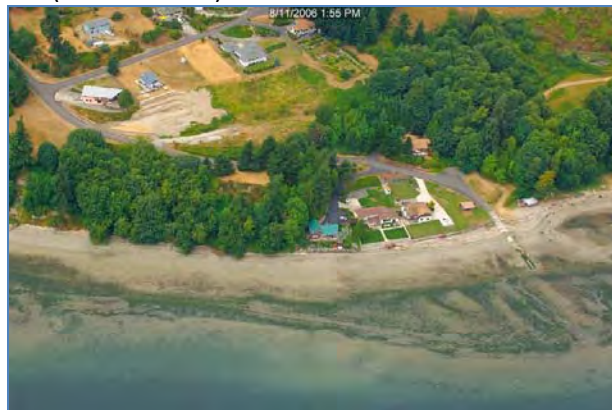
Ground based view (SPSSEG 2010)

Aerial view (DOE 2006)

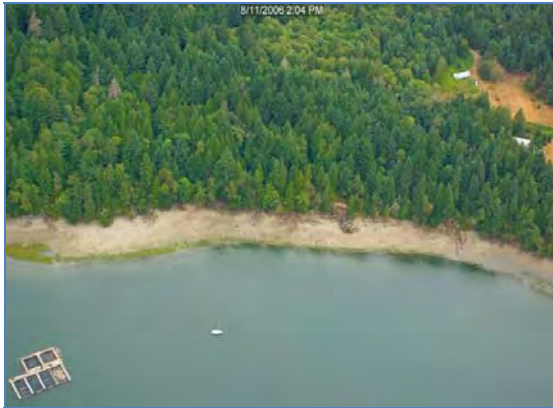
Project ID	Geographic Location		Project Category
44	Filucy Bay		Dock or Pier to Remove
Preliminary Design	Primary Habitat Target	Latitude	Longitude
N	Embayment	47.218790	-122.748600
Unit ID	All Species	Fry Migrant	Limiting Score
1586	24	32	1.125
Description and Restoration Recommendation			
Remove derelict fish pens

Aerial view (DOE 2006)

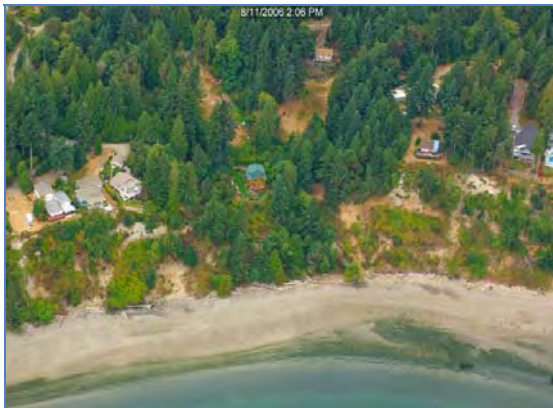
Project ID	Geographic Location		Project Category
45	Filucy Bay		Bulkhead Removal
Preliminary Design	Primary Habitat Target	Latitude	Longitude
N	Feeder Bluff	47.207887	-122.739480
Unit ID	All Species	Fry Migrant	Limiting Score
1592	14	18	0.950
Description and Restoration Recommendation			
Remove soldier pile bulkhead to restore feeder bluff

Aerial view (DOE 2006)

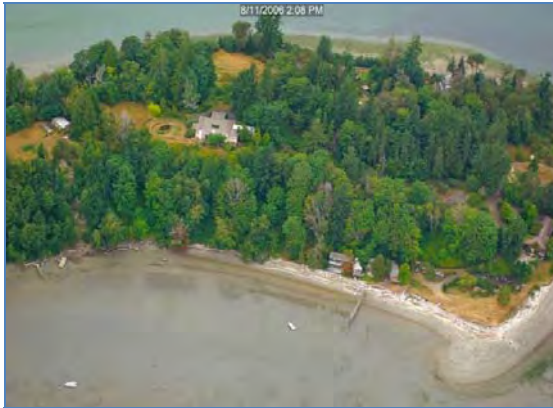
Project ID	Geographic Location		Project Category
46	Filucy Bay		Dock or Pier to Remove
Preliminary Design	Primary Habitat Target	Latitude	Longitude
N	Beach	47.248056	-122.720000
Unit ID	All Species	Fry Migrant	Limiting Score
1604	6	10	1.075
Description and Restoration Recommendation			
Remove old pier on point to improve longshore drift

Aerial view (DOE 2006)

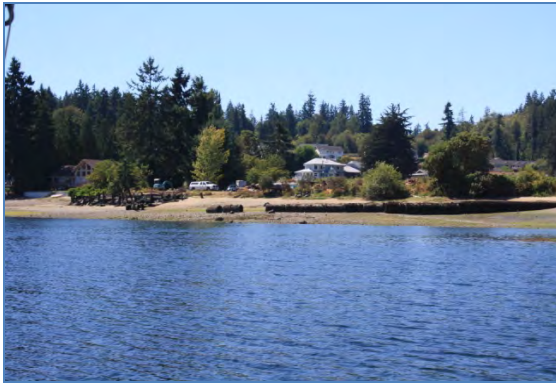
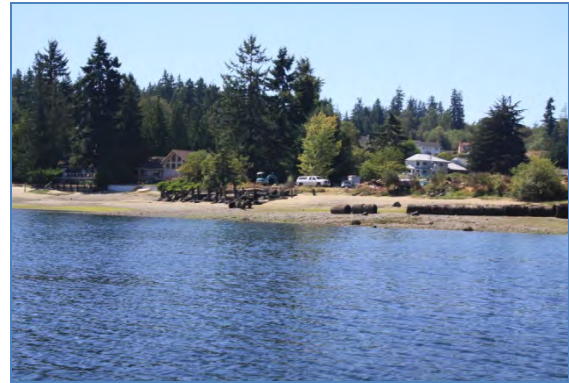
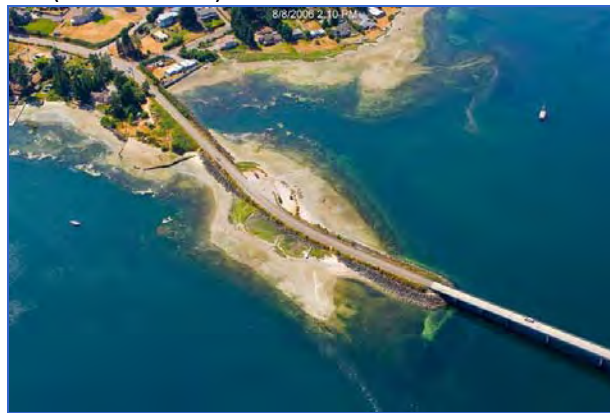
Project ID	Geographic Location		Project Category
47	Fox Island		Bulkhead Removal
Preliminary Design	Primary Habitat Target	Latitude	Longitude
N	Beach	47.273120	-122.651350
Unit ID	All Species	Fry Migrant	Limiting Score
1659	16	36	0.650
Description and Restoration Recommendation			
Remove derelict culvert on beach to restore beach profile and improve longshore drift

Ground based view (SPSSEG 2010)

Aerial view (SPSSEG 2010)

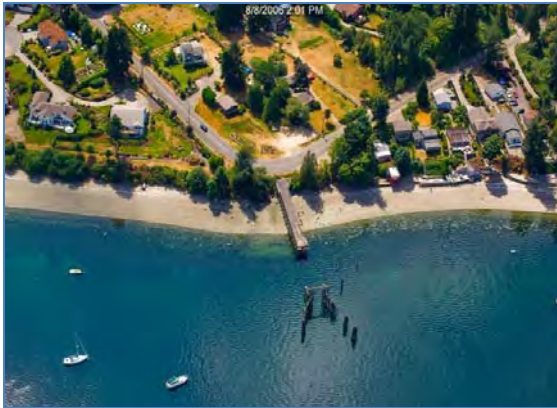
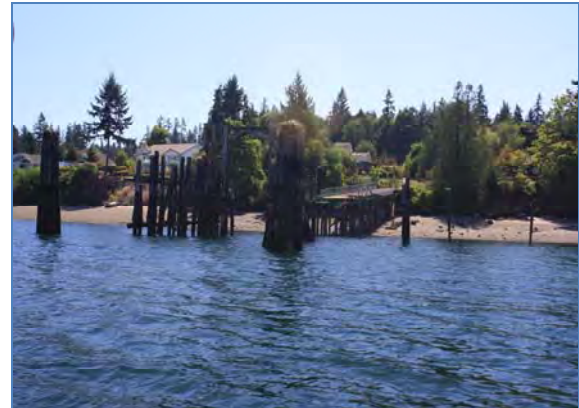
Project ID	Geographic Location		Project Category
48	Fox Island		Dock or Pier to Remove
Preliminary Design	Primary Habitat Target	Latitude	Longitude
N	Beach	47.258410	-122.620570
Unit ID	All Species	Fry Migrant	Limiting Score
1641	16	20	0.438
Description and Restoration Recommendation			
Remove derelict ferry dolphin to restore beach profile and improve longshore drift

Aerial view (DOE 2006)

Ground based view (SPSSEG 2010)

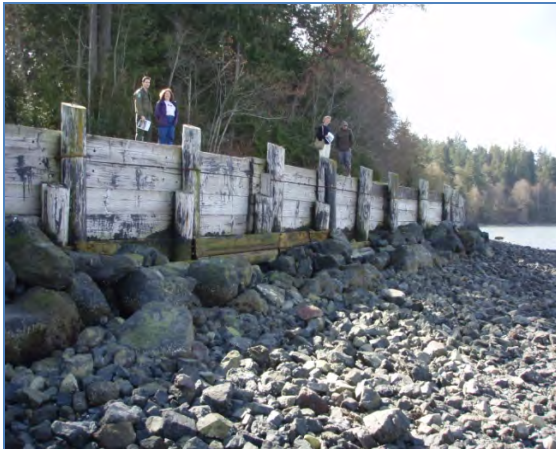
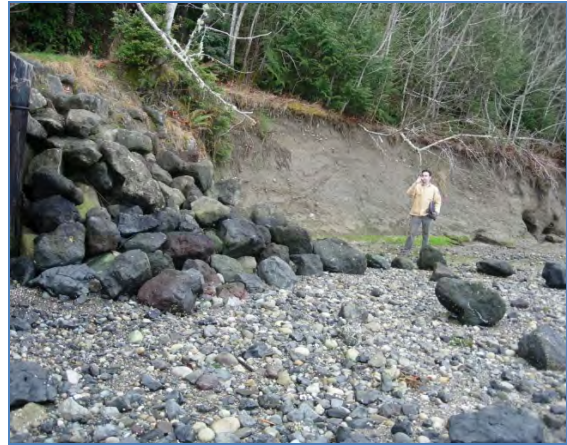
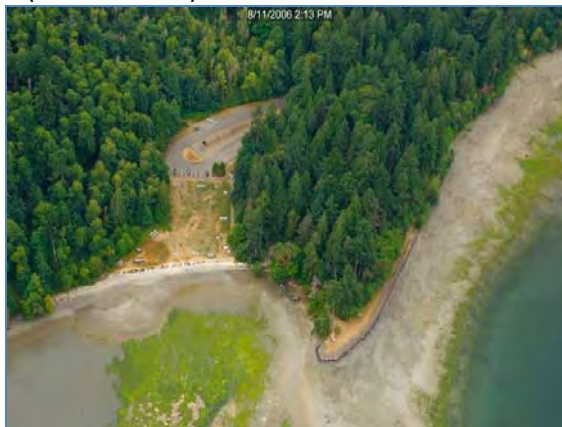
Project ID	Geographic Location		Project Category
66	Mayo Cove		Bulkhead Removal
Preliminary Design	Primary Habitat Target	Latitude	Longitude
Y	Beach	47.260278	-122.745295
Unit ID	All Species	Fry Migrant	Limiting Score
1351	18	22	0.875
Description and Restoration Recommendation			
Remove large creosote bulkhead with rip rap toe protection to restore beach profile and feeder bluff

Ground based view (SPSSEG 2009)

Aerial view (DOE 2006)

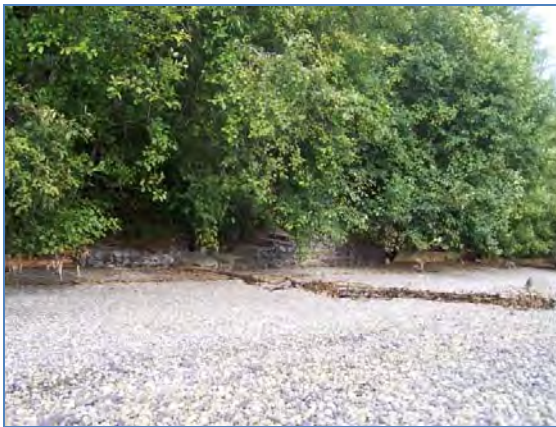
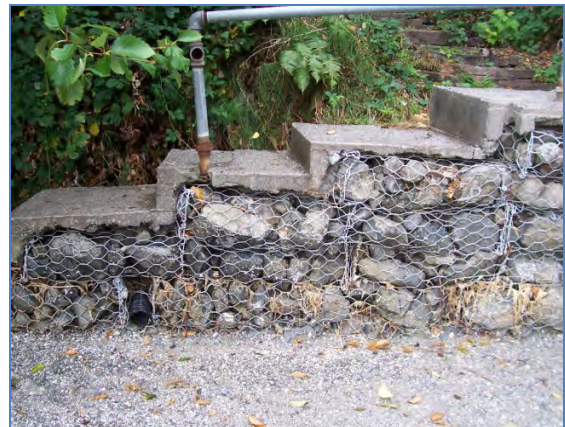
Project ID	Geographic Location		Project Category
67	Carr Inlet		Bulkhead Removal
Preliminary Design	Primary Habitat Target	Latitude	Longitude
Y	Beach	47.297905	-122.747135
Unit ID	All Species	Fry Migrant	Limiting Score
1373	8	10	0.788
Description and Restoration Recommendation			
Remove gabion bulkhead, and concrete/creosote timber stairchase to restore beach profile and feeder bluff

Ground based view (SPSSEG 2009)

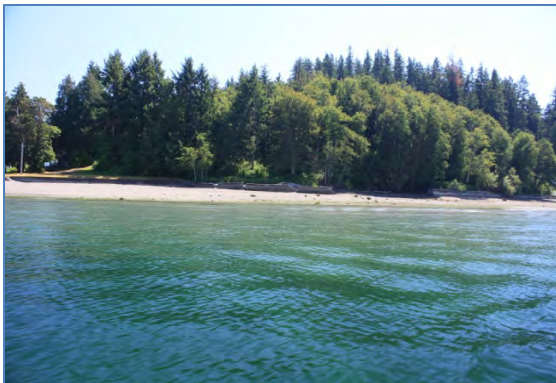
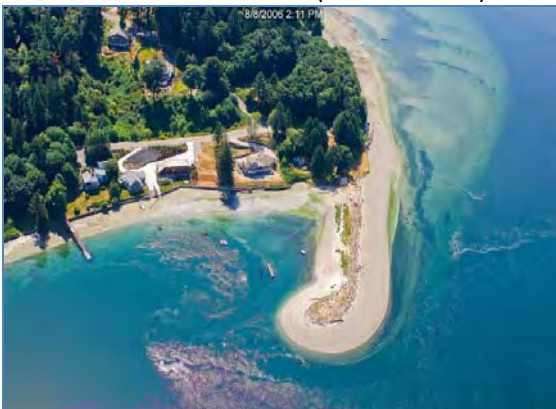
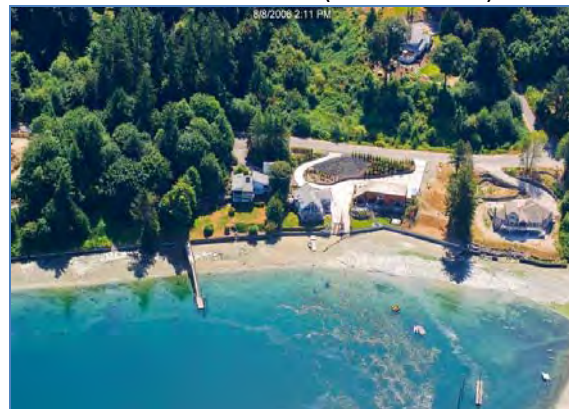
Project ID	Geographic Location		Project Category
68	Fox Island		Bulkhead Removal
Preliminary Design	Primary Habitat Target	Latitude	Longitude
N	Beach	47.277549	-122.666438
Unit ID	All Species	Fry Migrant	Limiting Score
1663	16	20	0.900
Description and Restoration Recommendation			
Remove concrete bulkhead to restore beach and reconnect riparian

Ground based view (SPSSEG 2010)

Aerial view (DOE 2006)
