Strategic Identification of Areas and Projects for Nearshore Restoration throughout Key Peninsula-Gig Harbor-Islands Watershed, WRIA 15, Washington

March, 2011

Prepared for Salmon Recovery Funding Board and West Sound Watershed Lead Entity (WRIA 15)

Prepared by Kristin Williamson and Jerilyn Walley, South Puget Sound Salmon Enhancement Group, and Kyle Brakensiek, Independent Consultant

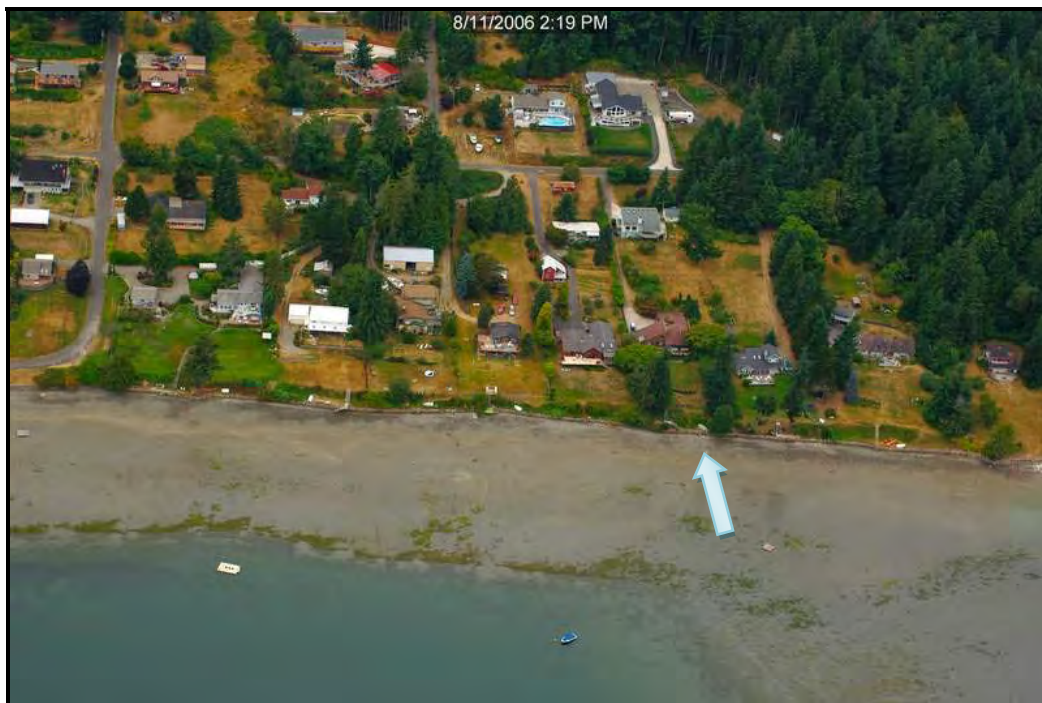
Figure 7.1 Aerial photo (DOE 2006) location of bulkhead removals, project may include removal of one to five bulkheads.

This bulkhead removal project is located on the northeast section of VonGeldern Cove. The following design report analyzed feasibility and design alternatives for removal of two adjacent bulkheads (210-feet) in VonGeldern Cove with the goal to restore natural processes and enhance nearshore habitat function on several (up to five) adjacent properties in the Cove (Coastal Geologic Services 2010). The site consists of a low bank beach with gently sloping uplands developed as single family homes. The site presents a good opportunity for restoration as shoreline armor appears to be unnecessary given the low wave energy and low erosion potential.

The toe of the existing bulkheads meet the beach approximately 1.5-feet below Mean Higher High Water, limiting the function of the active beach and back beach area. The conceptual approach for this project as detailed in the following design report would be to remove the vertical pile bulkhead(s) and grade the upper beach and upland area towards a more natural, gently sloping profile. The proposed toe of the slope would be moved 15-20 feet landward of the existing bulkhead toe to allow for colonization of saltmarsh vegetation and wave energy dissipation. The following report focused on two parcels with willing landowners, but the approach could be utilized at adjacent sites to expand the footprint and increase the benefit of the project, depending upon interest.

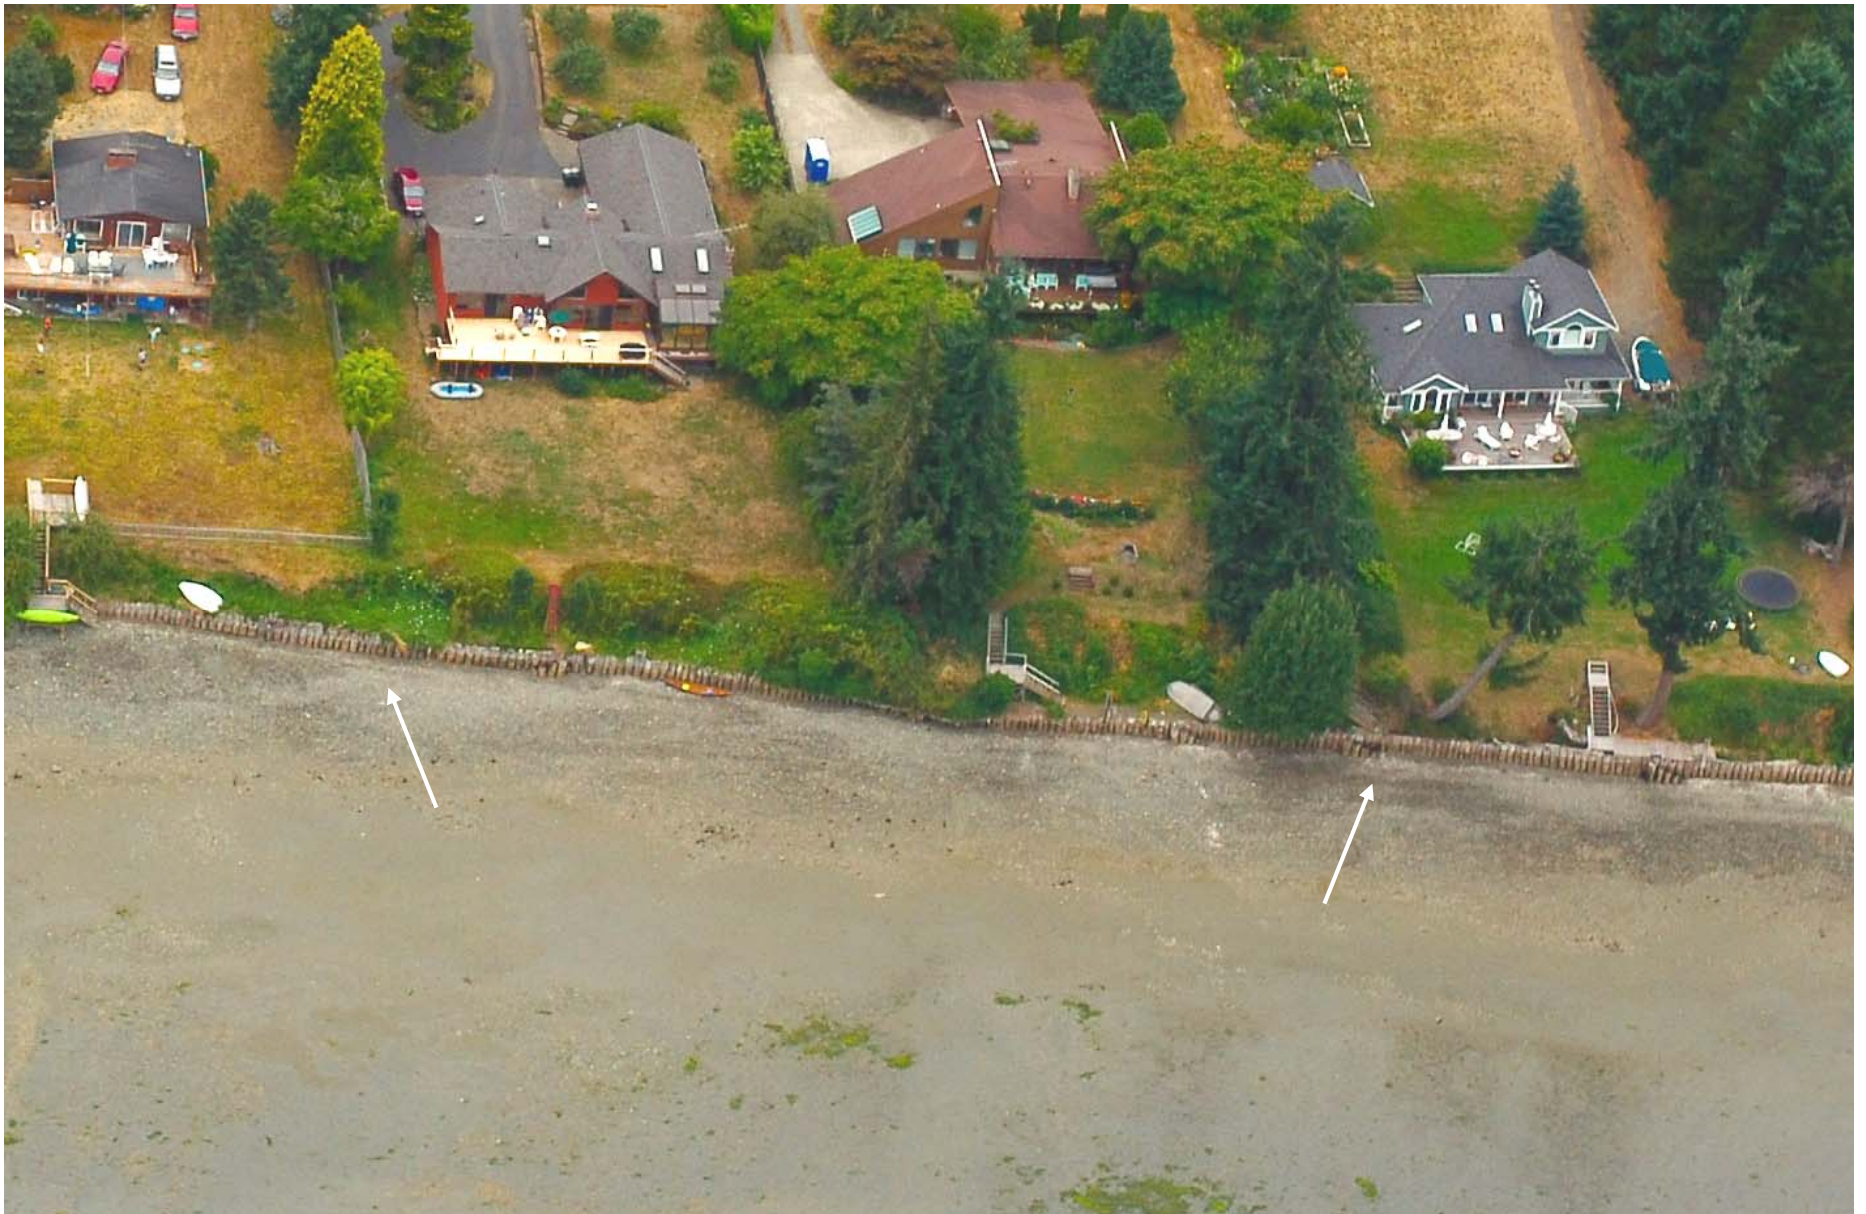
Figure 1. Von Geldern Cove site. Image enlarged from 8/11/06 shoreline oblique by WA Dept. of Ecology. Arrows show extent of potential project area.

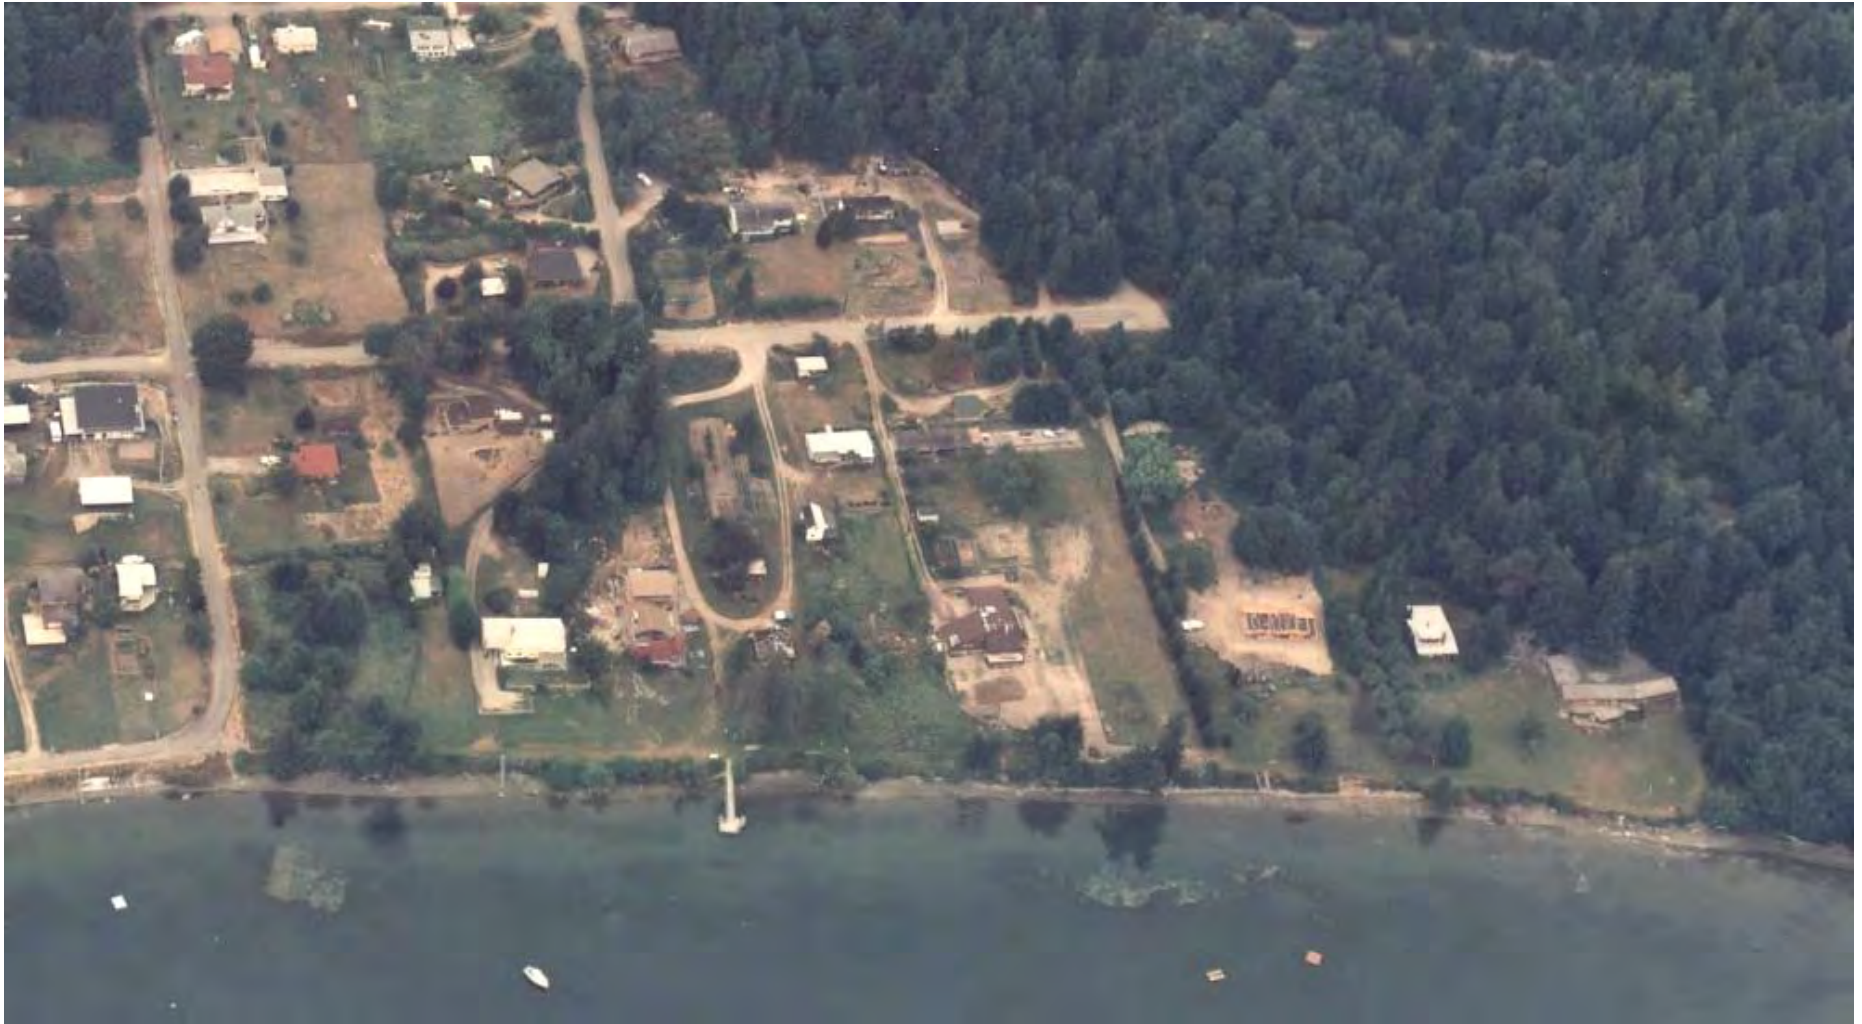
Figure 2. Von Geldern Cove site. Image enlarged from 6/27/77 shoreline oblique by WA Dept. of Ecology. Williams house (red roof, near center) was recently constructed with cut visible in landward portion of yard and apparent fill near marine bank.

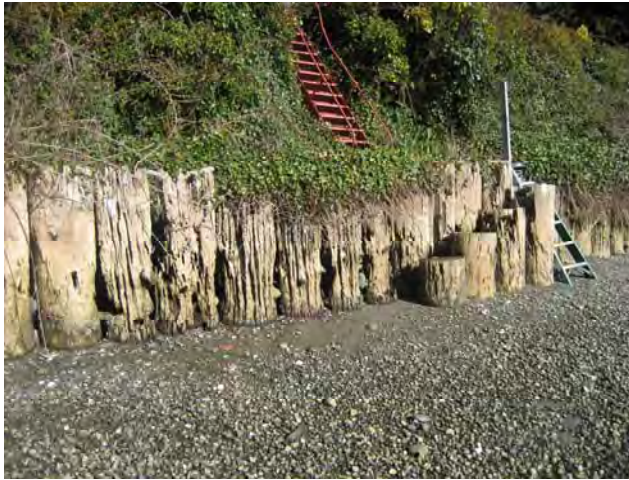
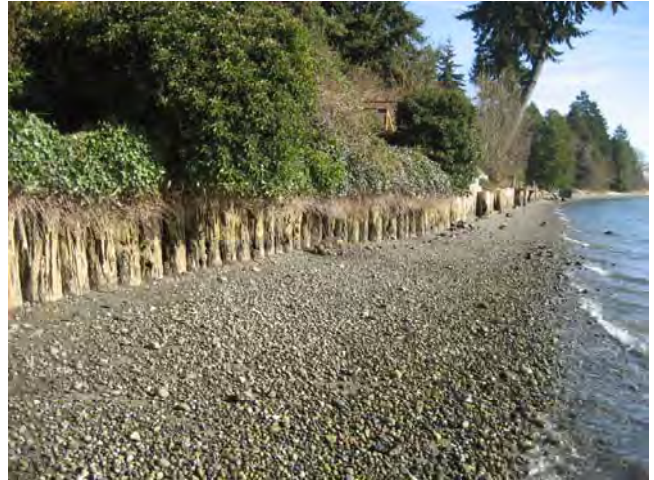
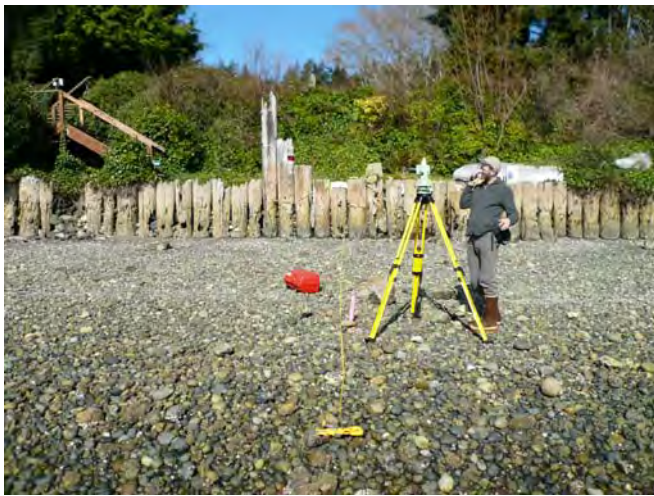
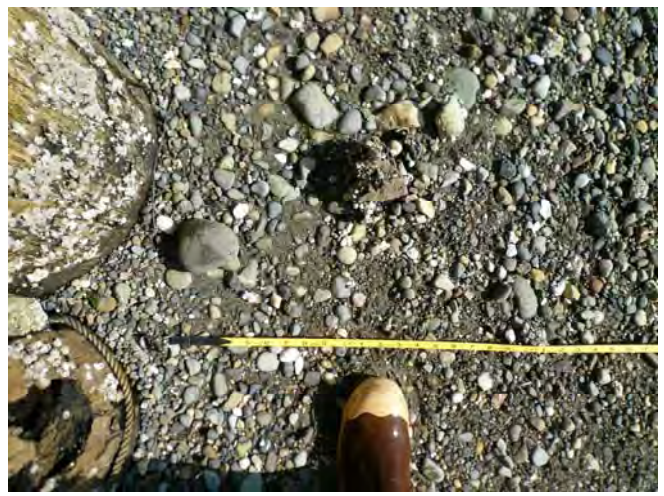
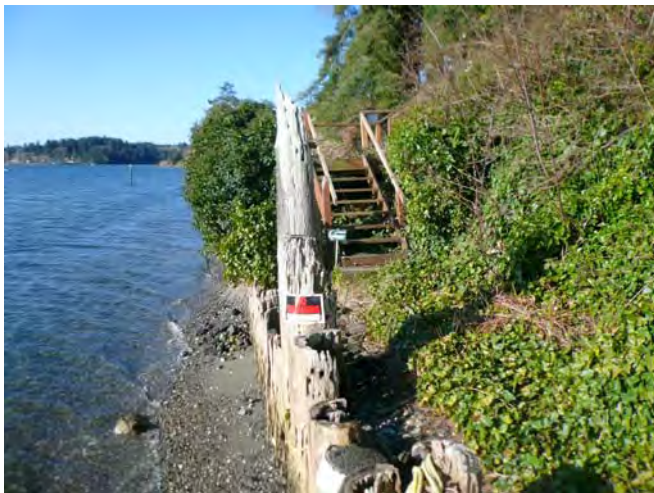
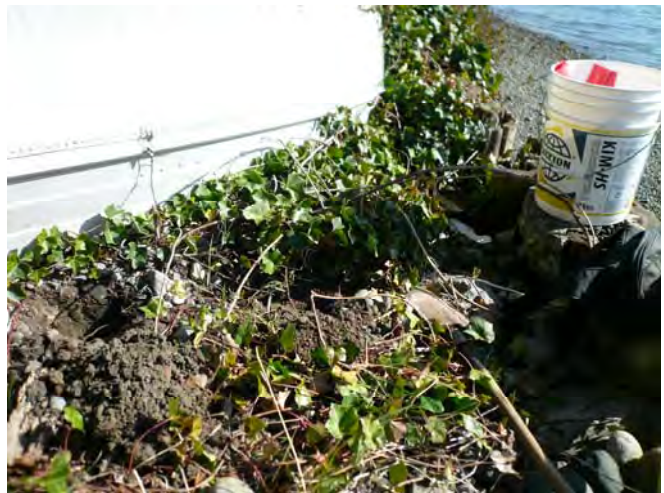
Figure 3. Photo page showing beach and bank, at lower and higher tides, on March 19, 2010. Fourth image shows upper beach substrate at Williams site. Last image shows bulkhead backfill.

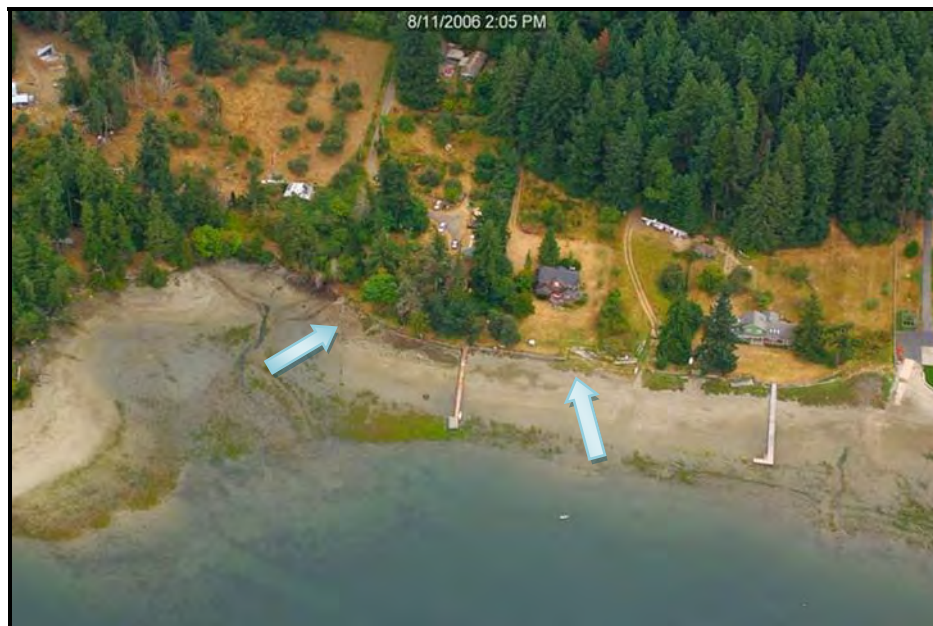
Figure 7.2. Aerial photo (DOE 2006) location of bulkhead removal in Filucy Bay. The project includes removal of two bulkheads.

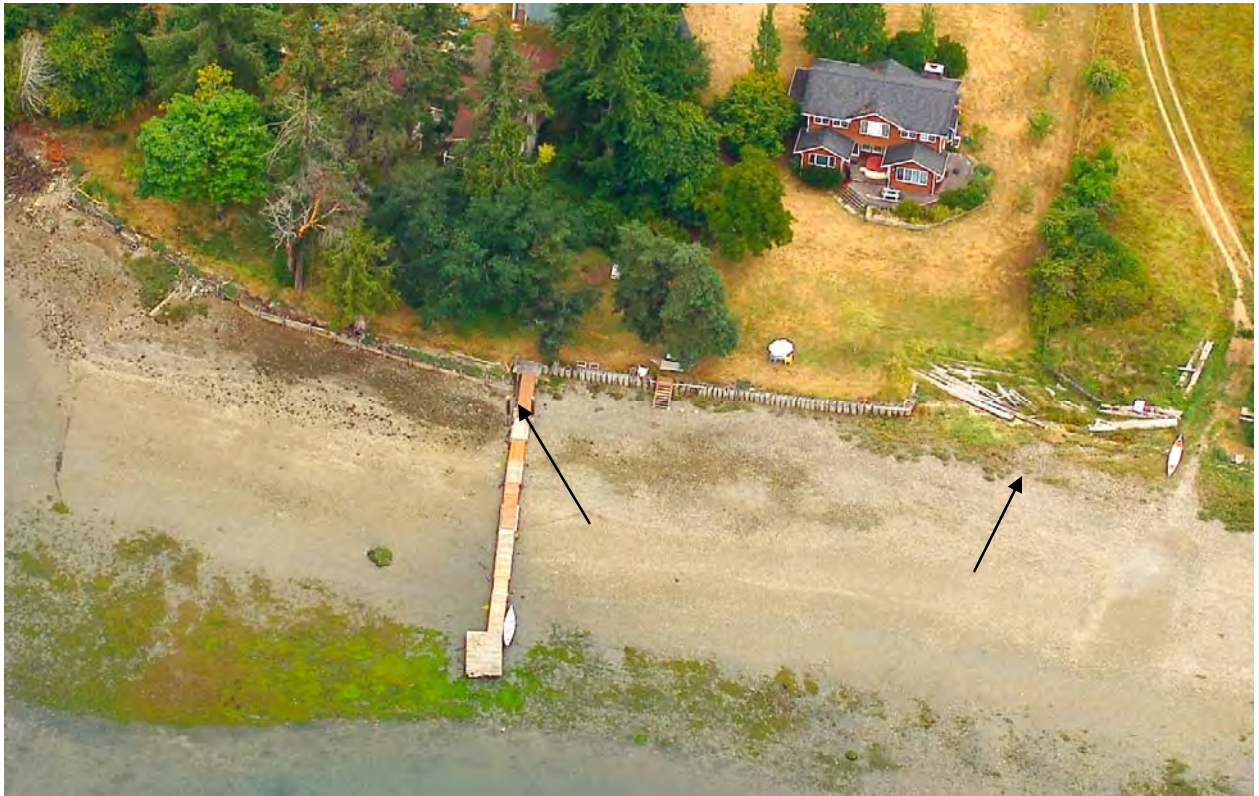
Figure 1. Oblique aerial photo from 8/11/06 (enlarged) by WA Dept. of Ecology. Arrows point to extent of the site.

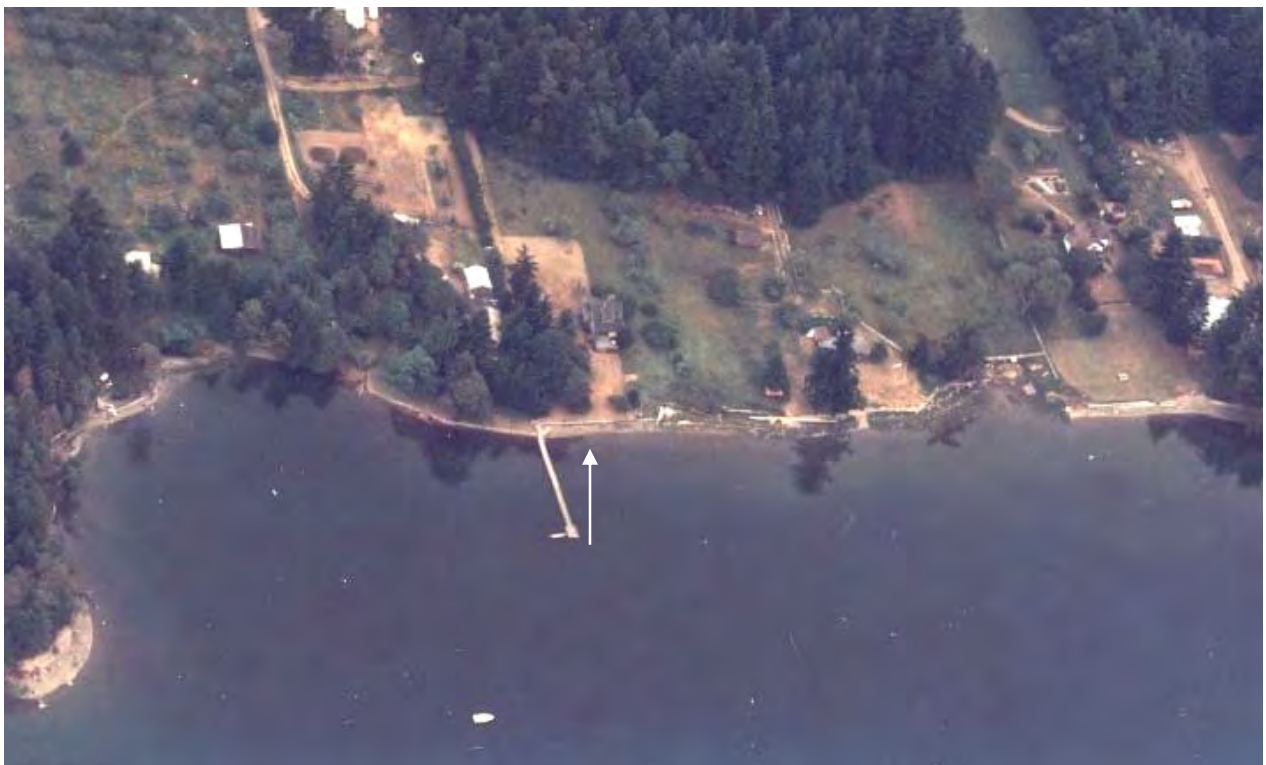
Figure 2. Oblique aerial photo from 7/27/77 (enlarged) by WA Dept. of Ecology. Arrow points to site. Image appears to show an older bulkhead in place at the site, just to right of long dock. Owners reported that the current bulkhead was installed in 1982, and the new house was constructed in 1989.

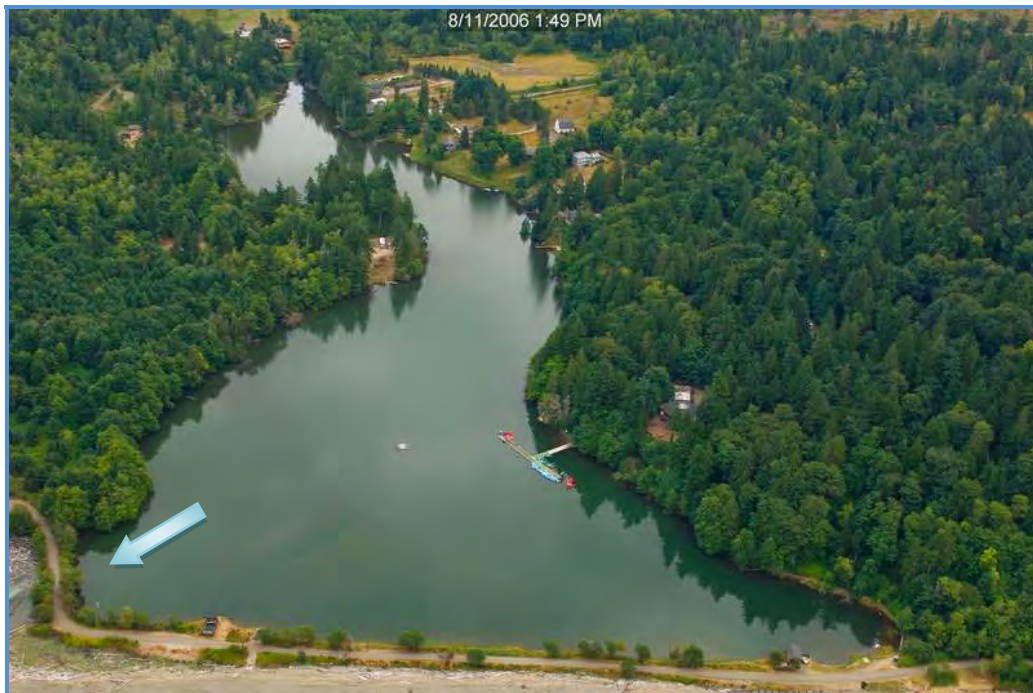
Figure 7.3. Aerial photo (DOE 2006) showing roadway impoundment a historic barrier estuary, Whiteman Cove.

Whiteman Cove is a large (relative to South Puget Sound), historic, barrier estuary. The historic barrier spit was filled for maintenance of a roadway and the outlet to the estuary was dammed, allegedly for maintenance of the road and for use of the impoundment for Washington State Fisheries coho rearing programs. Two tide gates breach the spit and maintain surface water elevation of impounded water. Whiteman Cove presents a benefit restoration opportunity to increase estuarine rearing habitat, salt marsh recolonization and food production.

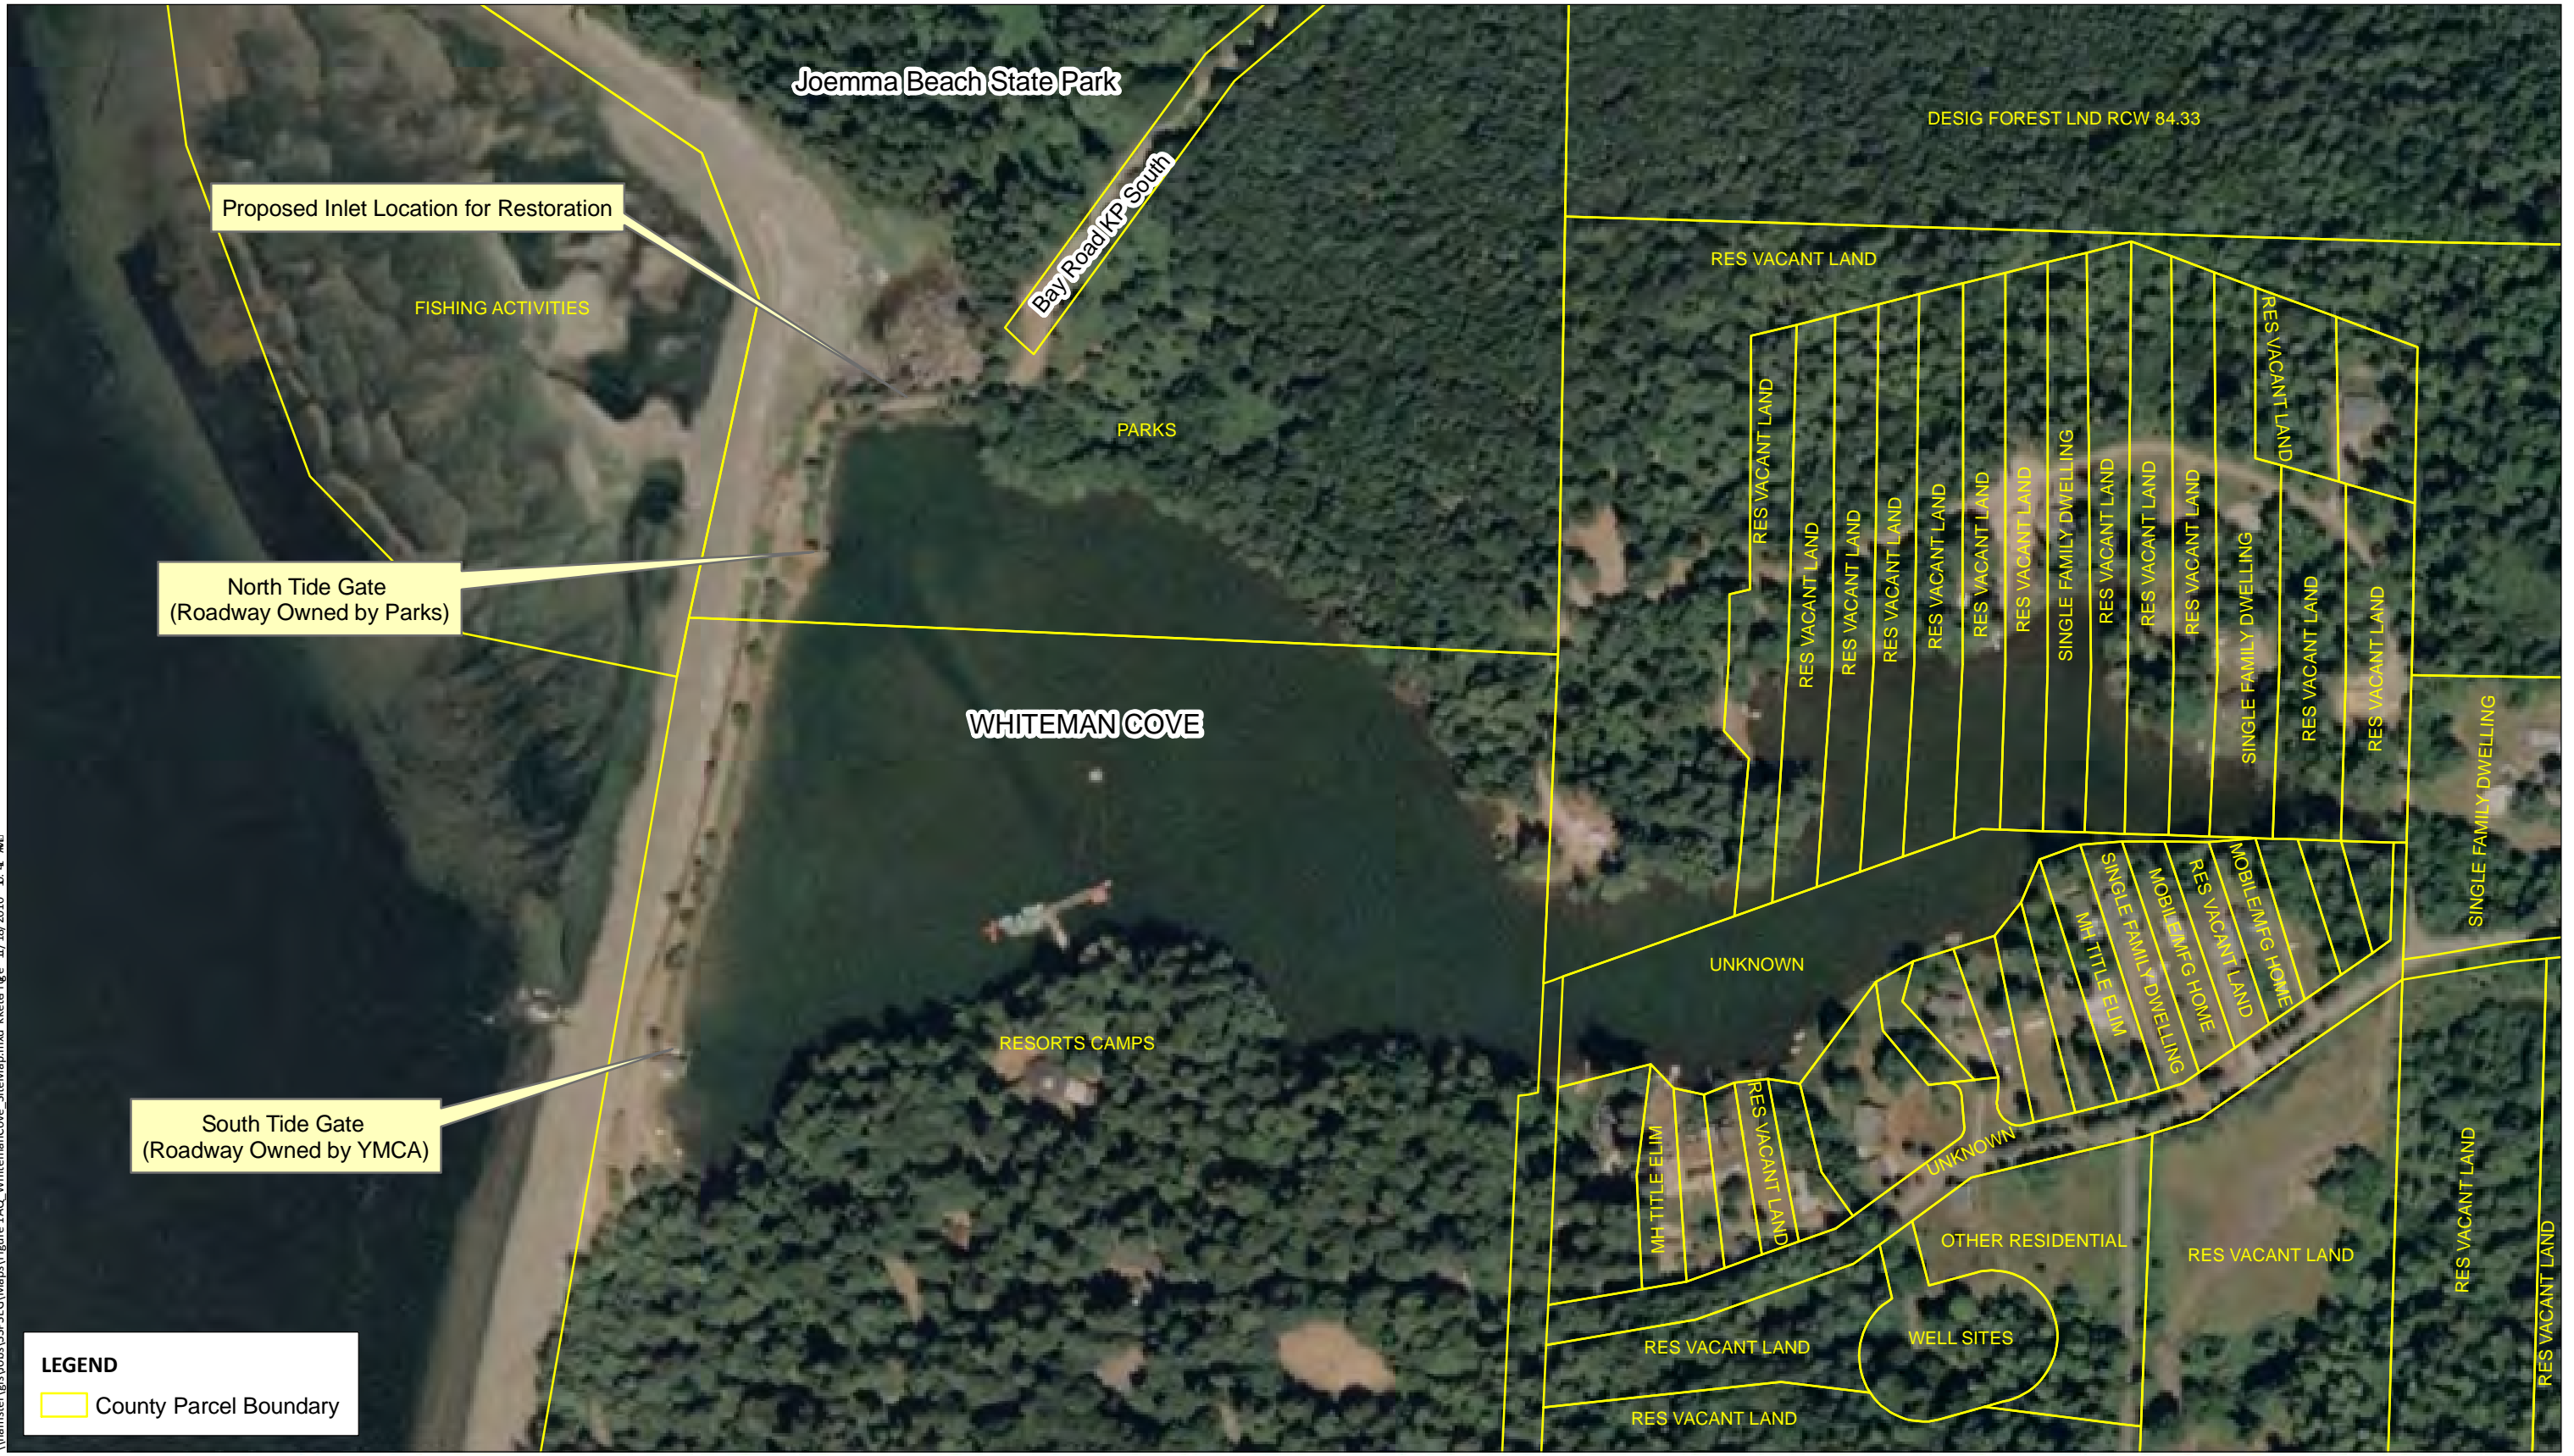
Figure 1
 Project Site Map
 Whiteman Cove
 South Puget Sound Salmon Enhancement Group

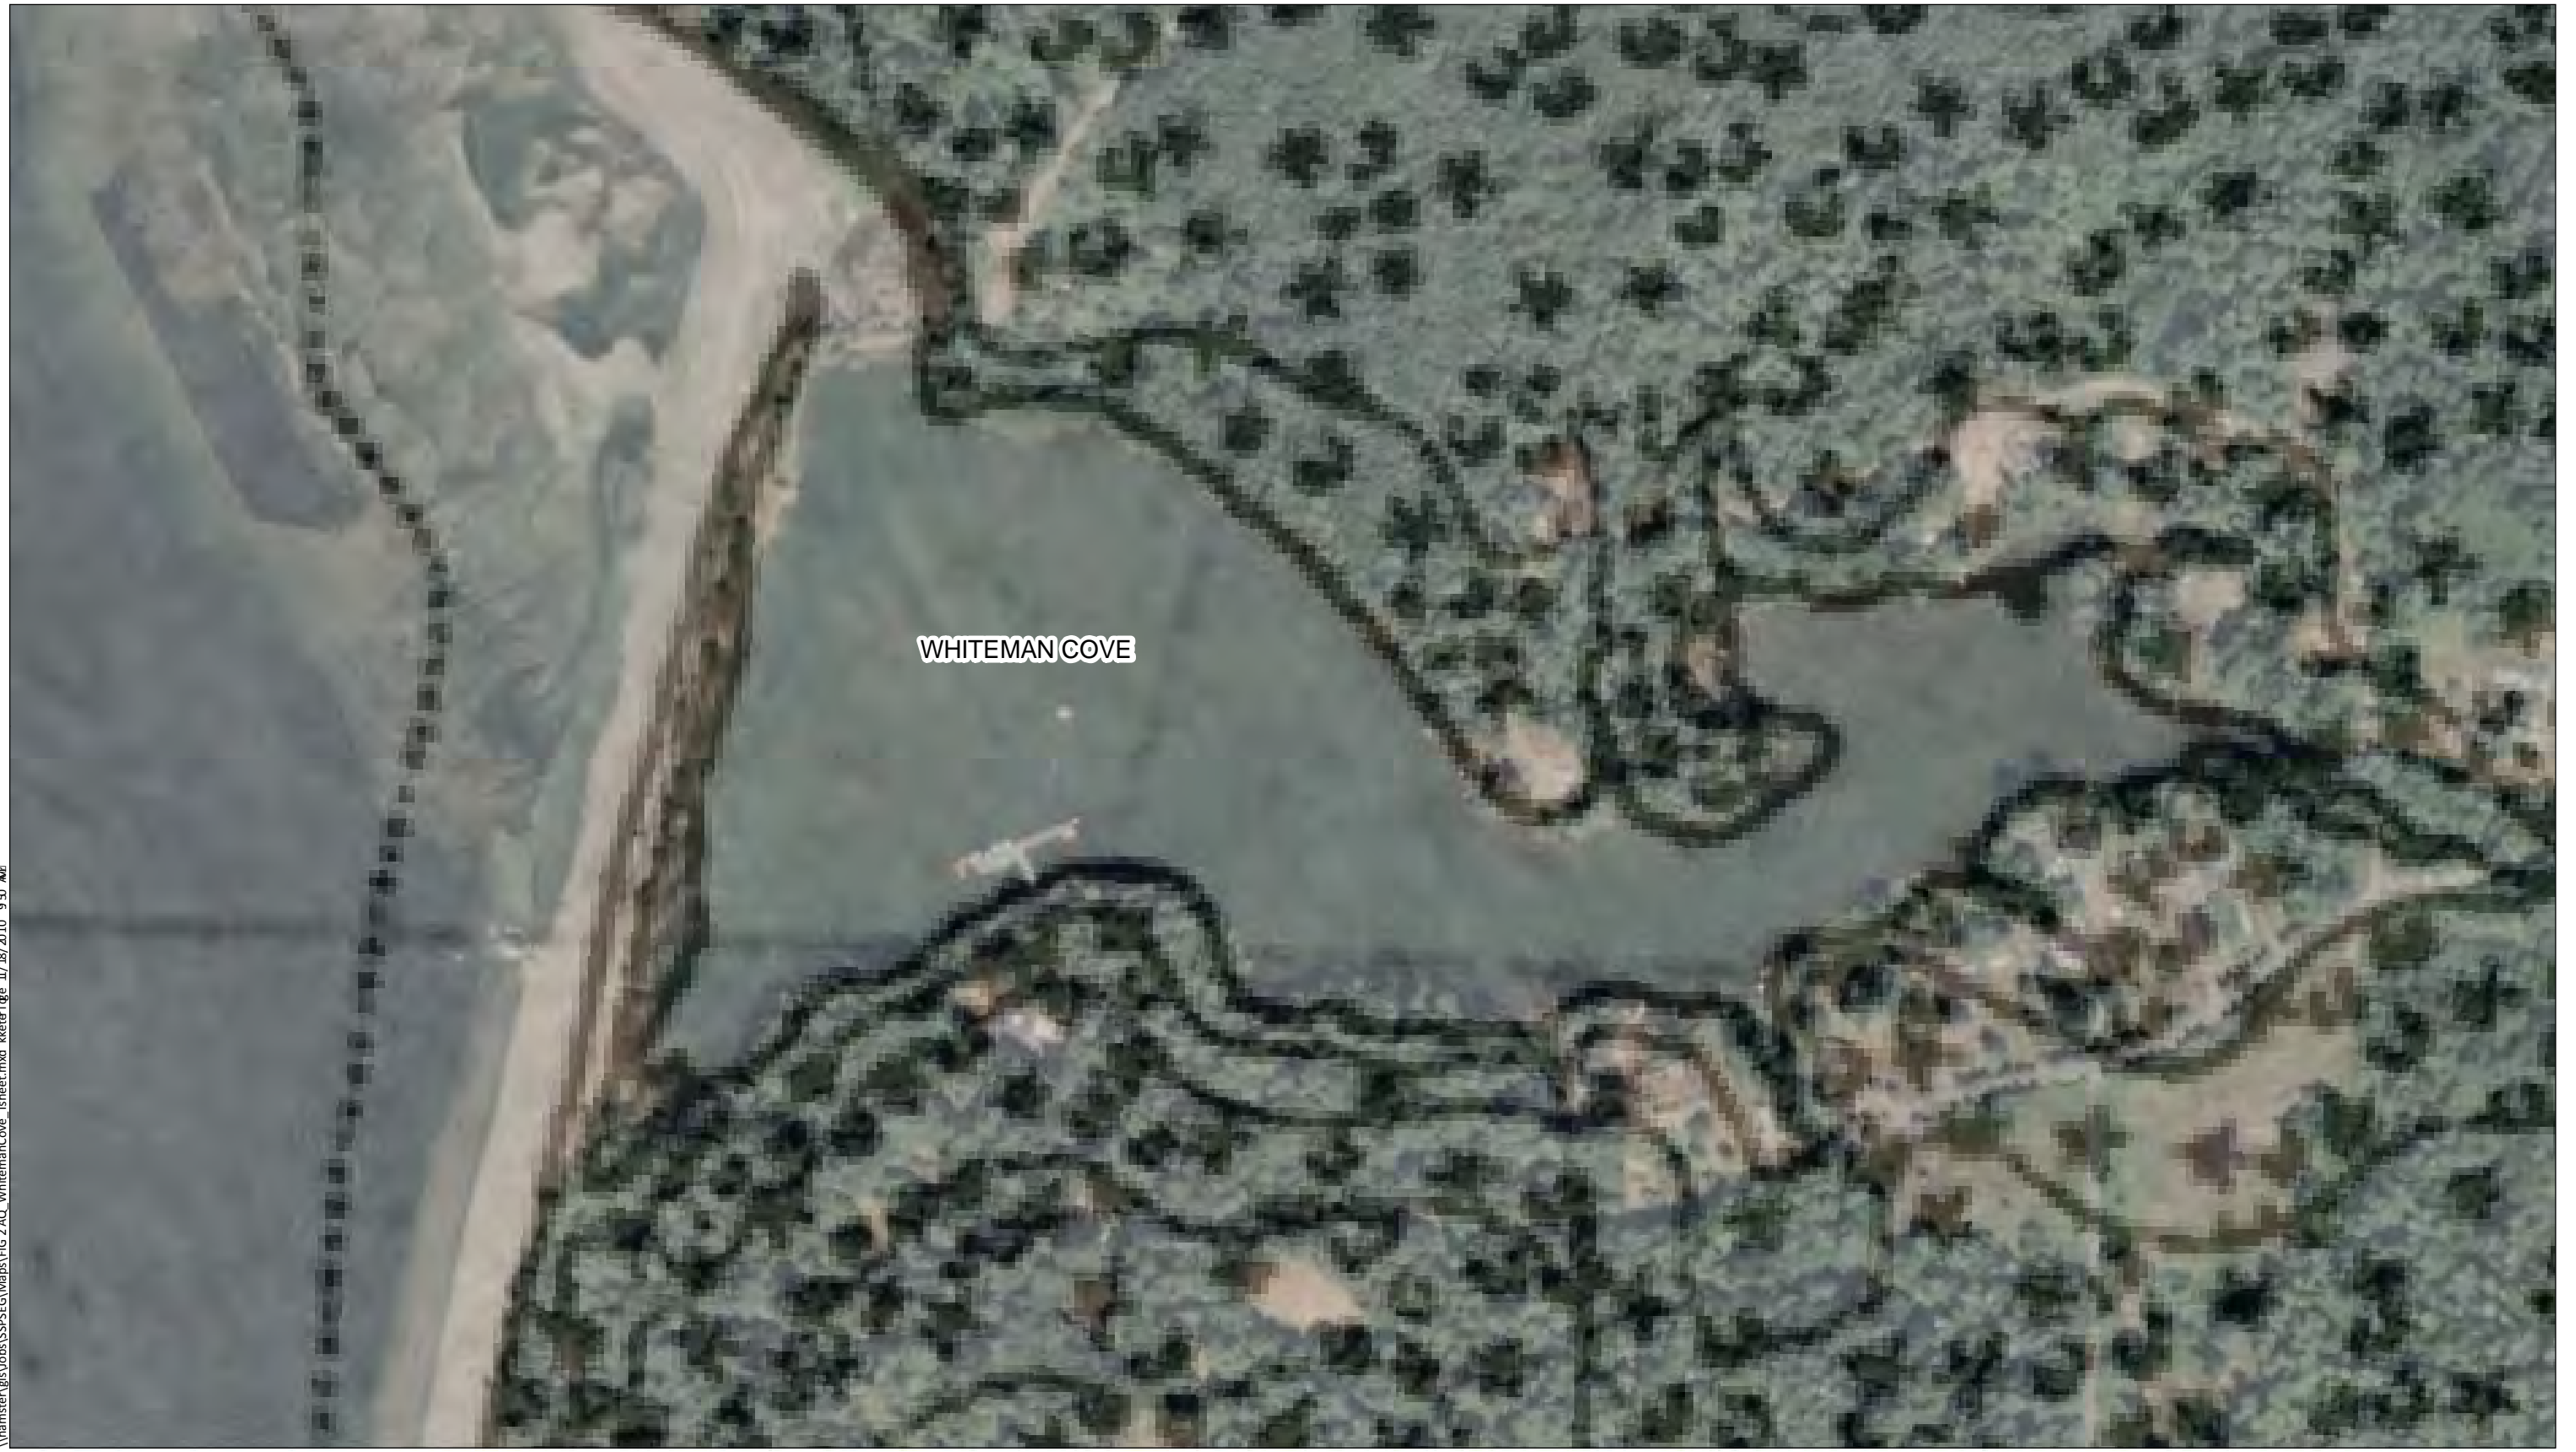
NOTES:
T-Sheet, US Coast Survey, 1878

Figure 2
T-Sheet
Whiteman Cove
South Puget Sound Salmon Enhancement Group

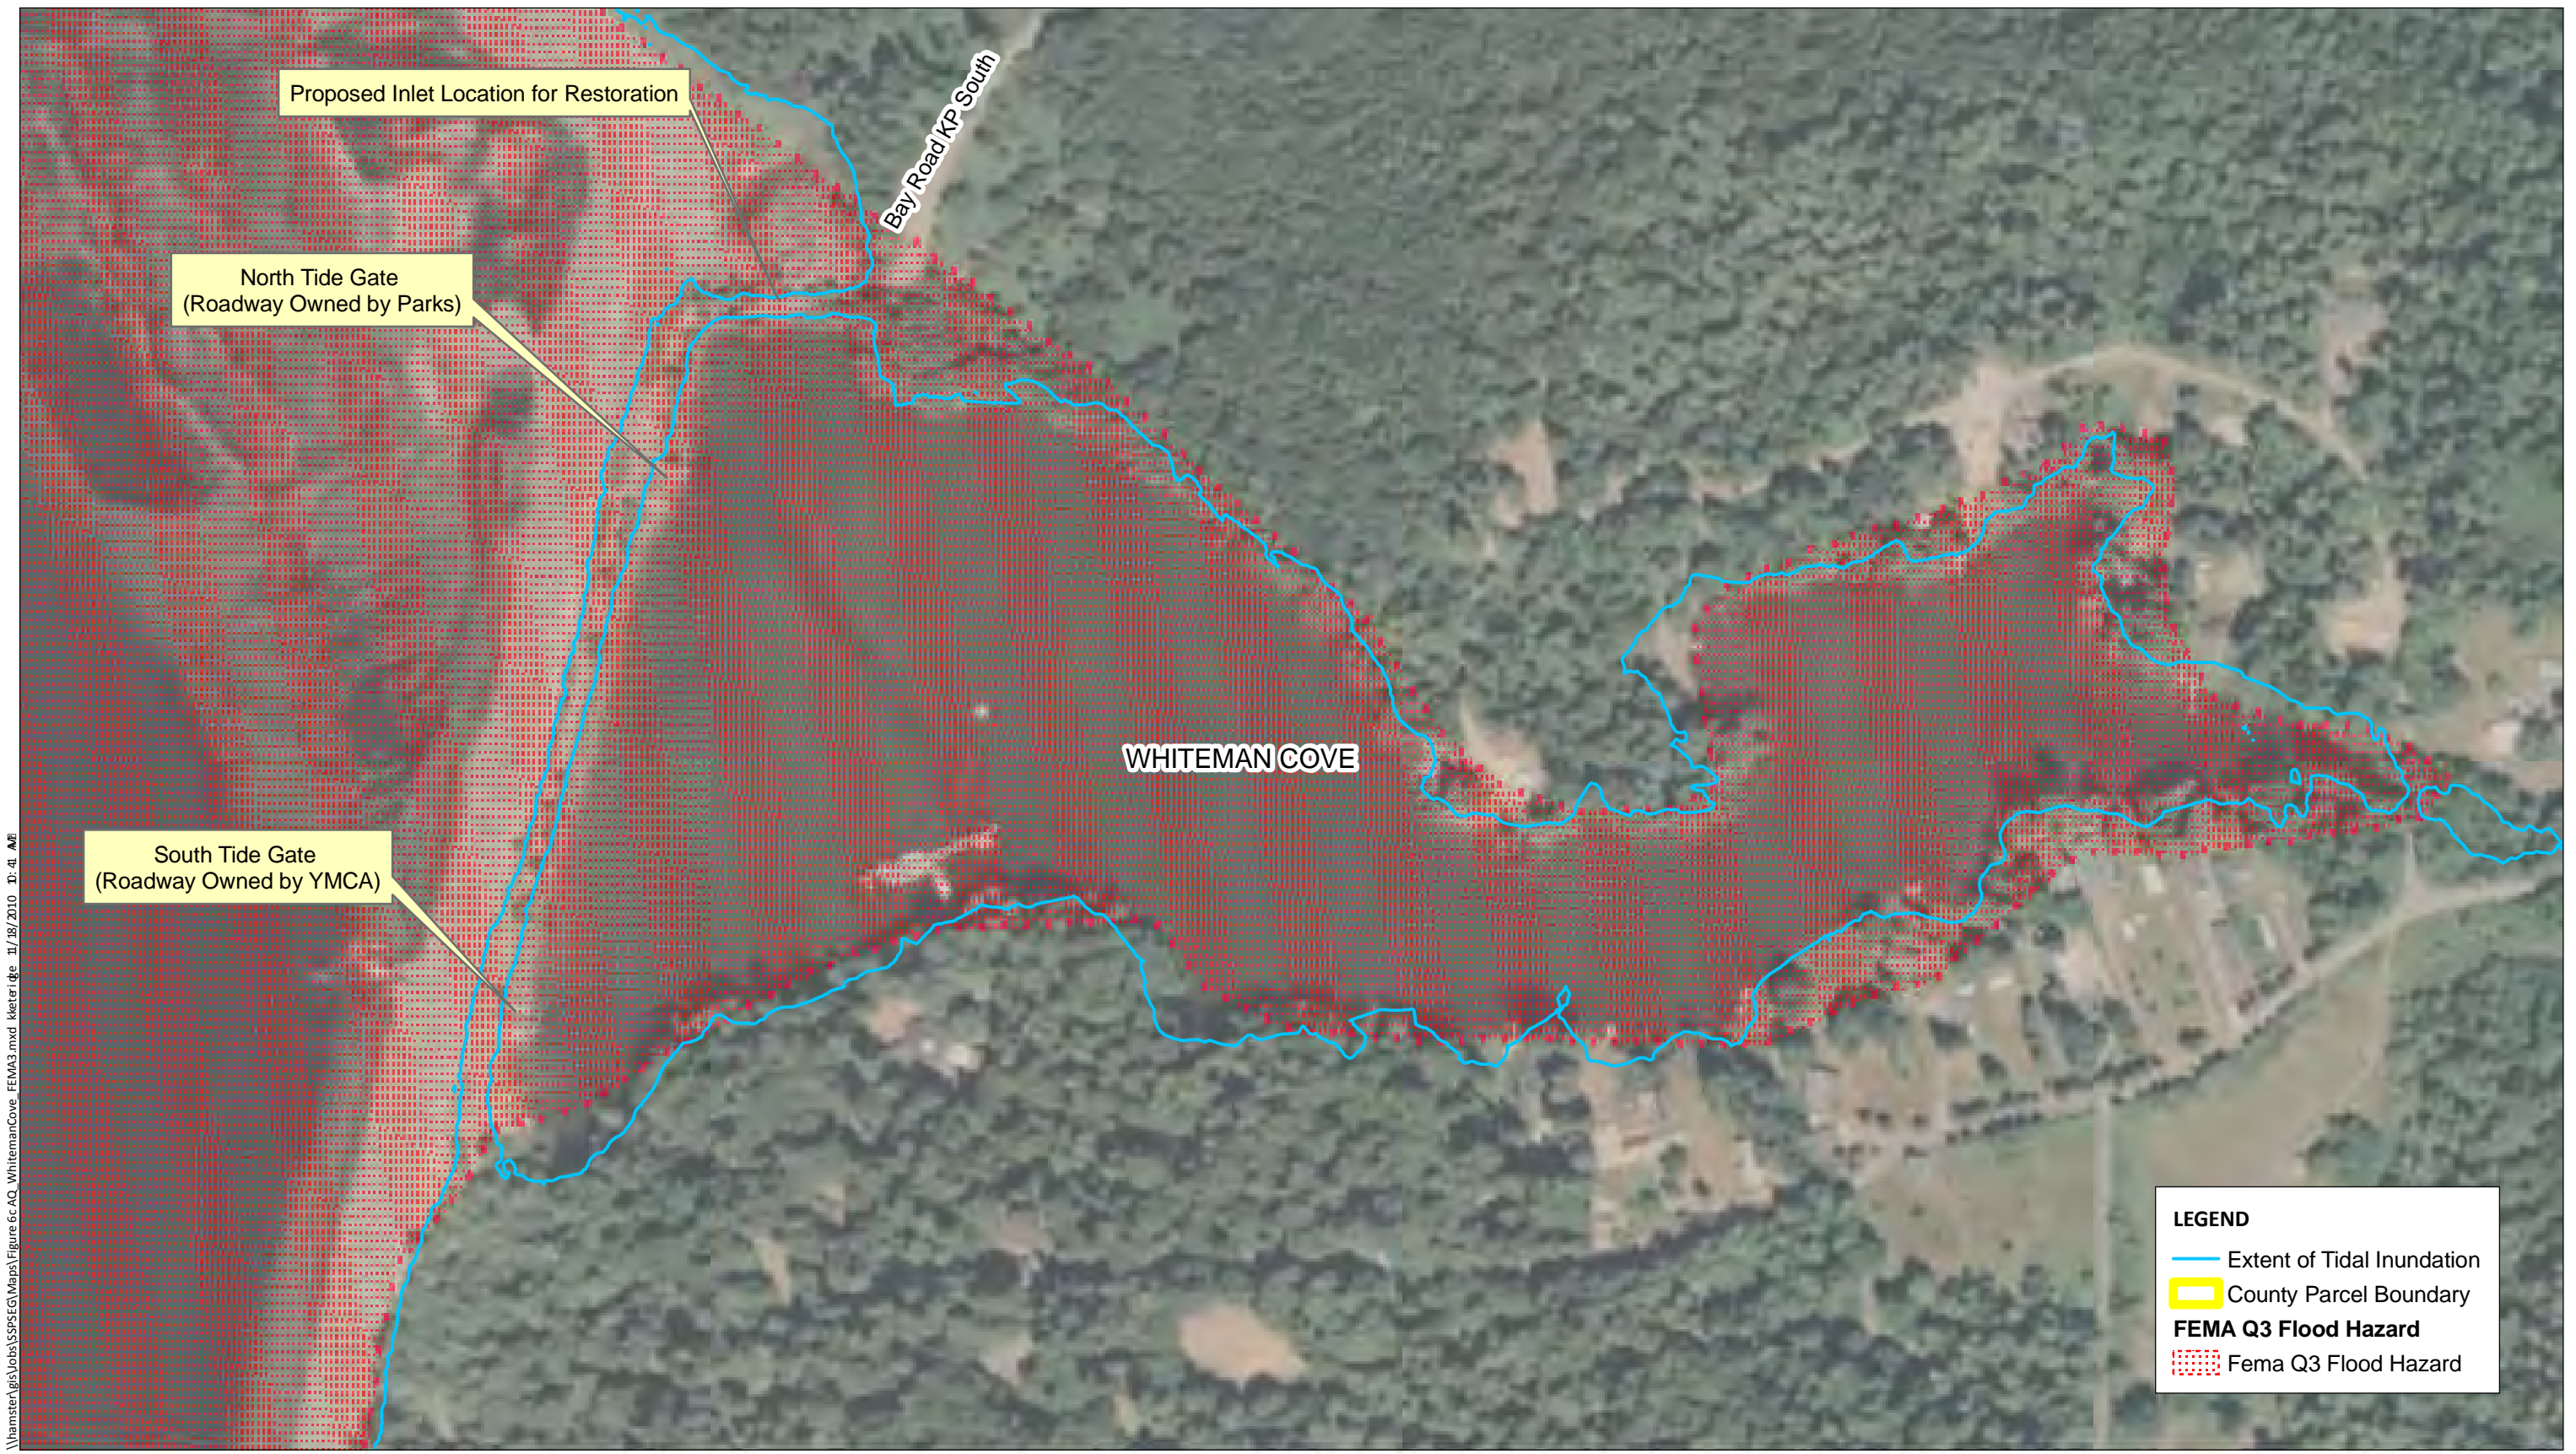
NOTES:
 Elevation based on Lidar and Tidal Datum Benchmarks.
 Tidal Inundation Estimated for Extreme High Tide (without storm surge) and is estimated as 13.5 ft NAVD88.

Figure 6C
 Comparison of FEMA 100-yr Flood Extent and Predicted Tidal Inundation
 Whiteman Cove
 South Puget Sound Salmon Enhancement Group

LiDAR data for the project site (provided by Puget Sound LiDAR Consortium, 2002) was used to extract the 13.5 ft NAVD88 contour line from the project site topography. This elevation corresponds to approximate extreme high water at the project site. (Evaluation of impacts due to storm surge, localized increase in water level due to onshore wind and large waves, on the project site was outside the scope of this evaluation.) Figures 6A and 6B show the county parcel boundaries and the extent of tidal inundation (the 13.5 ft NAVD88 contour line) within Whiteman Cove post-restoration. Figure 6C provides a comparison between the 100-year FEMA Flood Zone and the estimated post-restoration tidal inundation. Observations from the evaluation of potential flooding impacts (and review of Figures 5 and 6A through 6C) are summarized below. In general, it appears that restoration of Whiteman Cove may not significantly increase risk of flooding to adjacent property owners.

- The extent of tidal inundation (post-restoration) appears to be within the extent of the 100-year floodplain in Whiteman Cove at most locations (see Figure 6C).
- Restoring tidal inundation to Whiteman Cove does not appear to flood any homes or other structures (not including docks or boathouses) that are visible in the aerial photograph (see Figures 6A and 6B).
- Tidal inundation may extend an additional 50 to 100 feet inland from the current edge of water shown in the aerial photograph.
- Existing dock and boat house structures would need to be modified to take into account a fluctuating water level, as well as the increase in water level due to tidal inundation. This includes the large YMCA dock fronting Camp Coleman.
- The Marine Center at Camp Coleman, which is located just south of the south tide gate, will be inundated by the tide post-restoration, and will need to be relocated.
