Strategic Identification of Areas and Projects for Nearshore Restoration throughout Key Peninsula-Gig Harbor-Islands Watershed, WRIA 15, Washington

March, 2011

Prepared for Salmon Recovery Funding Board and West Sound Watershed Lead Entity (WRIA 15)

Prepared by Kristin Williamson and Jerilyn Walley, South Puget Sound Salmon Enhancement Group, and Kyle Brakensiek, Independent Consultant

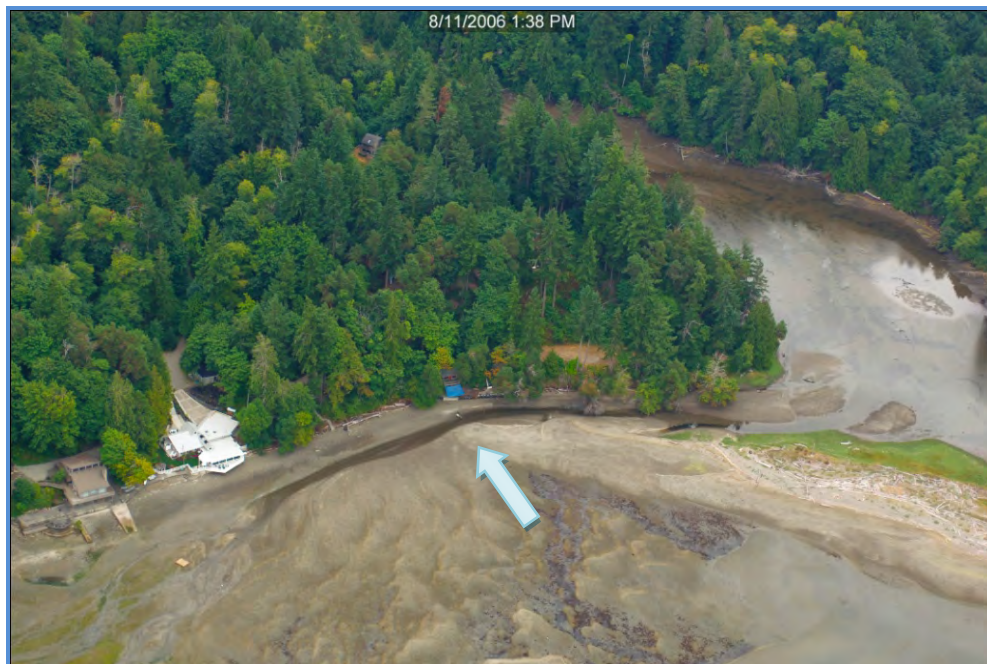
Figure 7.4. Aerial photo (DOE 2006) showing the bulkhead, lagoon, and tidal channel before channel reroute in 2009.

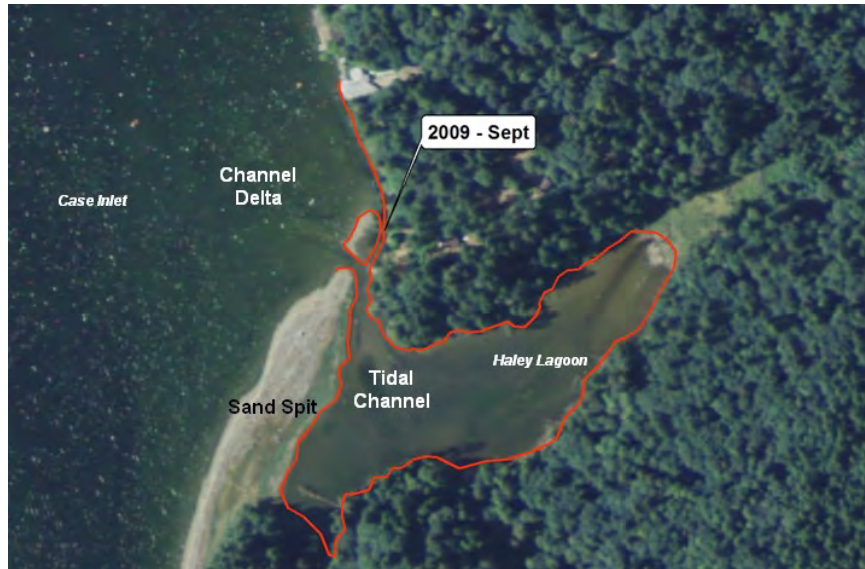
Figure 2. Tidal channel location near bluff in September 2009

Figure 2 is an aerial photograph showing the tidal channel confined between the northward trending sand spit at the Case Inlet shoreline and the channel's eastern bankline. A bulkhead composed of concrete filled scrap tires had been installed along one property as a response to

erosion risk, but it is undermined in places. Historically the property owners have repositioned the channel away from the bluff by shoveling a breach in the sand spit and allowing the channel to take a more direct route to Case Inlet. Outlet channel modification was conducted to prevent undermining and erosion of bulkheads and unprotected shoreline. Over time the channel would locate itself against the bluff again. The project reach is a length of bluff toe extending about 250 ft to the north and ending at the northern end of the tire bulkhead, and is indicated in Figure 3.

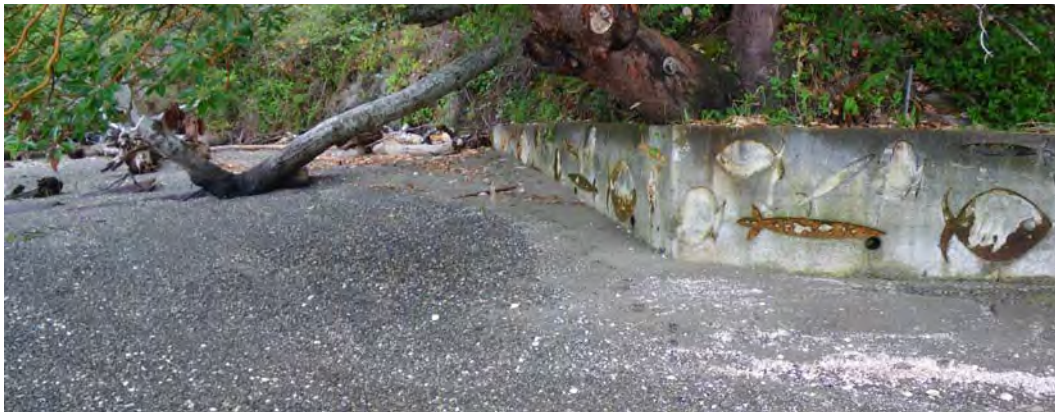
Figure 6. Southern extent of shoreline reach targeted for soft shore protection

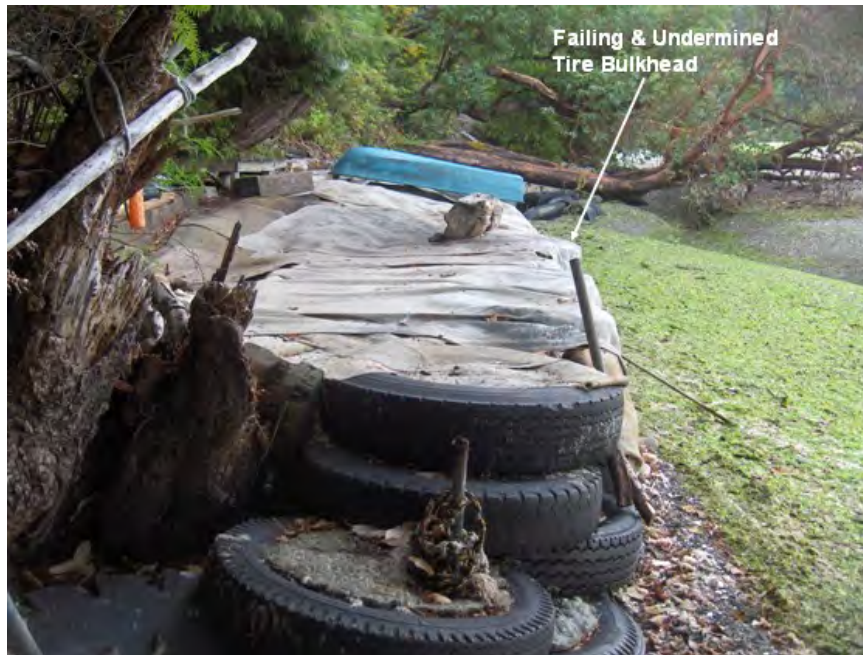
Figure 7. Scrap tire bulkhead constructed to protect upland from erosion

A concrete bulkhead return wall marks the southern limit of the habitat enhancement project (Figure 6). The bulkhead made of concrete-filled tires was constructed at the water's edge to protect a house foundation. Figure 7 shows the bulkhead that is the primary subject of the bulkhead removal and shore protection project. North from the northern end of the tire bulkhead is a separate property where rock had been placed to control erosion at the bluff toe (Figure 8). Farther north the foundation of a house projects onto the high tide shoreline.

The channel exiting the lagoon has a history of migrating toward the bluff toe in the distance from the concrete bulkhead northward for a distance of about 500 ft. At intervals of 10 to 15 years the channel was re-routed to a more direct path to Case Inlet by hand excavation, with excavated material placed to block flow from reentering the former channel. A cabin (the "association cabin") was built in the central portion of the study area. A tire bulkhead was constructed in front of the cabin after erosion threatened the cabin. The tire bulkhead has since been damaged by erosion (Figure 7).

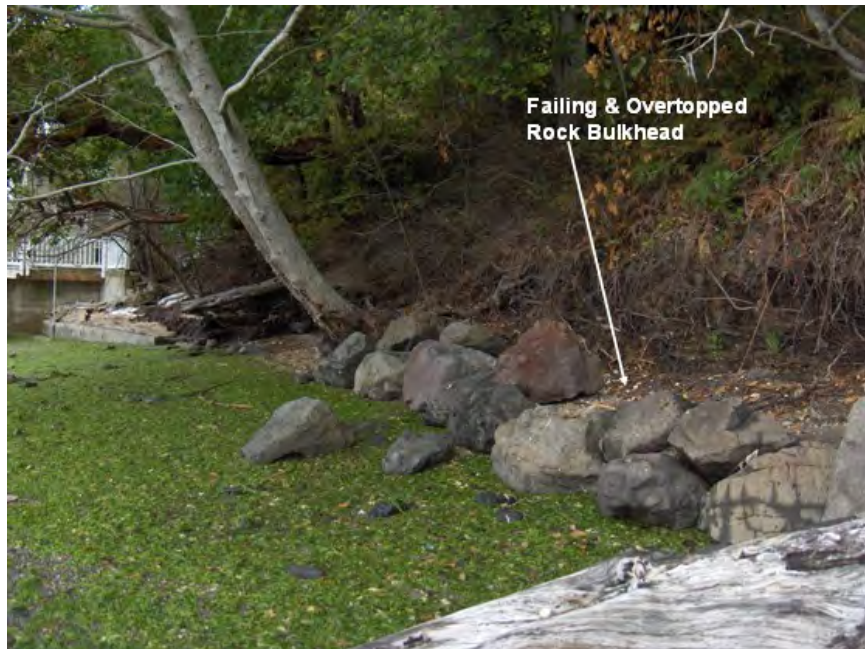
Figure 8. Rock revetment placed to control erosion of bluff toe

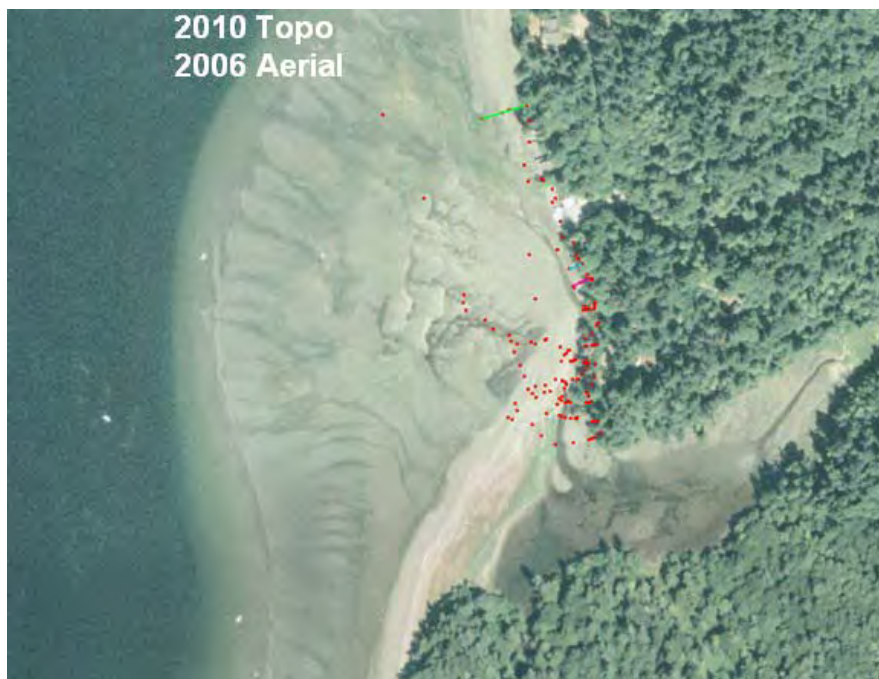
Figure 9. Locations of survey points collected in field survey of Sep 7, 2010

Elevation data were collected at 150 locations using a total station to define critical details of the site configuration, document beach profiles, determine locations of existing shoreline structures, and form the basis for preliminary designs of shore protection concepts. Survey shot locations are shown with dots in Figure 9. Survey transects of the beach profile are shown as straight lines oriented perpendicular to the shoreline.

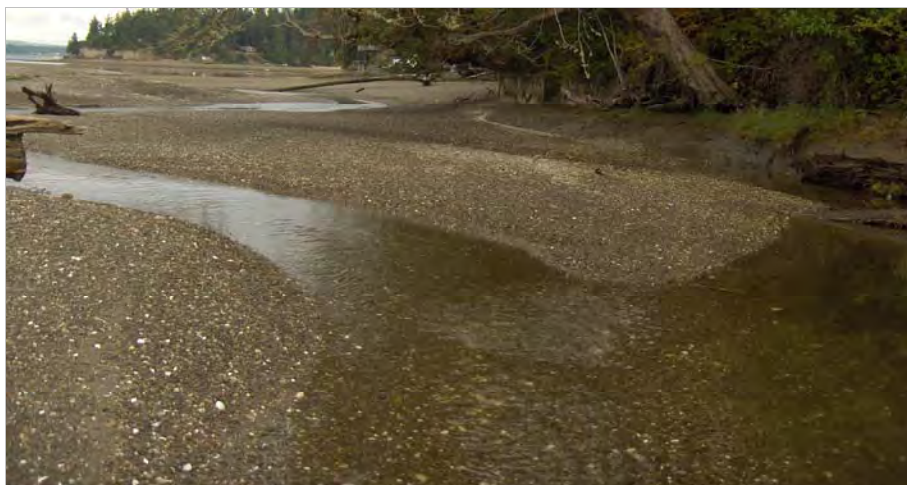
Figure 13. Channel bed sediment and channel form at lagoon outlet, indicating abundance of sediment that must be transported by the flow

Aerial photographs dated 1990 to present, although taken at different tide levels, nevertheless document the lengthening of the spit and changing tidal channel position. A delta is located northward from the spit, formed by sediment supplied from the Haley Lagoon channel, longshore transport, and bluff erosion. The multiple branches within the channel exiting the lagoon indicate the channel must transport an abundance of sediment (Figure 13). The irregularity in the bluff line at the location of the delta indicates bluff retreat has been more rapid there than at locations north or south from there. Figure 10 shows the topography of the project area in 2002 created from LiDAR data, and the shoreline and channel locations, illustrating the northward orientation of the spit. A study by Schwartz and Wallace (1989) contained conclusions from their observations at Vaughn Bay that a drift cell extends from the north end of Dutcher Cove northward to the north end of the spit at Vaughn Bay. They estimate the net shore-drift rate at Vaughn Bay to be 2,013 cu meters per year (71,000 cu yd/yr).

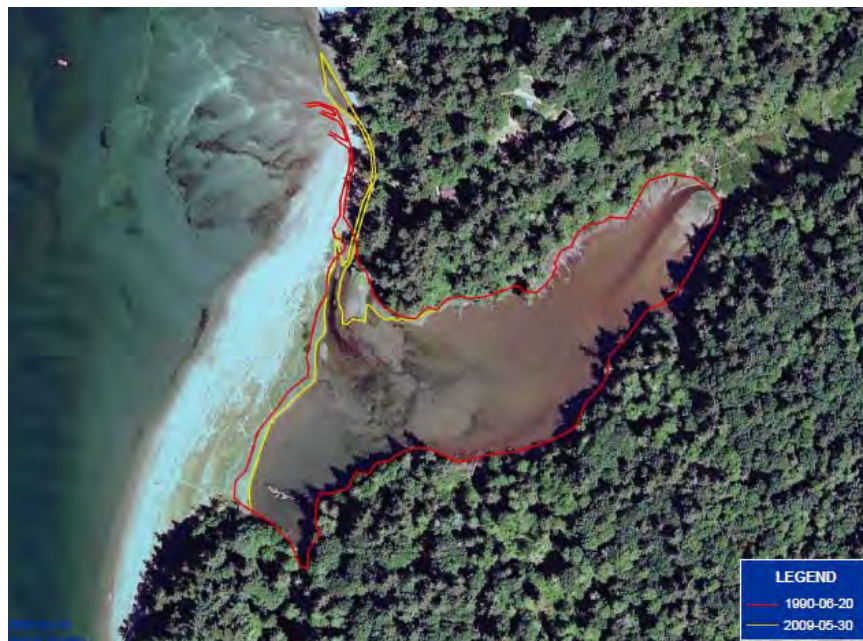
Figure 14. Channel positions in 1990 and 2009

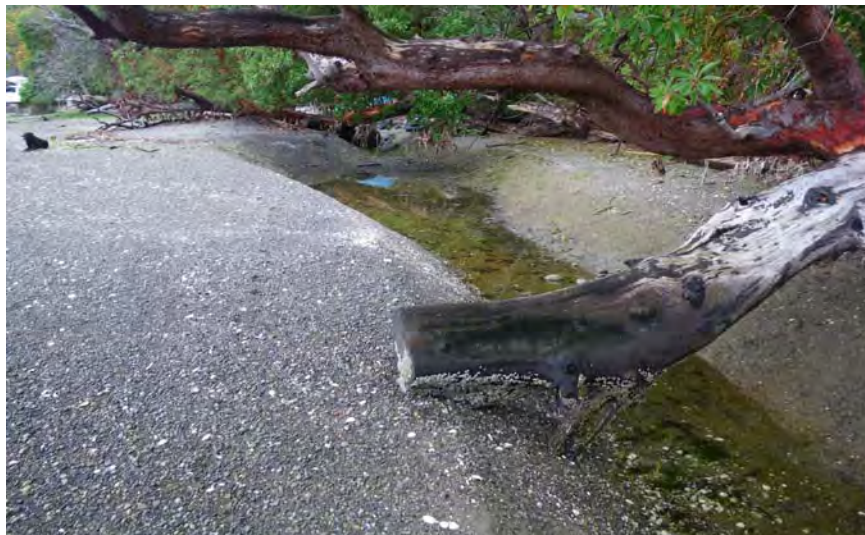
Figure 16. Evidence of wave transport of sediment into creek channel

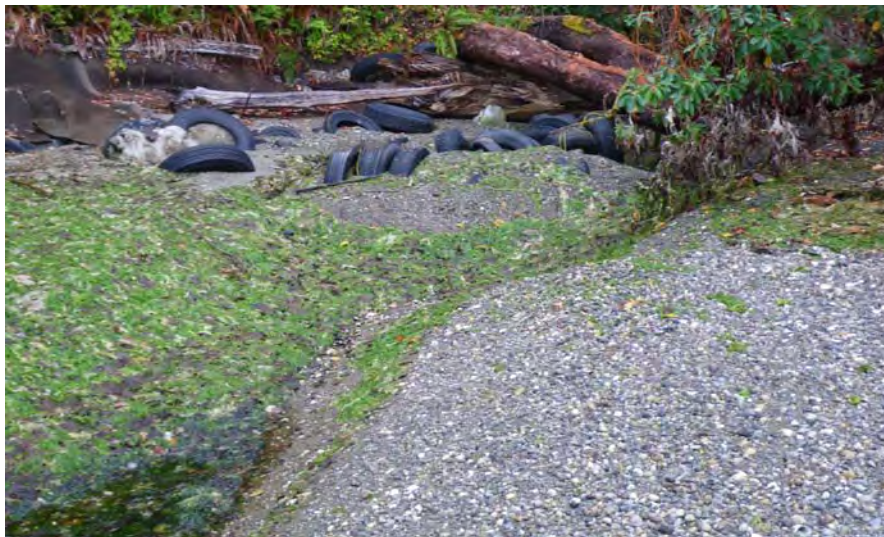
Figure 18. Depth of abandoned channel near tire bulkhead

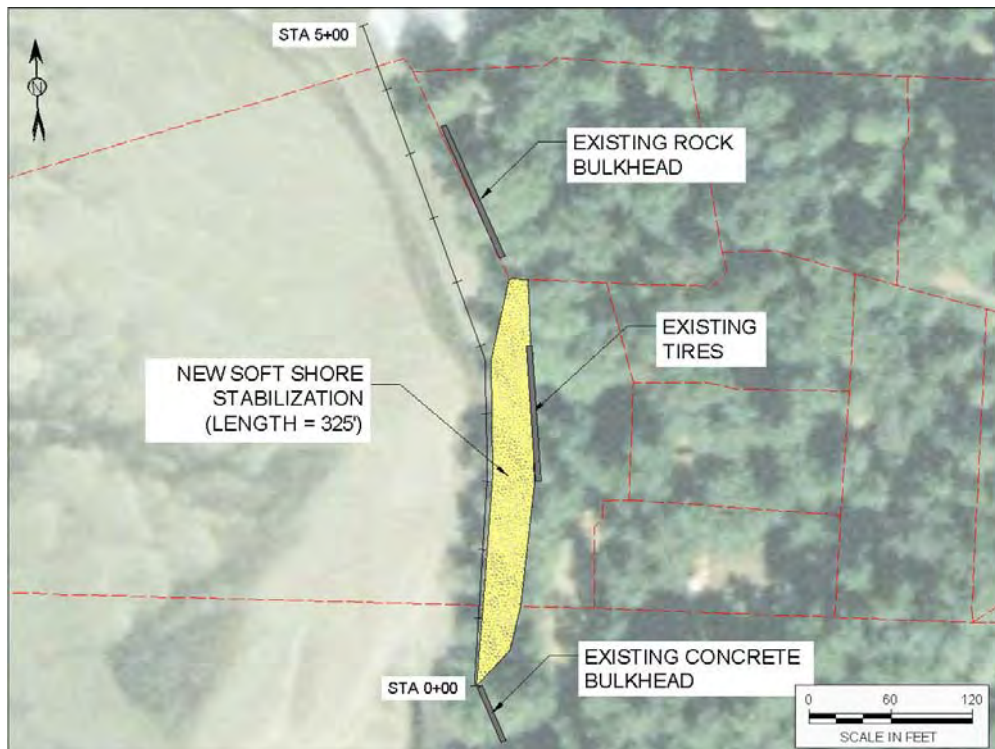
Figure 21. Alternative 1A project limits for soft shore protection concept of length 325 ft

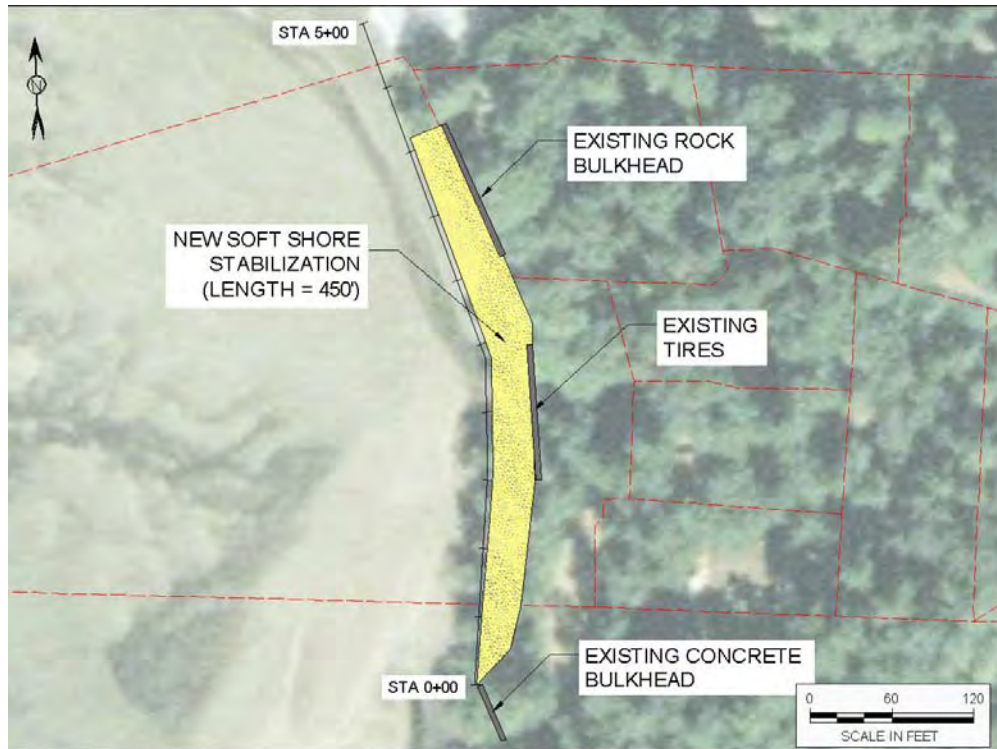
Figure 22. Alternative 1B project limits for soft shore protection concept of length 450 ft

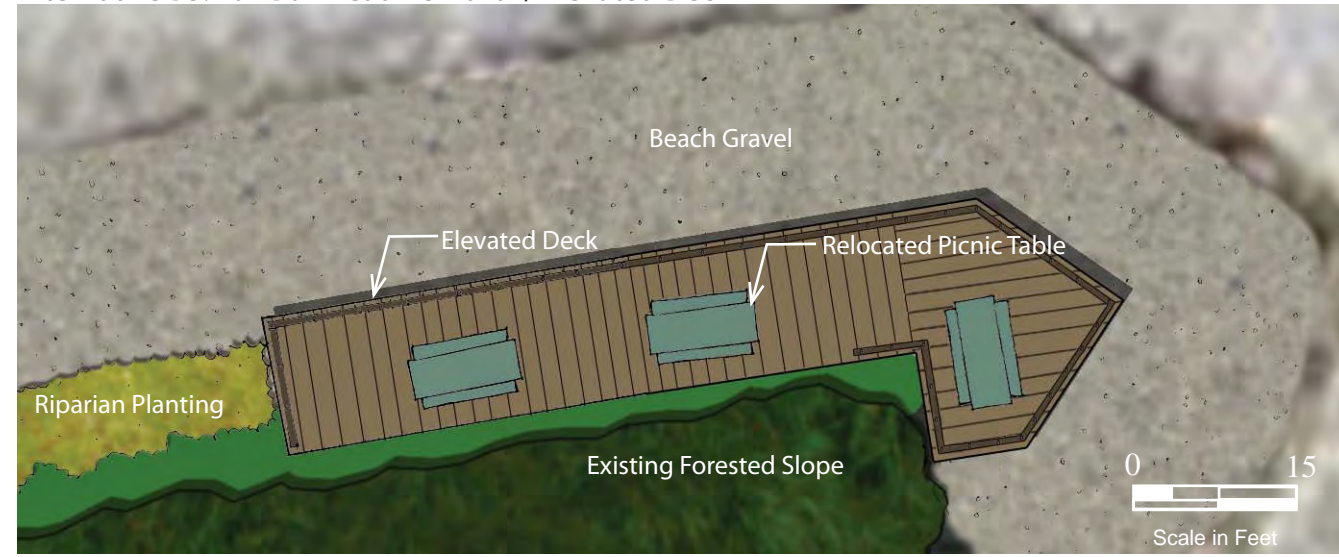
Alternative B3: Full Bulkhead Removal / Elevated Deck

Figure 6 presents a conceptual view of Alternative B3.

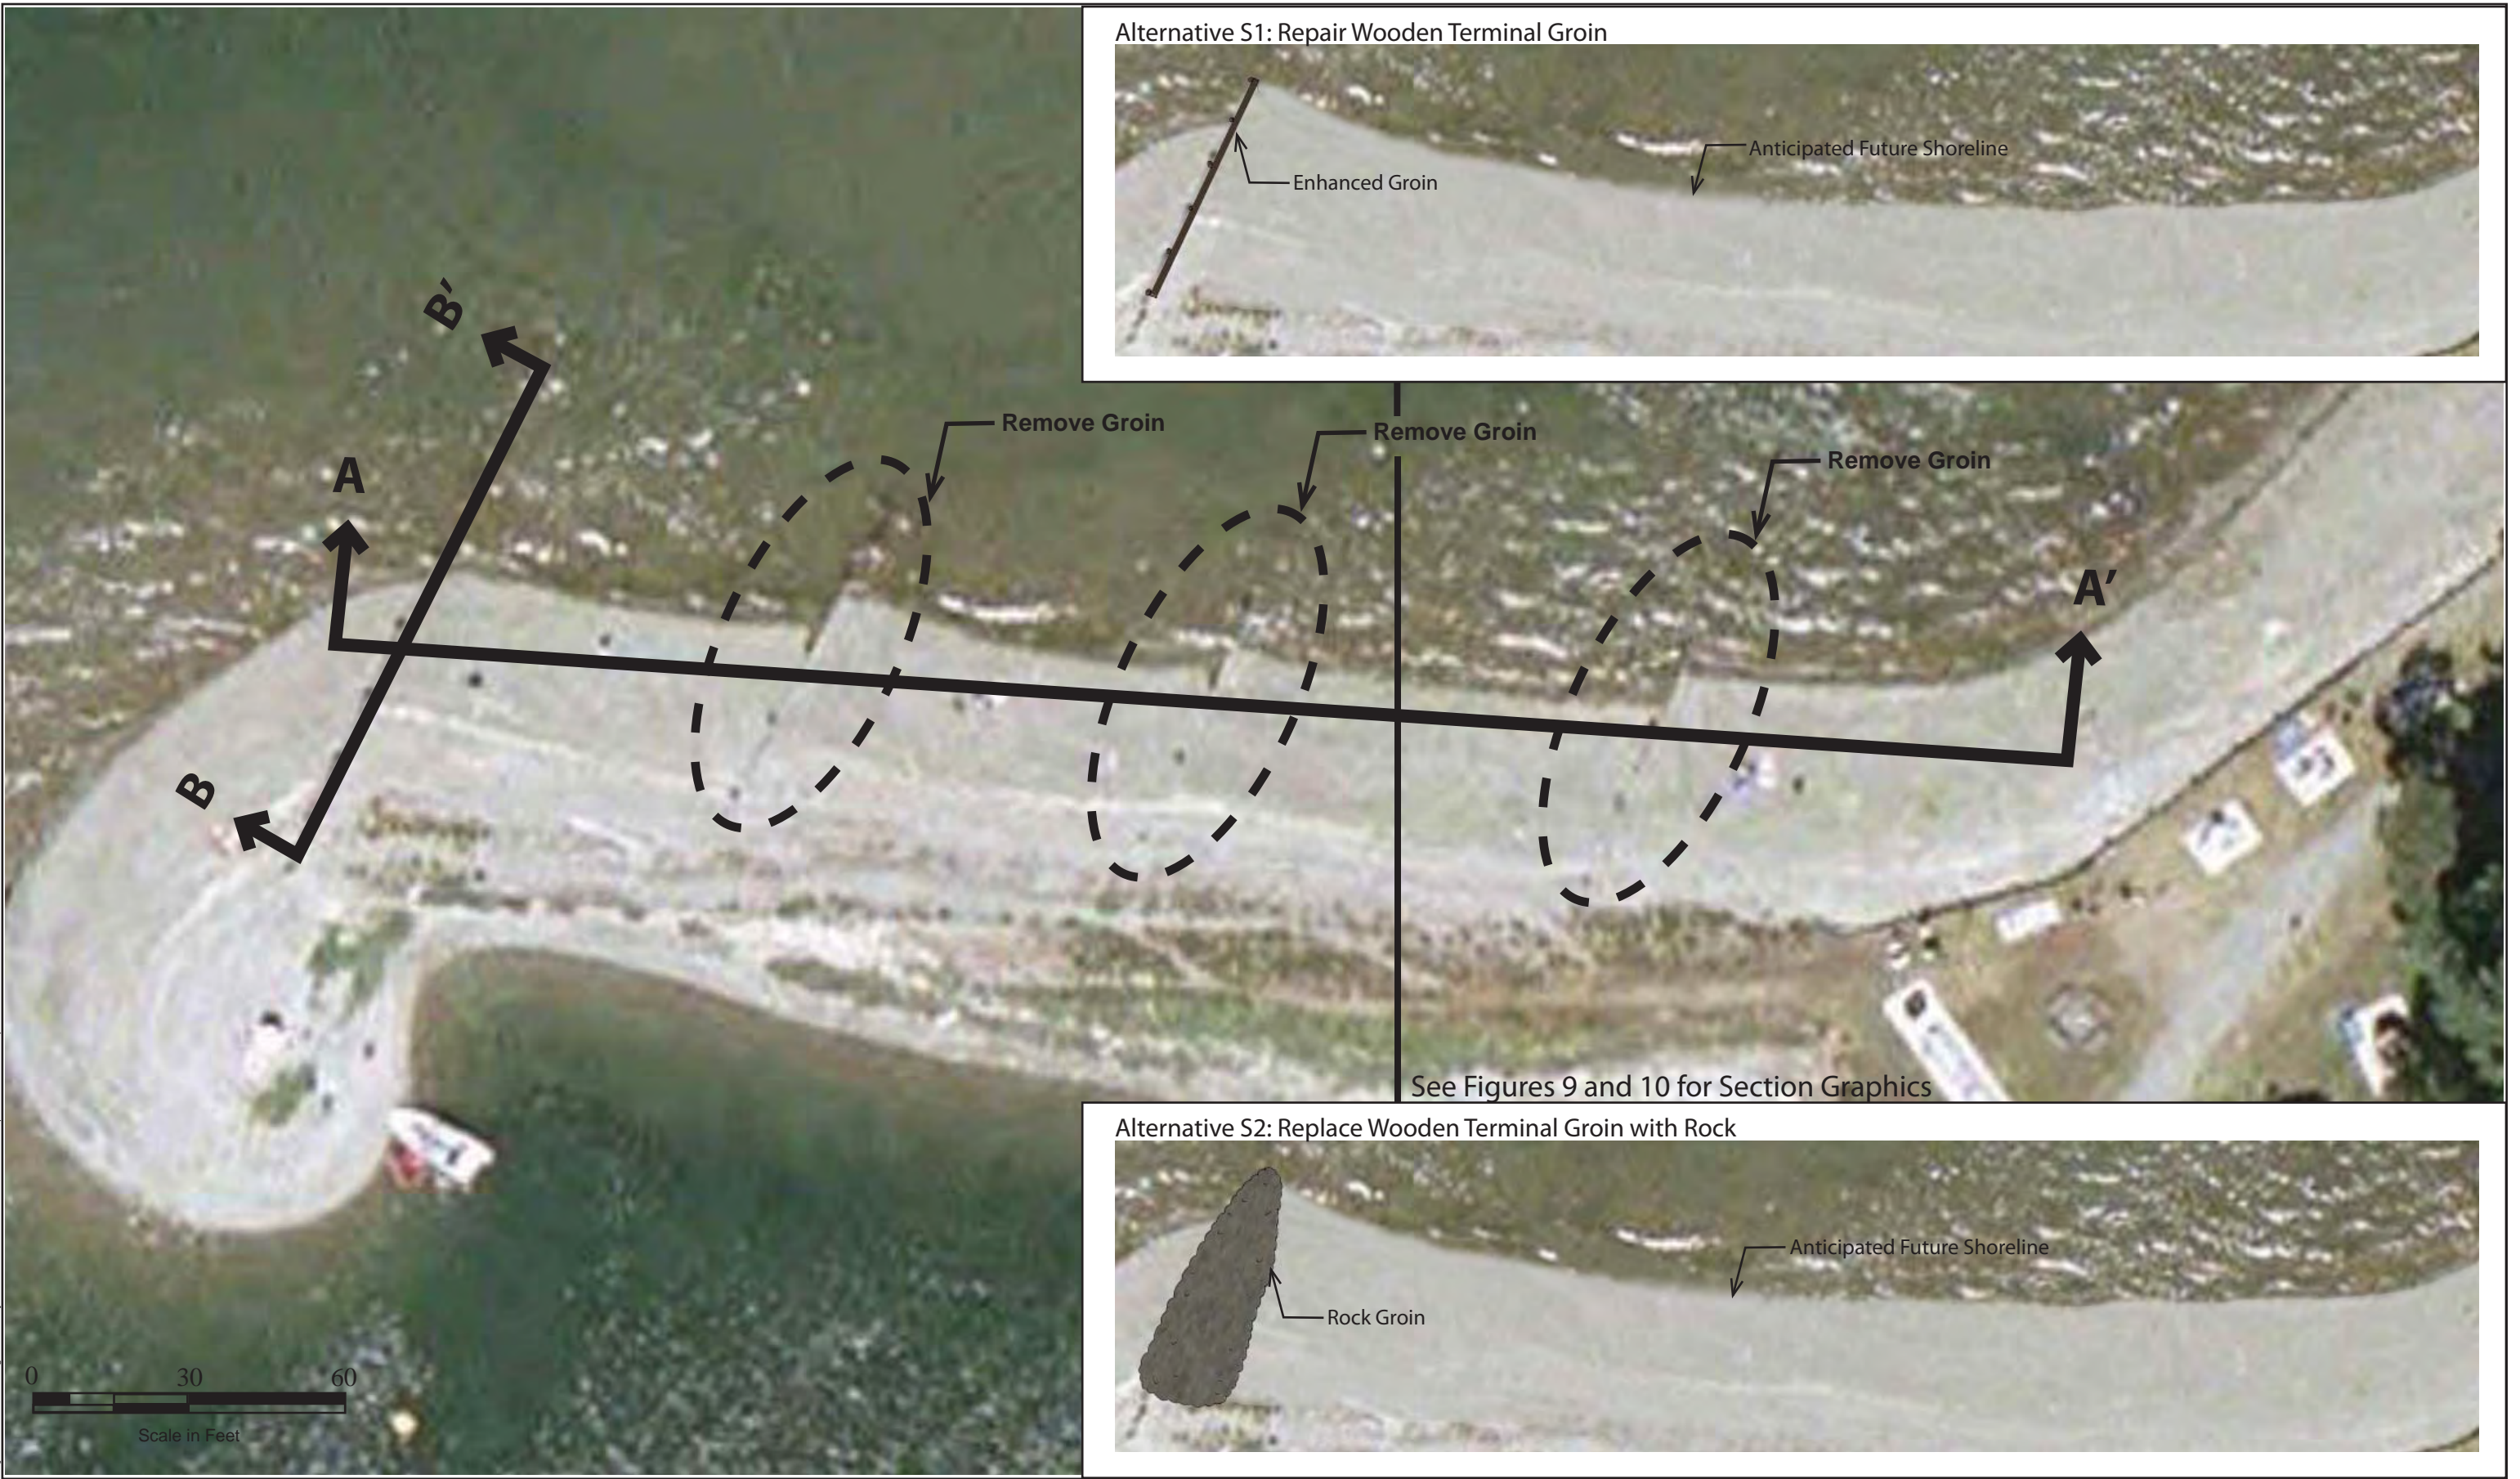
Figure 8
Sand Spit Area Plan
Penrose Point State Park

Figure 8 illustrates plan views of the Sand Spit Area proposals and section line locations, which correspond to conceptual section graphics for each alternative (Figures 9 and 10).

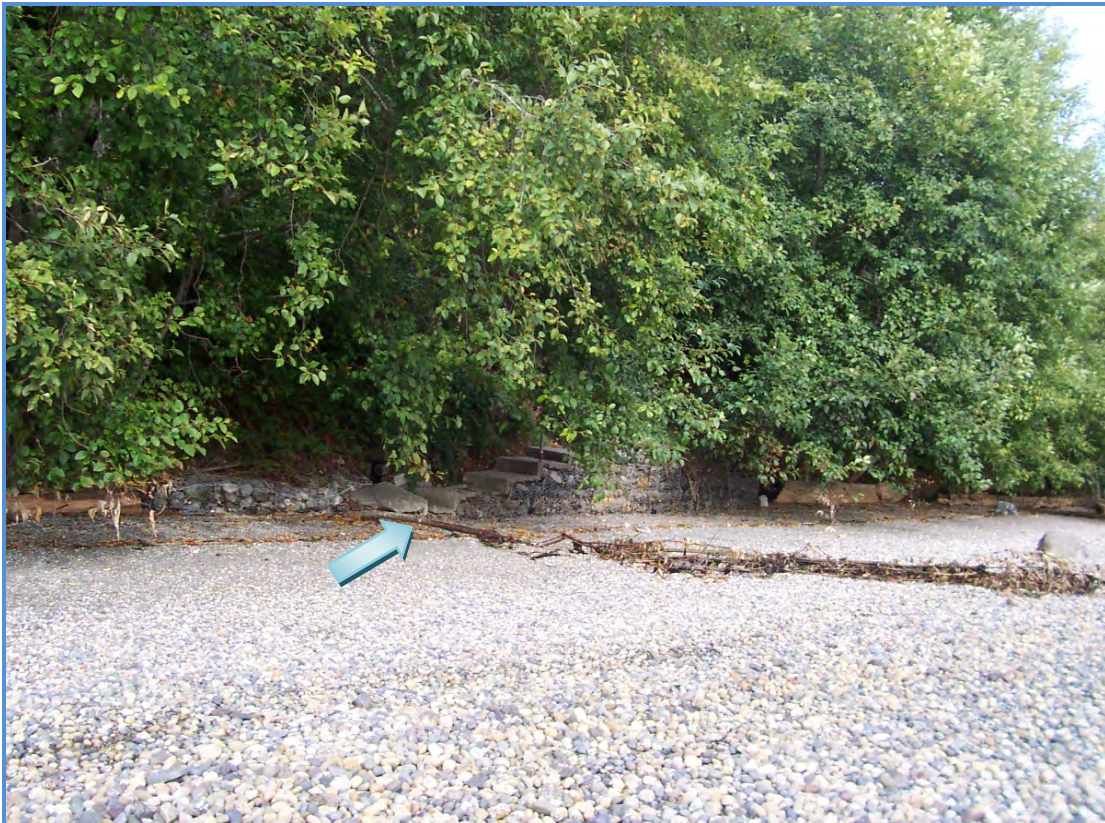
Figure 7.6. Ground photo (SPSSEG 2009) of concrete and gabion bulkhead at Maple Hollow Park.

This project will address a small gabion/concrete bulkhead and upland creosote stairs on a documented forage fish spawning beach. The project is located on the west side of Carr Inlet. The property is owned by the Department of Natural Resources and leased by the Key Pen Parks District. Through this development project SPSSEG worked with Key Pen Parks to develop a restoration plan for this shoreline. Key Pen Parks has now taken over implementation of the shoreline restoration project and is planning to remove shoreline armor, place beach logs at the toe of the slope, and plant the shoreline where the stairs are to be removed, with Pacific Willow, Alder and Salmon Berry. Project activities will restore the upper beach profiles, remove toxic creosote materials and restore a small section of bluff and riparian habitat.
