# Surveying Harper Estuary

## **Final Report: Surveying Harper Estuary**

### ***Executive summary:***

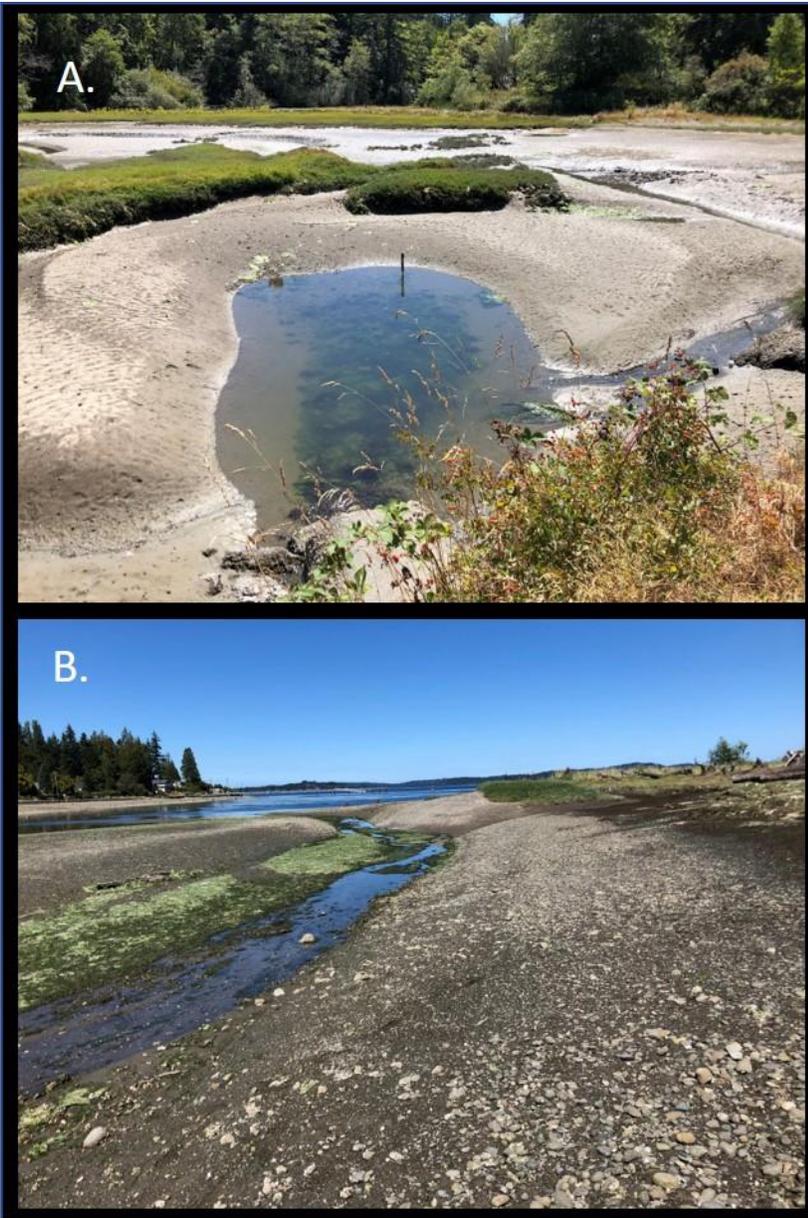
Figure 14. The Harper Estuary (pre-restoration site) is characterized by reduced channel width, increased water flow velocity, and high directional flow caused a localized scour above and below the culvert. This creates a bowl-shaped depression above the culvert (landward; Figure 14A) and steep banks below the culvert (seaward; Figure 14B). This obstruction results in the loss of tidal flushing that may accumulate the high salinity concentrations. In addition, this may also impede the dilution of metals that may be a residual impact from the former brick company.

Gorelick 2016). In contrast, below the culvert was deeply channelized, resulting in a vertical gradient with a perched landform disconnected from tidal influence, as evident by the presence of salt intolerant invasive species and woody riparian plants. Also deeply channelized was the intermediate site with the lower marsh vegetation comprised of halophytic forbs, graminoids, and rushes on the seaward side, and riparian woody species present above the bridge (landward side). The primary difference in this site was the size of the bridge (7 m), which resulted in a deep channelization and steep vertical gradient disconnected from tidal influence, as evidenced by the riparian plant communities. This is in contrast to the undisturbed site at Dewatto Estuary, where natural flood plains result in tidal flushing and flood plains that result in native, salt marsh vegetation (Figure 15).

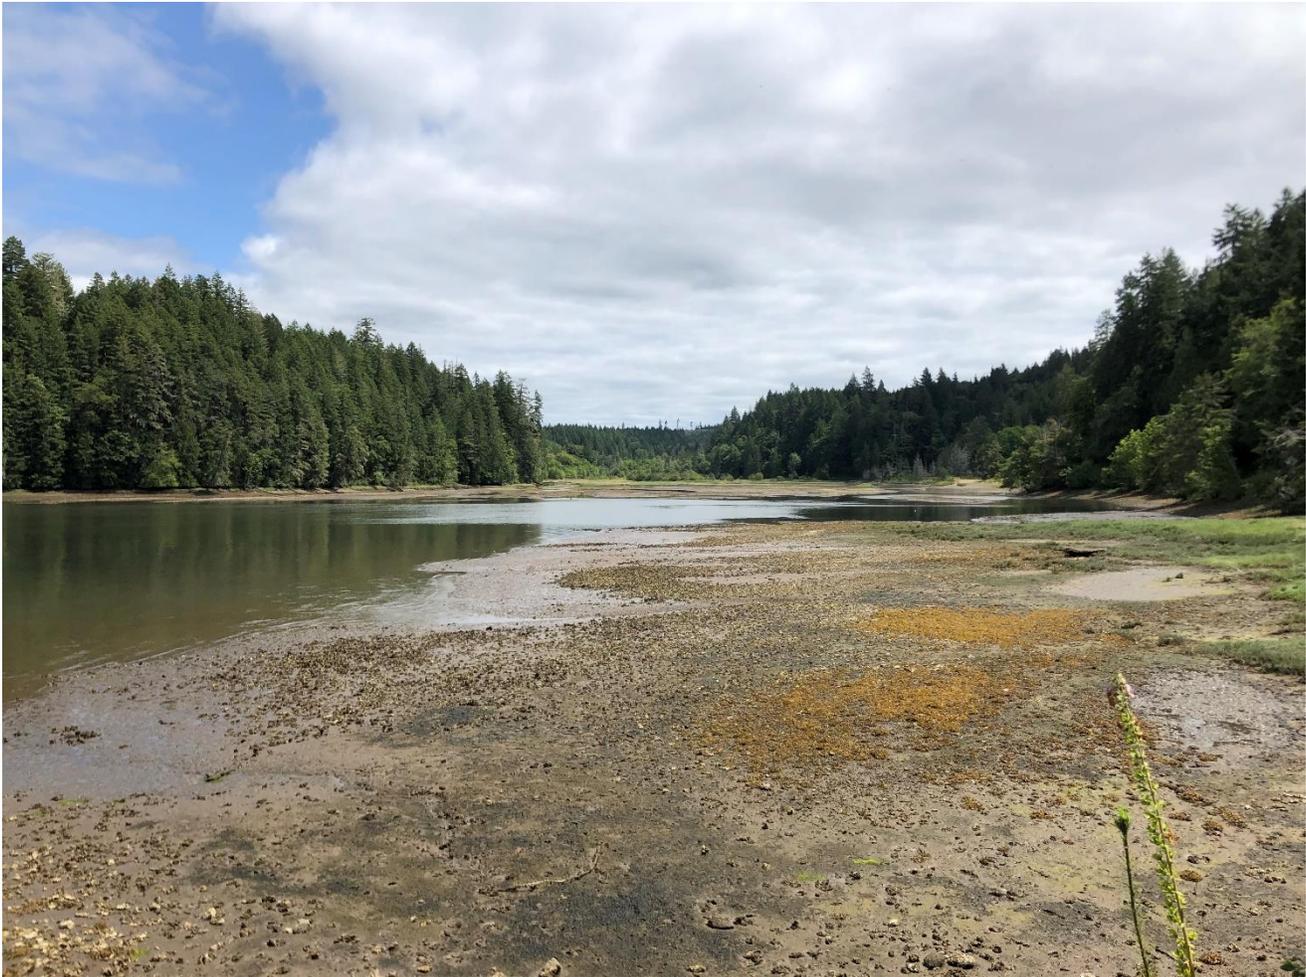
Figure 15. Dewatto Estuary represented the undisturbed site, where natural flood plains result in tidal flushing and flood plains that result in native, salt marsh vegetation (data not shown).
