Chico Creek Watershed Assessment for the Identification of Protection and Restoration Actions

Kitsap County, Washington

July 31, 2014

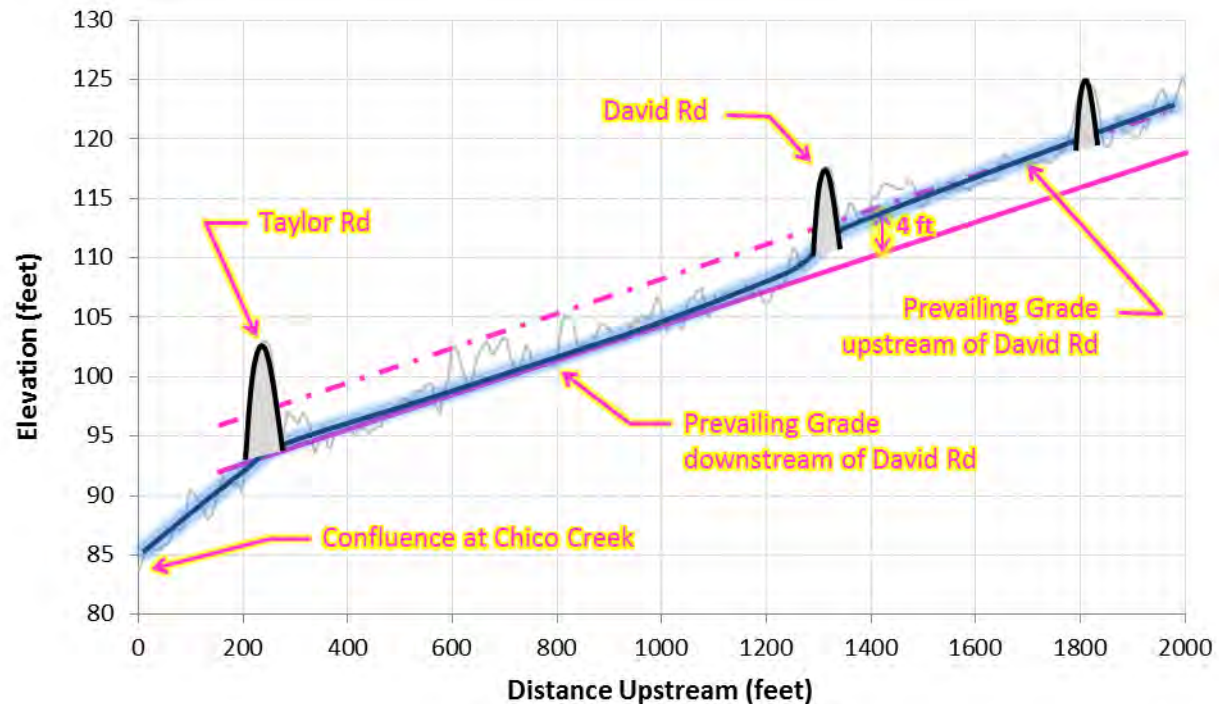
imposed by the mainstem channel. The incision along Dickerson Creek has been checked, in part, by grade control created by the culverts at Taylor Road and David Road. The channel segment upstream of David Road has a similar gradient as that of the segment below, but is perched approximately 4 ft higher (Figure 36). This vertical offset represents a minimum value of historical channel incision downstream of David Road. The actual magnitude of incision due to historical land use practices is likely much greater as early land use practices had likely cleared the area and channelized the stream prior to installation of the culvert.

Figure 36. Longitudinal profile of the lower 2,000 ft of Dickerson Creek. Existing culverts function as grade control structures in the incised channel system. An estimated vertical offset of approximately 4 ft represents a minimum value of channel incision. Topographic data from 2000 LIDAR DEM.

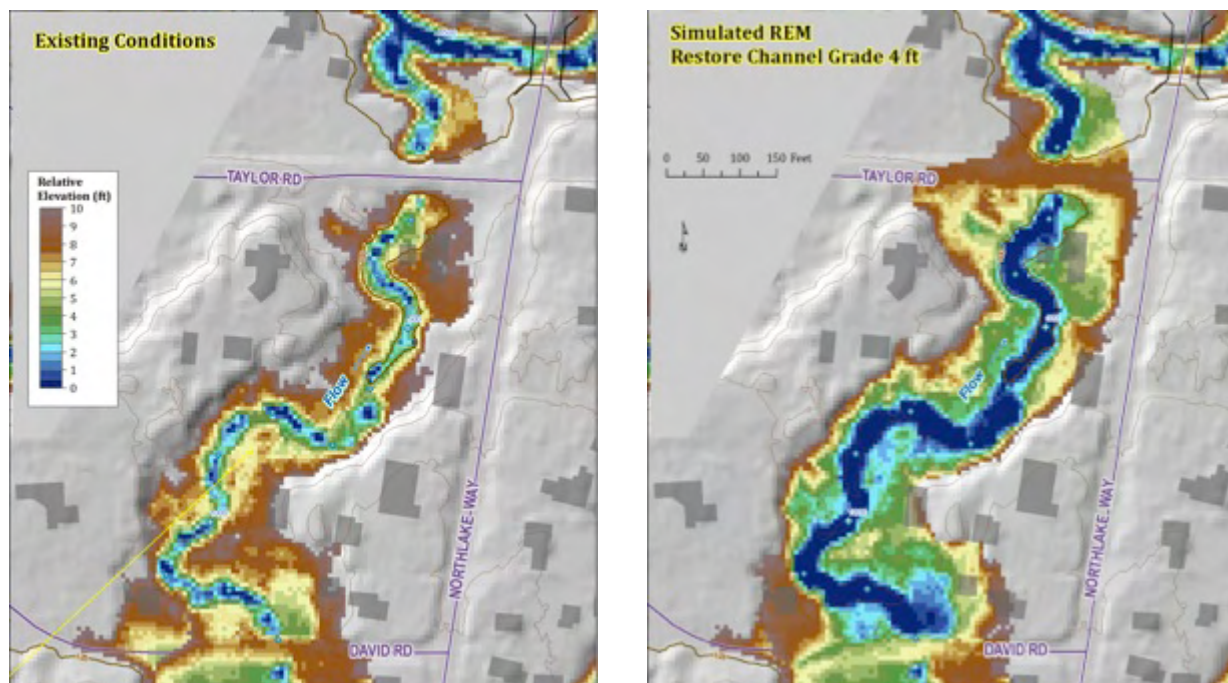
Potential losses of floodplain habitats in incised channel reaches are illustrated by the map of relative floodplain elevations (Figure 37). The existing channel segment in lower Dickerson Creek is flanked by high banks that are 6 to 8 ft above the low flow channel. For reference, predicted bankfull depth is less than 2 ft based on regional hydraulic geometry relations (Castro and Jackson, 2001). The simulated condition in the right hand panel of Figure 37 shows a threefold increase in floodplain width associated with aggradation of the stream bed by 4 ft. This simulated condition represents a potential distribution of floodplain habitats prior to channel incision driven by land use activities in the watershed.

Figure 37. Map of relative elevation model (REM) comparing existing and potential future (simulated) conditions assuming aggradation of the channel bed downstream of David Rd. to restore pre-incision grade and reconnect abandoned floodplain habitats. Relative elevations between 0 and 3 ft correspond to active floodplain areas. Data are derived from 2000 LiDAR DEM.

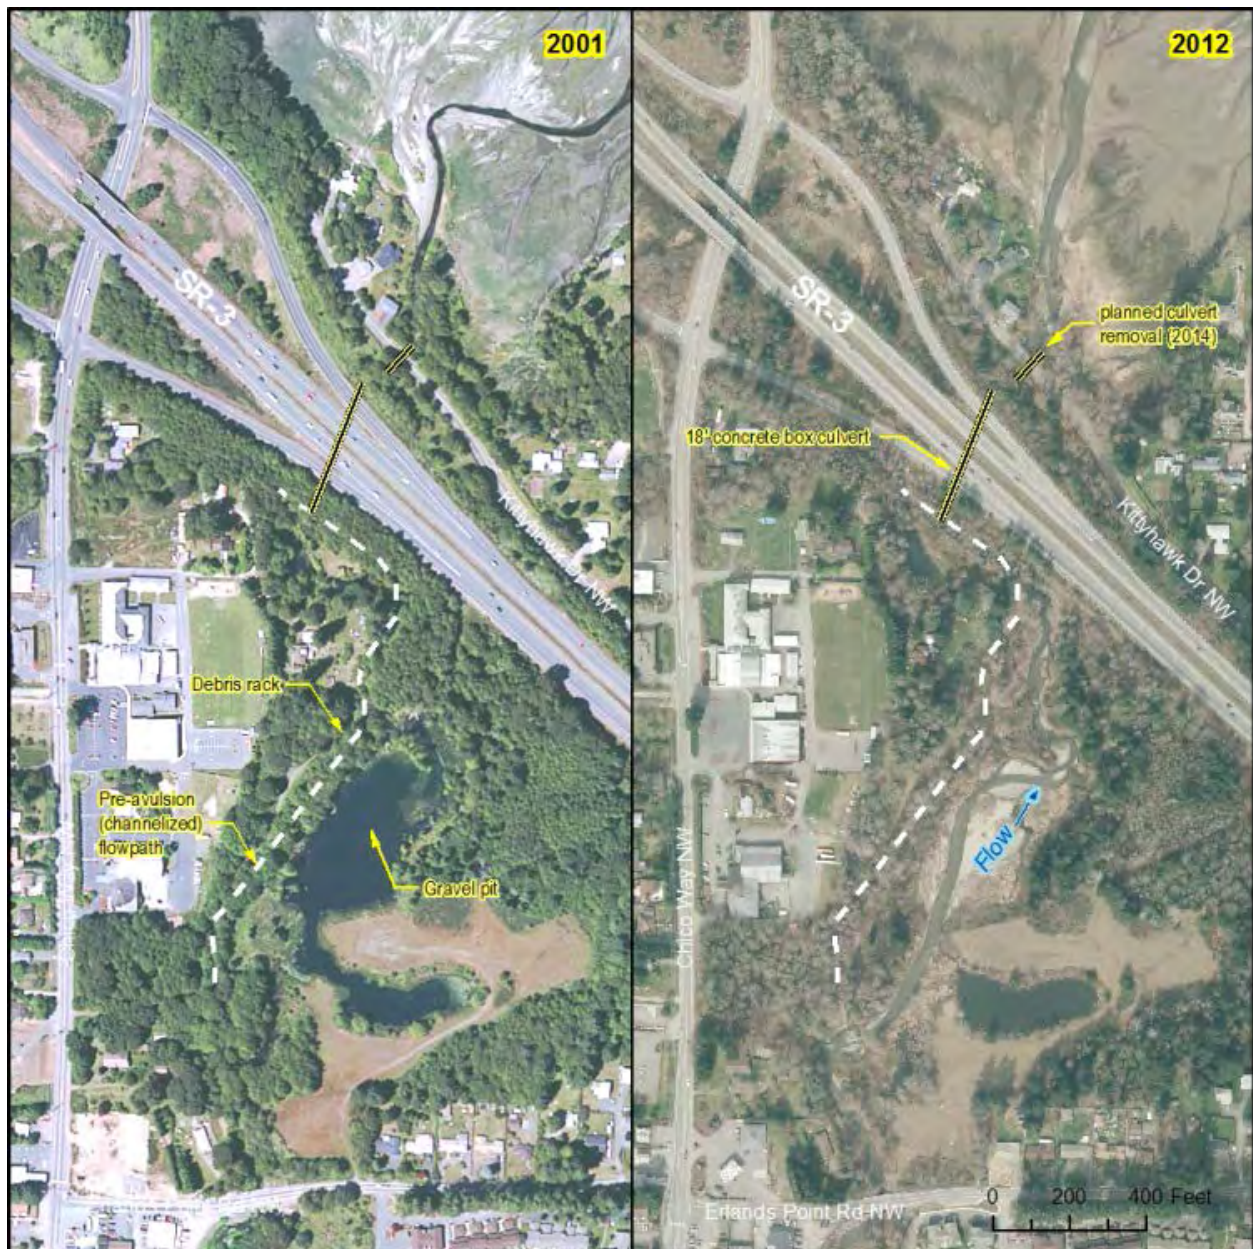
Problem: Upstream of the SR 3 culverts Chico Creek was historically channelized (probably in the early 1960s during construction of SR 3 crossing) into a straight alignment along the west side of the valley and confined by a 4-ft high levee that disconnected the channel from the floodplain. Gravel was extracted from the east half of the valley to fill an embankment as part of SR 3 construction. Gravel pits were left as ponded areas in the disconnected floodplain. A metal debris rack was installed in the channelized segment approximately 800 ft upstream of the culverts to prevent debris from blocking the double box culvert at SR 3. The debris rack was a barrier to fish passage when blocked with wood transported from upstream and required frequent maintenance by WSDOT to remove material accumulated during storm events. A channel avulsion in the early 2000s resulted in split flow with a majority of the streamflow being redirected into the gravel pit areas and bypassing the debris rack channel (Figure 47). Sediment has since accumulated in the pond area as the channel rebuilds a floodplain within the former gravel pit.

Figure 47. Aerial photo comparison showing recent channel changes in the reach between Erlands Point Road and SR 3.

Approach: This action will restore habitat-forming processes within a 2,100 ft channel segment owned and managed by Kitsap County (Erlands Point Park). Project components include removal of existing floodplain constraints (levee, metal debris rack), riparian forest restoration, and instream habitat enhancements. Wood placements should be incorporated to create stable hard points to establish an anabranching corridor characteristic of low gradient forested alluvial channels. Barnard (2009) prepared a conceptual design plan as part of the scoping report for planned replacement of the double box culvert at SR 3. This project should be coordinated with the planned culvert replacement downstream at SR 3.

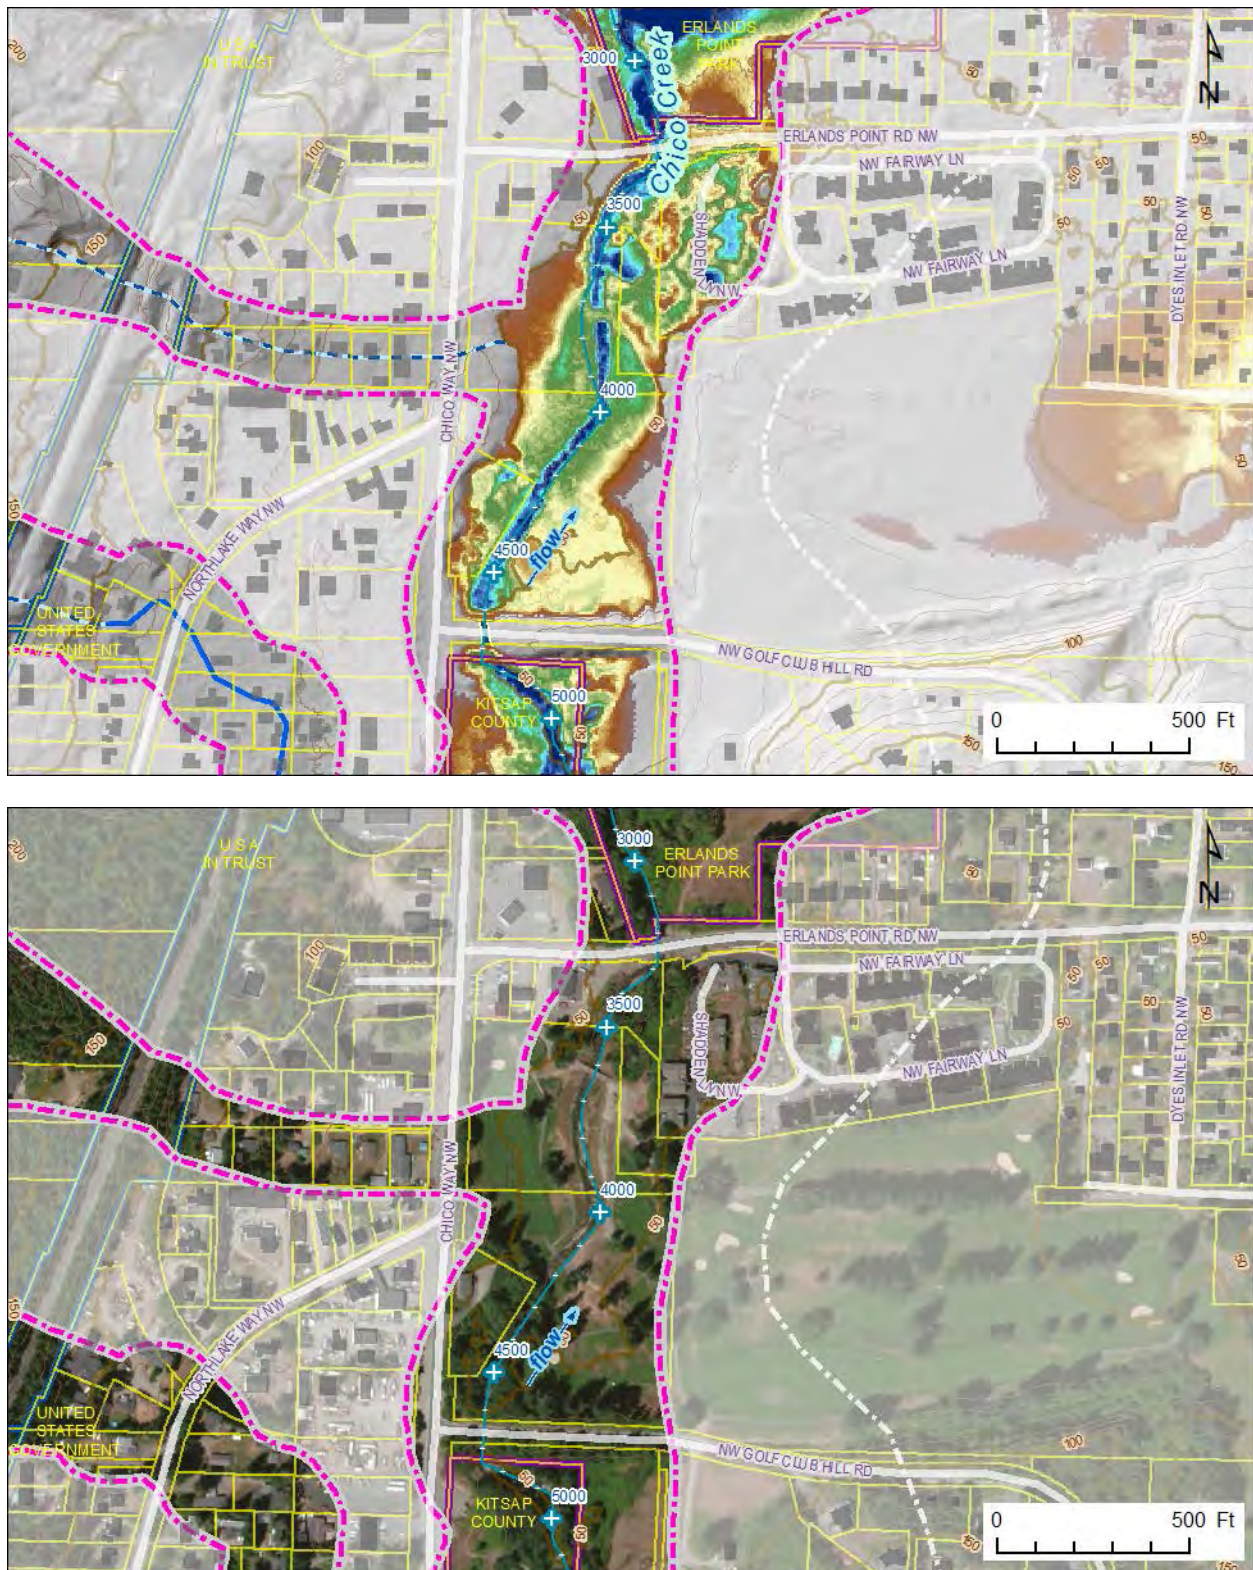
Problem: Artificial fill brought in to construct the road embankment encroaches into the floodplain on both sides of channel (Figure 48 and Figure 49). The bridge crossing confines the stream corridor and restricts habitat-forming processes.

Figure 49. Excerpt from geomorphic map (top panel, Appendix A) and aerial imagery (bottom panel, Appendix B) highlighting the stream corridor (dashed pink line) between Erlands Point Road NW and NW Golf Club Hill Road. Note artificial confinement by road fill at Erlands Point Rd NW and NW Golf Club Hill Road.

Problem: The road prism for NW Golf Club Hill Road follows the alignment of a former railroad grade that constricts the floodplain near river station 4600 (Figure 49). Topographic characteristics of this segment reveal a natural floodplain width of approximately 500 ft. Artificial fill placed for the road embankment is approximately 20 ft high, 120 ft in the downstream direction, and restricts the floodplain to a narrow opening with a triple box culvert with openings 12 ft in width (Figure 50). The culvert was identified as a partial barrier to fish passage in WDFW's (2012) Fish Passage Barrier Inventory. Channel incision downstream of the culvert had previously undermined a series of weirs and produced a headcut that extended to the culvert outlet. The headcut was addressed as part of recent channel/floodplain modifications on the Kitsap Golf & Country Club property; however, the culvert remains a significant floodplain constriction and continues to restrict habitat-forming processes in the reach.

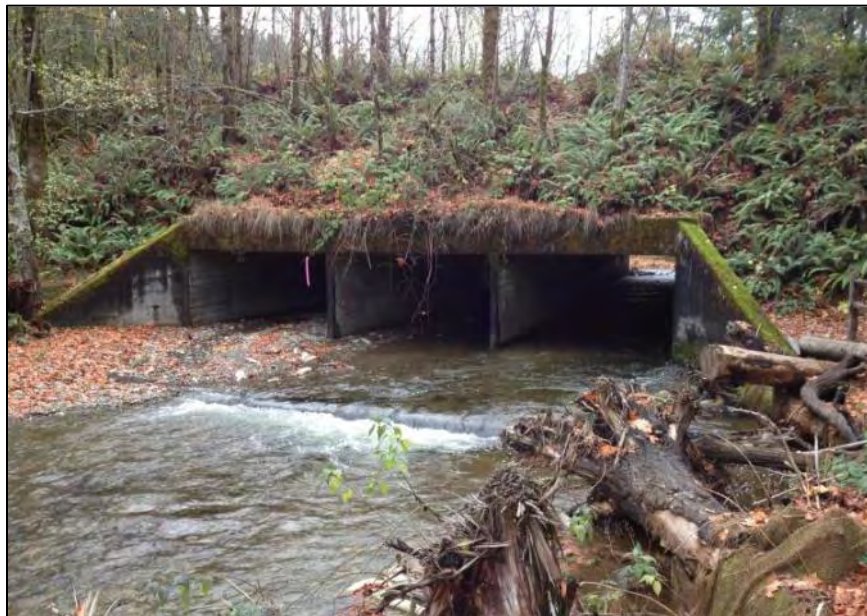
Problem: Past impacts to reach-scale processes in this channel segment have resulted in channel incision and disconnection of floodplain habitats. Key factors degrading habitat conditions include: floodplain constriction at the triple box culvert for NW Golf Club Hill Road, loss of roughness elements such as instream wood, and impairment of riparian processes such as wood recruitment and shade. Existing habitat conditions are characterized by a lack of channel complexity (few pools, limited refugia), low abundance of instream wood, loss of side-channel and off-channel habitats, and poor riparian conditions (Figure 51).

Figure 50. Photo of the triple box culvert at NW Golf Club Hill Road (view upstream). Photo taken November 2012 by Shawn Higgins, NSD.

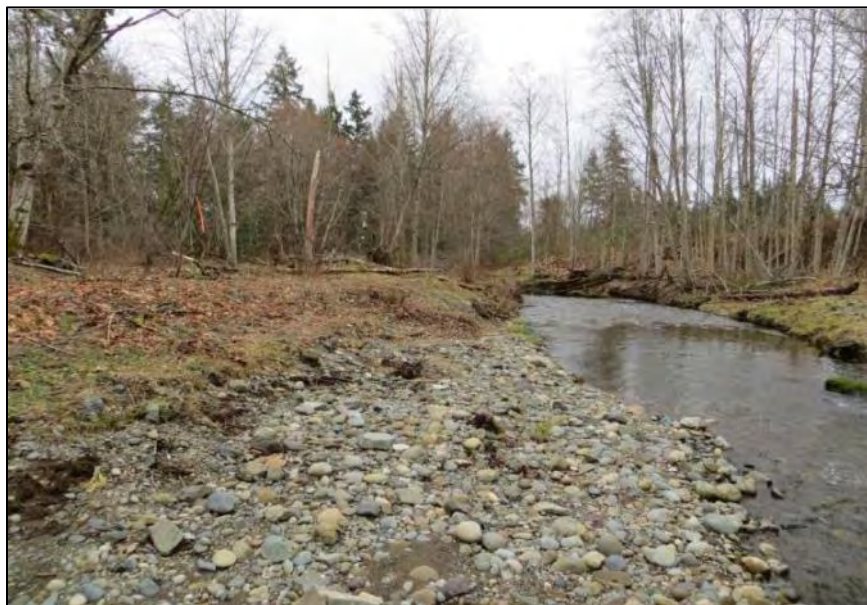
Figure 51. Photo of Chico Creek upstream of NW Golf Club Hill Road (view downstream). Photo taken February 2013 by Steve Todd, Suquamish Tribe.

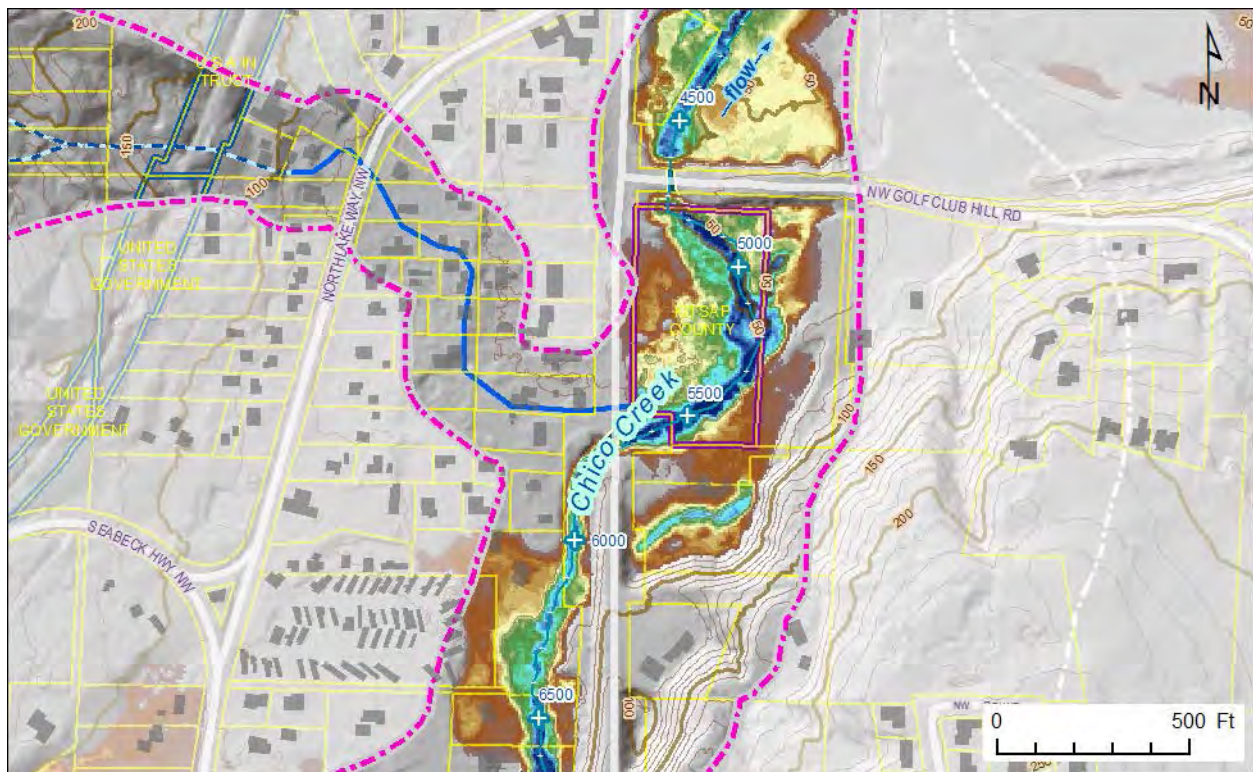
Problem: Artificial fill constricts the floodplain and restricts habitat-forming processes in the upstream and downstream reaches. The Chico Way bridge was damaged in the December 2007 flood and replaced with a new structure in 2009. The investment in this new structure likely limits opportunity to replace the bridge for several decades until the structure is nearing the end of its design expectancy or is damaged in future flood events. Unfortunately, the new bridge continues to confine the stream corridor. In addition, an isolated side channel feature in the floodplain, approximately 700 ft in length, is disconnected at the upstream end by fill placed for the Chico Way NW road embankment and is disconnected at the downstream end by past incision (Figure 52).

Figure 52. Excerpt from geomorphic map (Appendix A) highlighting the stream reach between NW Golf Club Hill Road and Chico Way NW.

Approach: This action will open up the floodplain to reduce constriction and aid in the restoration of habitat-forming processes in upstream and downstream reaches. The crossing should be constructed with a longer span and/or additional bridges to enable reconnection of floodplain habitats including potential to restore connectivity with approximately 700 ft of right bank side channel habitat. The two parcels are owned by the same landowner and have a combined value of approximately \$300,000 as assessed in the 2012 tax records. Acquisition of these properties for conservation of habitat forming processes was explored as part of an earlier feasibility assessment for realignment of NW Golf Club Hill Road. The landowner was not interested in selling property at the time (2012), however, we recommend that stakeholders continue engaging with landowners should future opportunities to acquire the parcels become feasible. Instream habitat enhancement will require strategic wood placements to increase channel complexity and restore natural stream grade through the incised segment. Floodplain areas will be graded at the upstream and downstream ends to reconnect the side channel.

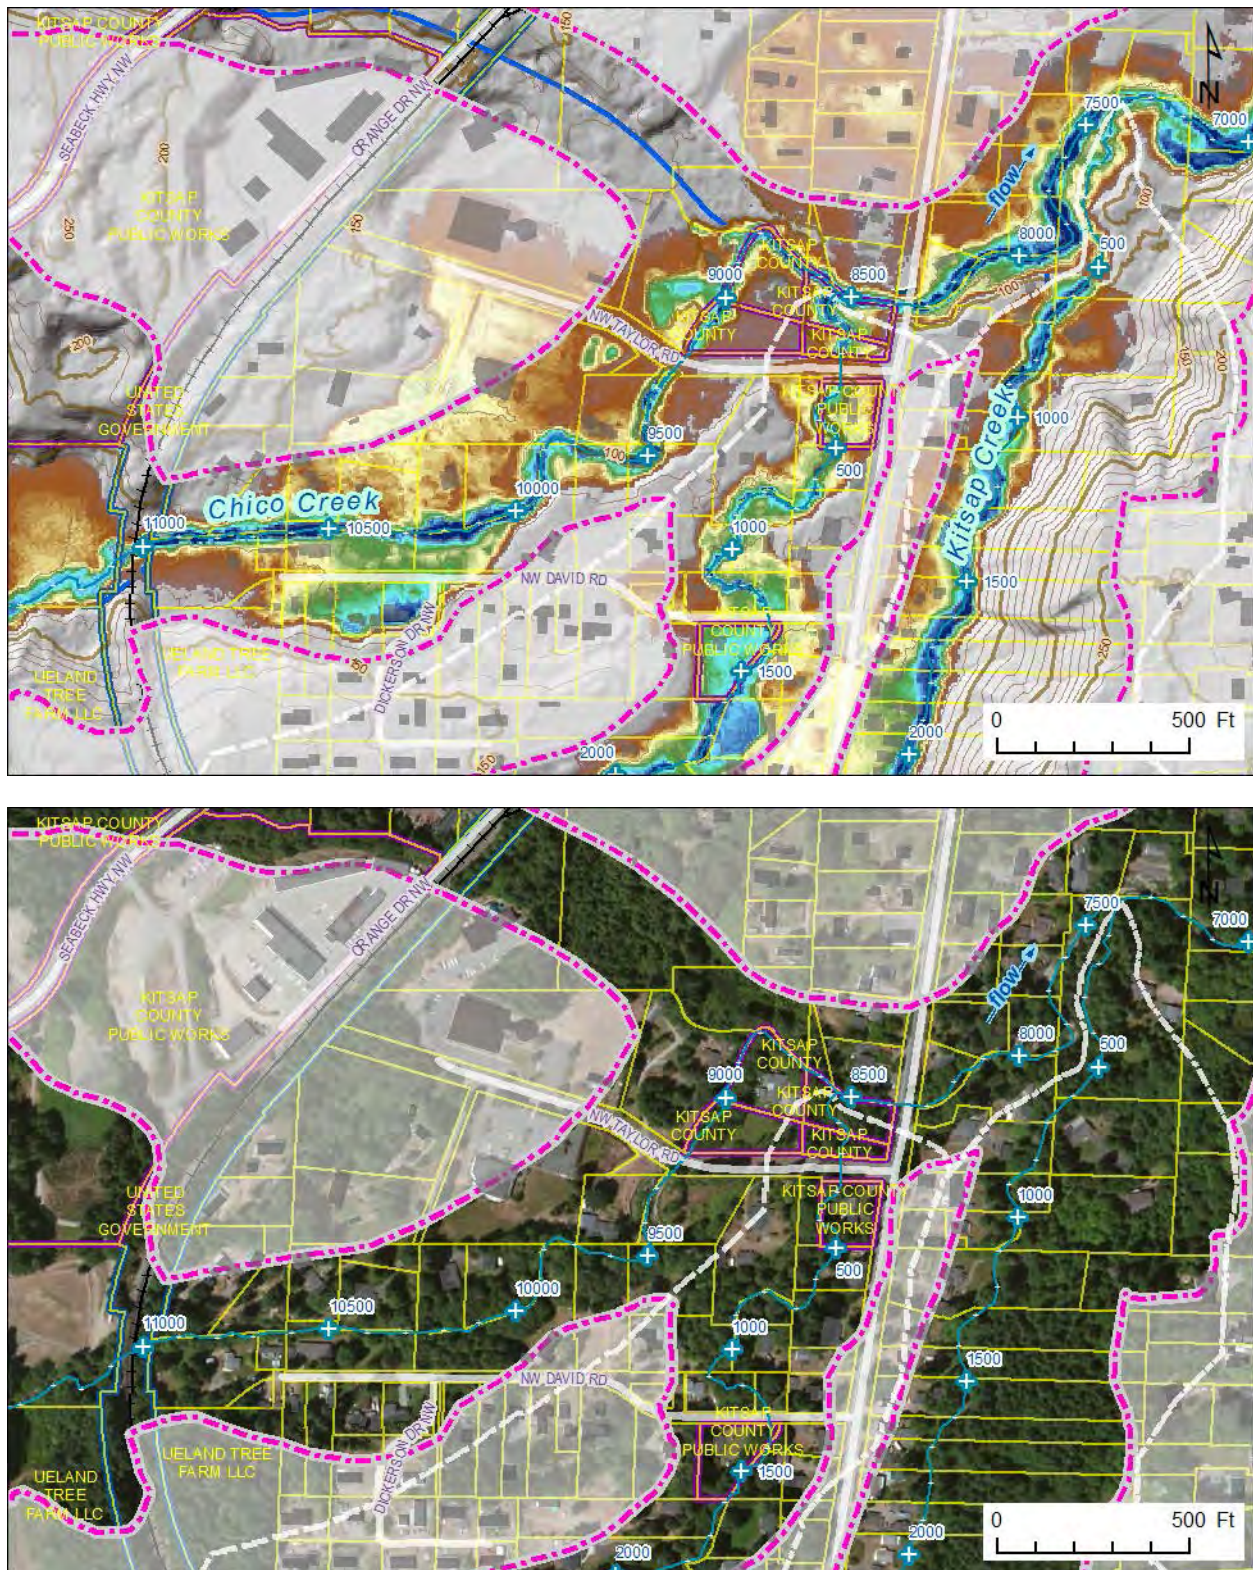
Problem: Habitat conditions are degraded from past impacts that have resulted in an incised channel (Figure 55) lacking in wood and characterized by low channel complexity with few pool habitats. The relatively flat surface on the inside of the 90 degree bend upstream of the Dickerson Creek confluence represents the pre-settlement floodplain surface prior to channel incision.

Figure 55. Excerpt from geomorphic map (top, Appendix A) and aerial imagery (bottom, Appendix B) highlighting the stream corridor (dashed pink line) between Chico Way NW and the Navy RR trestle as well as the lower reaches of Kitsap and Dickerson Creeks.

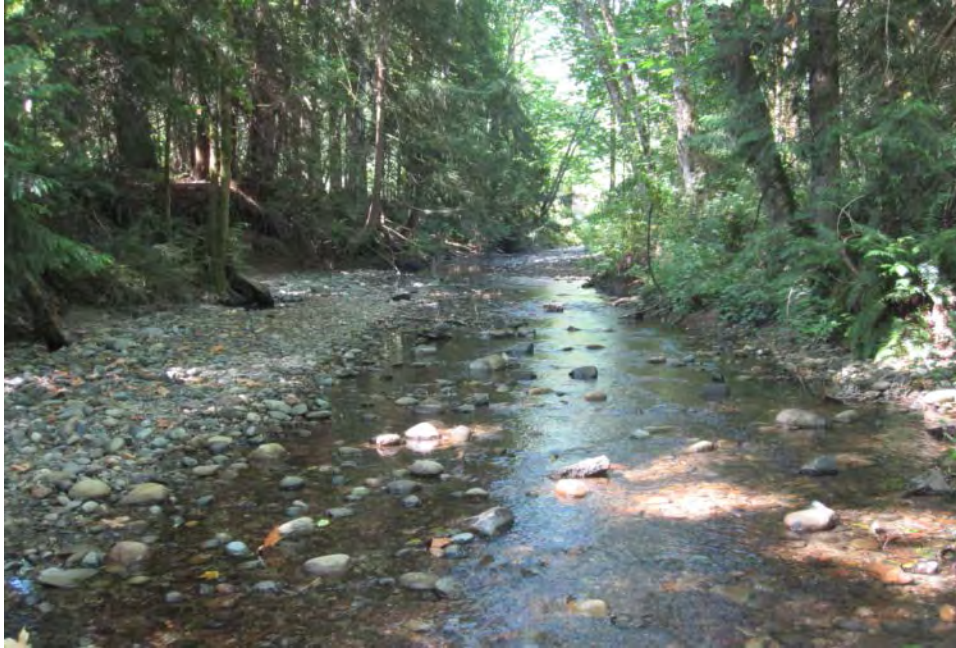
Problem: Habitat conditions are degraded from past impacts that have resulted in an incised channel lacking in wood and characterized by low channel complexity with few pool habitats (Figure 56). The geomorphic response to channel incision includes a tendency to widen and erode channel banks. In the absence of further impacts to floodplain and riparian processes, such erosion can be part of an evolving trajectory that could restore habitat-forming processes in the reach. This response is constrained, however, by residential development and bank armoring that protects infrastructure within the stream corridor. There are houses adjacent to this channel segment within 40 ft of the stream bank on both sides of the channel. A private driveway crosses the stream immediately downstream of the Navy RR trestle and has undermined footings due to channel incision. Bank armoring efforts include a recent project adjoining the church property on the left bank upstream of Taylor Road completed as part of the project funded by NRCS EWP and Kitsap County in response to erosion that occurred during the December 2007 flood.

Figure 56. Photo of channel and riparian conditions in Chico Creek between Taylor Road NW and the Navy RR Trestle (view upstream). Photo taken August 2012 by Steve Todd, Suquamish Tribe.

Approach: This action will aim to restore floodplain connectivity, riparian processes, and instream habitat conditions. The primary mechanism for past channel incision has been removal of instream roughness due to loss of instream wood and impairment to riparian processes. Restoration actions should focus on restoring the riparian forest conditions and include targeted wood placements to increase channel complexity and restore natural stream grade. Properties within the stream corridor should be dedicated to maintenance and provision of habitat-forming processes. Landowner negotiations should consider opportunities to establish conservation easements and/or land acquisition to facilitate restoration in the stream corridor. Key parcels intersecting the preliminary corridor boundary in this segment include 10 parcels totaling 6.5 acres (5 along David Road and 5 along Taylor Road) with an assessed value of \$1.6 M per 2012 tax records. Additional negotiation should focus on opportunities to provide alternative access to property on the north side of the creek and removing the existing driveway crossing. The property along the south side of the channel (right bank) includes low-lying areas on the south side of David Road that could provide opportunities for floodplain connectivity and off-channel habitat.

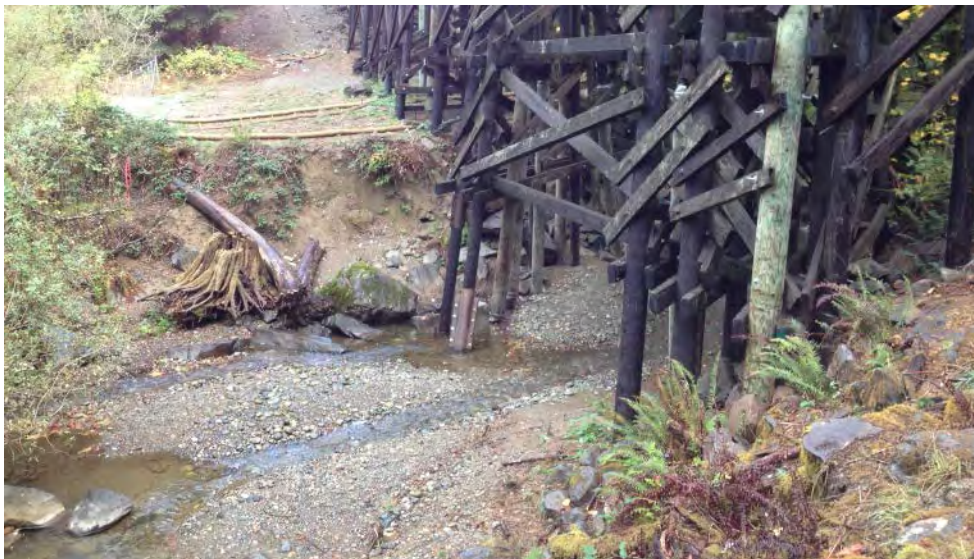
Problem: The Navy RR trestle was constructed in the 1940s of creosote-treated timber. Support piles occur within the stream channel, and trestle approaches are on fill that constrict the valley and constrain habitat-forming processes (Figure 57).

Figure 57. U.S. Navy RR trestle crossing at Chico Creek.

Approach: The trestle should be replaced with a longer span that accommodates channel migration and establishment of a wider stream corridor through this incised channel segment.

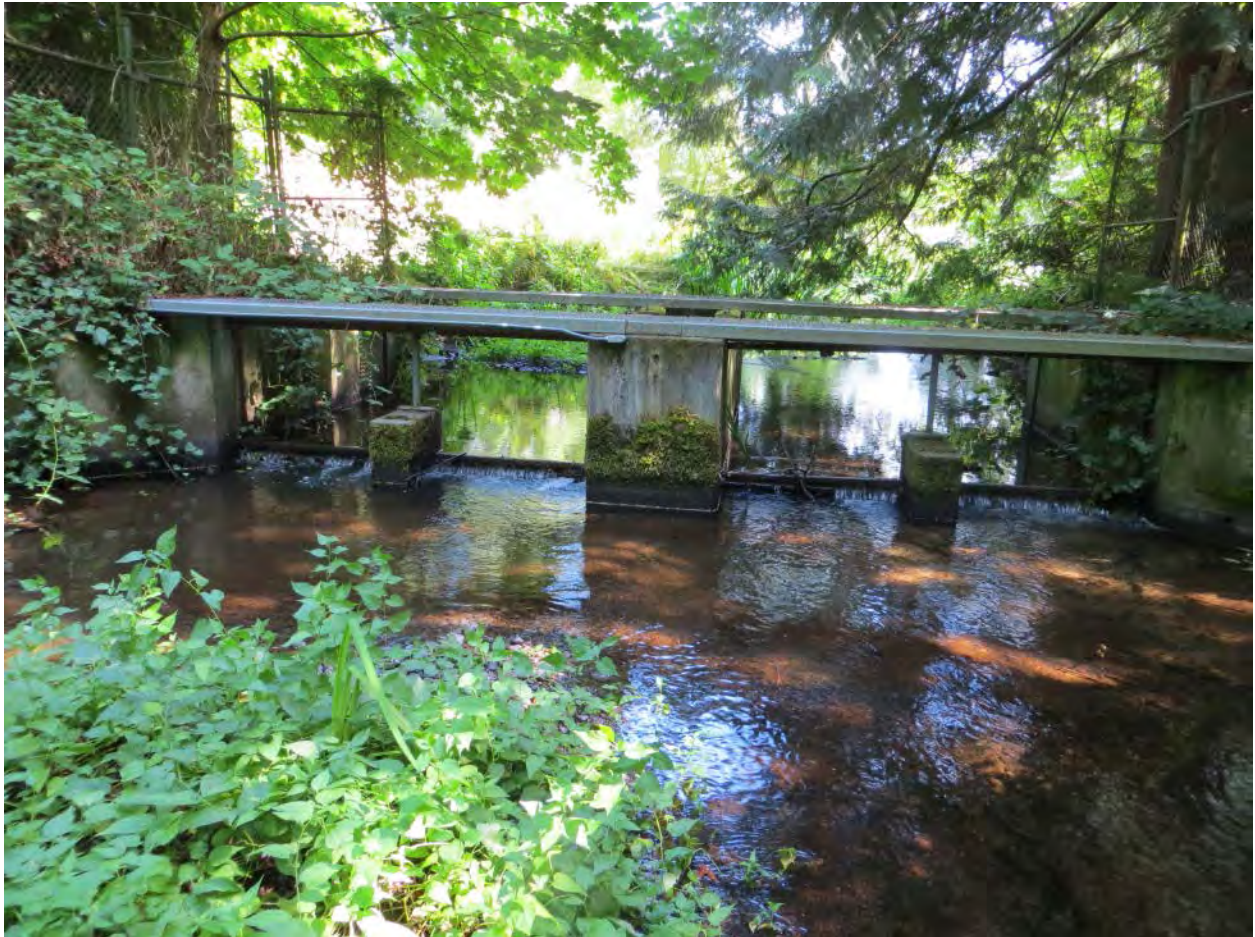
Problem: Fish screens at the outlet of Kitsap Lake previously restricted anadromous fish passage. The screens were removed in 1999; however, the concrete pieces that supported the screens remain in the channel (Figure 60). At times, this infrastructure has been altered by local residents to control the lake level without authorization. Such action results in rapid drawdown of streamflow in downstream segments of Kitsap Creek.

Figure 60. Existing infrastructure at outlet of Kitsap Lake (photo by S. Todd, August 2013).

Approach: Remove infrastructure from the channel at the lake outlet to prevent future manipulation of lake levels.

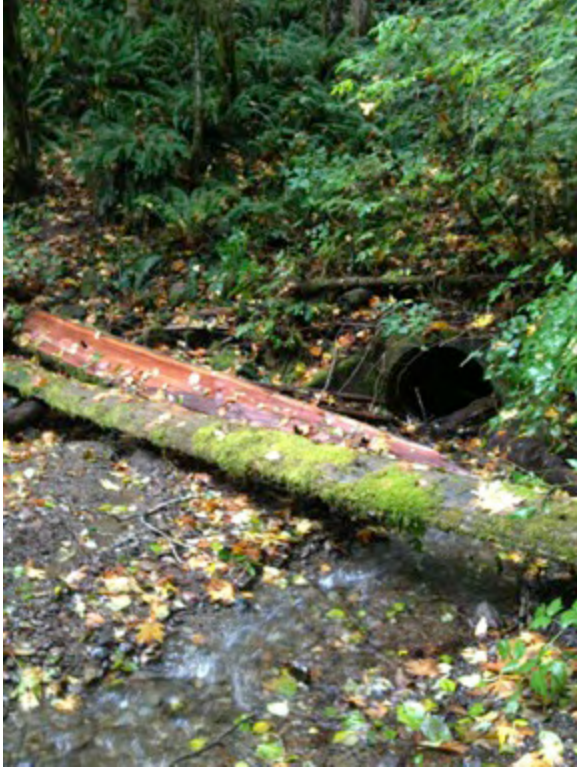
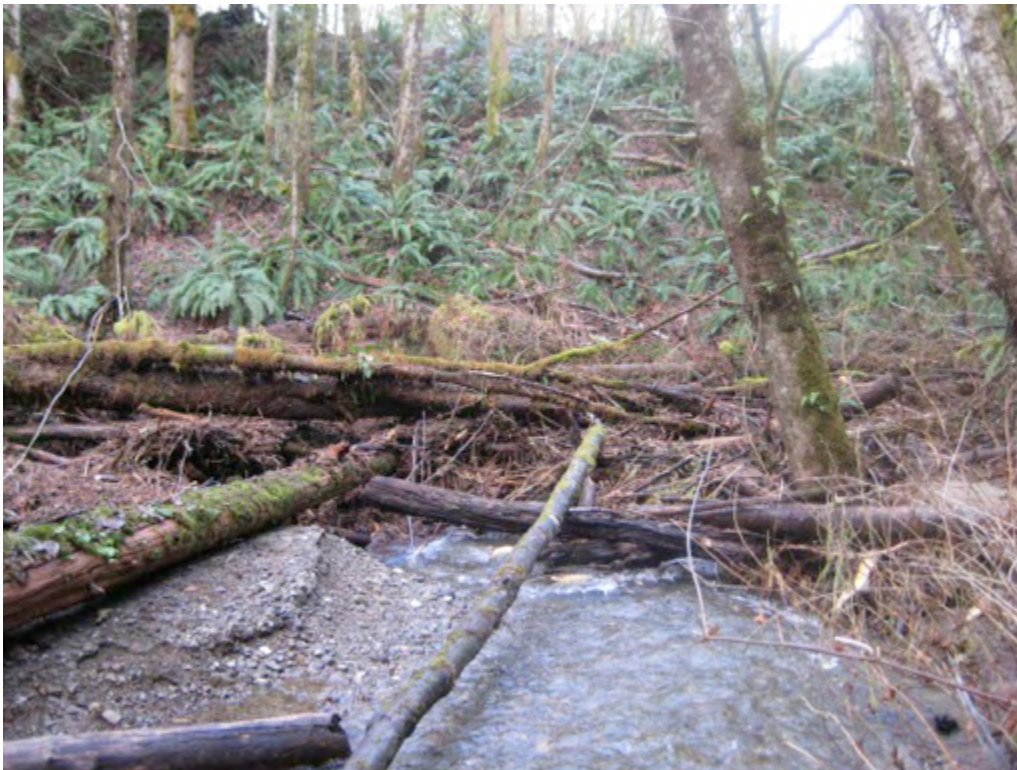
Problem: The U.S. Navy railroad crossing at Dickerson Creek is constructed on artificial fill that rises 40 ft above the valley floor. Two metal culverts pass through the railroad embankment. The culvert outlets are perched due channel incision downstream. A fish ladder maintains passage to one of the culverts (Figure 63); however, the culverts are assumed to be velocity barriers during high flows and also pose passage problems during low flows. The crossing restricts conveyance of sediment and wood from upstream reaches. Sediment and wood accumulate on the upstream side of the railroad grade during floods and are removed from the channel by the Navy's routine maintenance (Figure 64).

Figure 64. Photos of Dickerson Creek at the Navy railroad, view looking downstream. Upper photo from October, 2012 (photo by Tim Abbe, NSD). Lower photo from December 2010 shows blockage of the 48" diameter culverts (photo by Jon Oleyar, Suquamish Tribe).

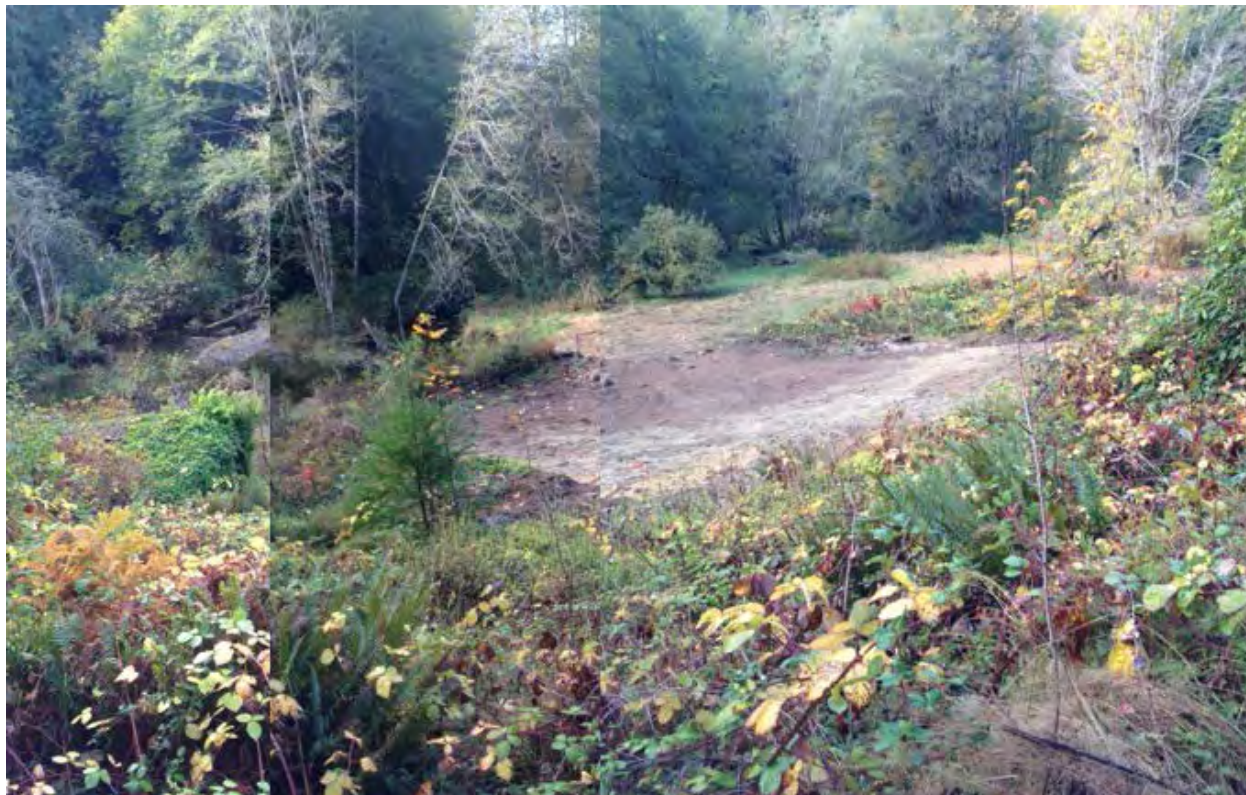
Problem: The riparian forest has been cleared along the lower 500 ft of Wildcat Creek (at the confluence with Lost Creek) as part of an abandoned homestead that is now part of the Rhododendron Preserve (Figure 66). The channel is slightly incised, has unvegetated banks, and is lacking in channel complexity due to impairments to natural wood recruitment.

Figure 66. Photo of the homestead area along Wildcat Creek at the confluence with Chico and Lost Creeks (photo taken Oct. 2013 by Tim Abbe, NSD).

Approach: Re-establishing native forest is crucial to the long term restoration of the stream corridor. Recent efforts to remove abandoned buildings from the property create opportunity to re-plant riparian vegetation. The addition of large wood to the stream will not only increase the number of pools and

cover, but raise water elevations and improve floodplain connectivity. Minor excavation work can restore ephemeral side channels and wetlands along the left bank floodplain that were filled when the site was farmed. Beavers have been very active in the area and restoration designs at this site (as well as some other locations in the watershed) will need to consider how beavers utilize the area and alter the channel, floodplain, and riparian characteristics of the stream corridor. The site may be ideal for public access where visitors can see a very rare Puget Lowland stream in near-pristine condition (upstream of homestead) and see a locally impacted area in the process of being restored.
