Harper Estuary Restoration Project Update

December 1st, 2016

Southworth Drive Culvert Improvement

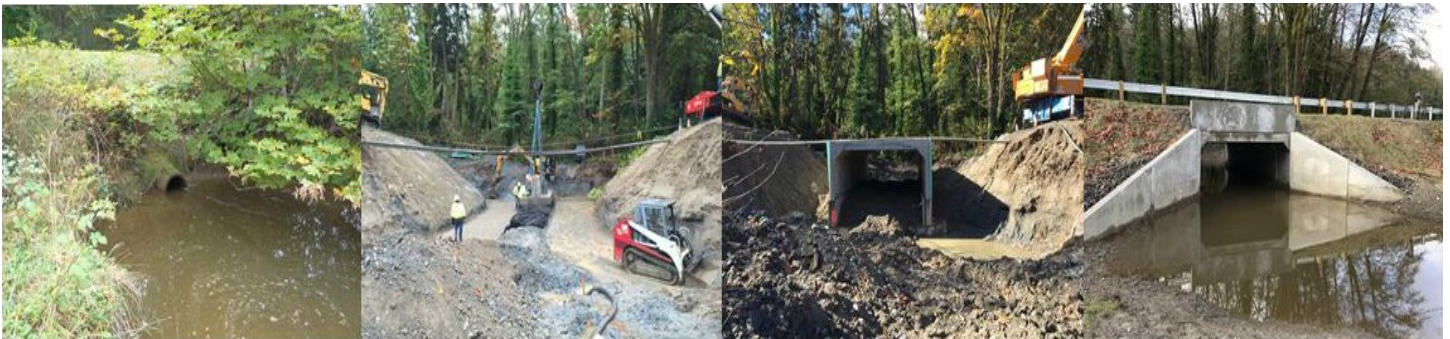
The photos below show the transformation that took place in just a few weeks from mid-September through mid-October. Within days construction workers started reporting sightings of salmon at the entrance of the culvert.

The installation of the replacement culvert under Southworth Drive was completed in early November 2016. The new 16-foot box culvert replaces an undersized 24-inch concrete culvert. This new culvert will allow fish access and more tidal influence to Harper Creek upstream of the road crossing. In addition to environmental benefits, larger culverts provide better conveyance of floodwaters, sediment and wood during winter storms.

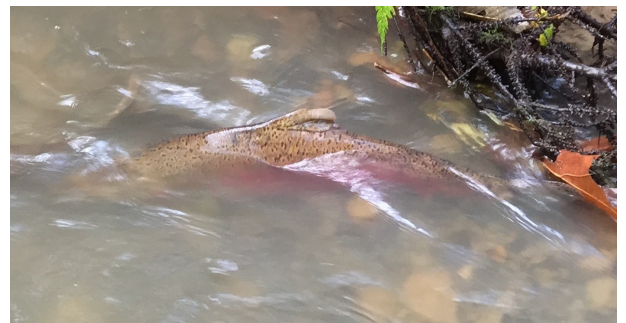
Photo: Female coho looking for the right spot to build a redd.

Starting November 9th, employees with the Washington Department of Fish & Wildlife (WDFW) began conducting salmon spawning surveys upstream of the newly upgraded culvert. The observations from the construction workers and residents were confirmed, salmon were indeed utilizing habitat upstream of the culvert. During the first survey, WDFW biologists observed six coho salmon and two redds (disturbed gravel where females have laid eggs). During subsequent surveys, thirteen Coho and thirteen redds have been observed. In the weeks prior to the replacement of the culvert, salmon were not observed upstream by WDFW staff.

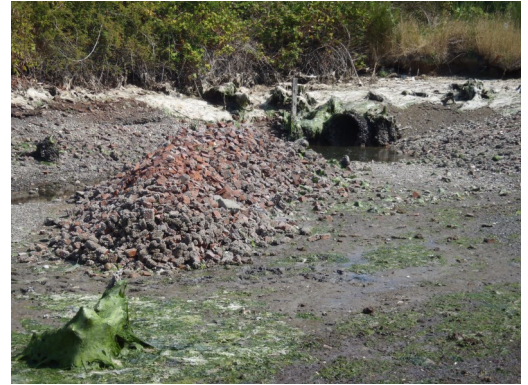
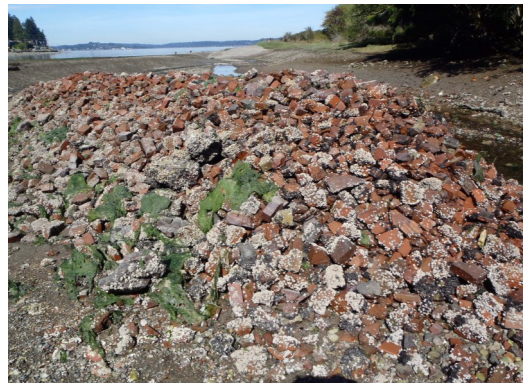
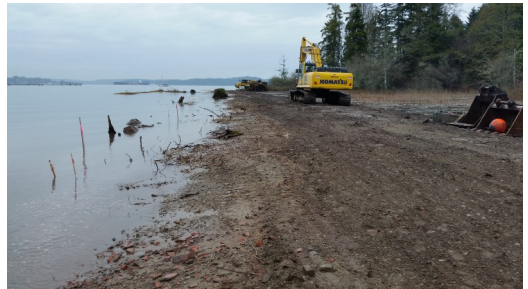
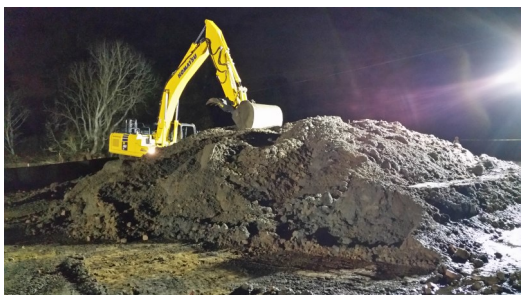
Work has begun on the removal of industrial fill including bricks, gravel, and extra fill placement. Some of the fill is quite deep, such that elevations will be restored following excavation with clean fill to re-establish estuarine habitat. In a few locations, the soil associated with this material was found to have slightly elevated levels of arsenic and cPAHs (Polycyclic Aromatic Hydrocarbons) during testing. This fill is being removed as part of the project and taken to approved disposal locations.

Much of the work is taking place at night due to take advantage of favorable low tides (see night work update). Additional work to be accomplished in coming months include removal of industrial fill on the south side of Olympiad Drive, excavation of a tidal connection to the wetland to the east of the Olympiad culvert and placement of logs and native plants. Water quality and sediment testing will continue throughout the project.
